## Partial Replacement of the Active Steel on the Turbogenerator End Zone

Original scientific paper

This modernization was done on the generators type TVV-200-2A in TPP Bitola, and is subject of this paper.

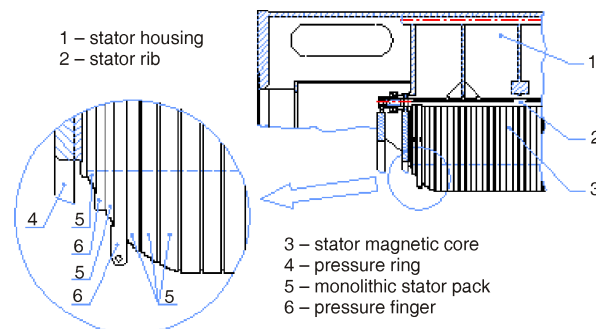
**Figure 1. Modernized end part of stator magnetic core for turbo-generator n.1 in TPP Bitola**

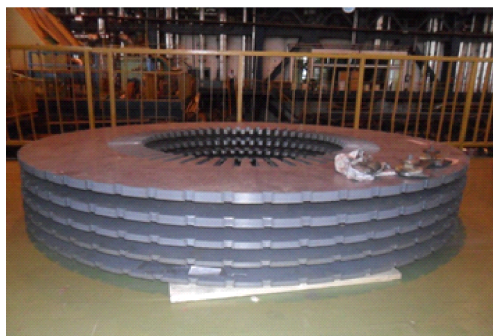
On fig. 2 monolithic (backed) packs which were mounted on the end parts of the stator magnetic core of turbo-generator n.1 in TPP Bitola are presented. As it can be seen packs are reducing in diameter going from the inside towards the end of the core but they are also reducing in thickness in the same direction.

Figure 2. Monolithic packs for replacement of the end part of stator magnetic core for turbogenerator n.1 in TPP Bitola

For reducing the loses and heating of the stator core so called “magnetic shunt” is applied. It represents special packs from electro-technical steel, similar to the packs from the basic core, but in length of 36.5 mm first, 31 mm second, 24 mm third, 18 mm fourth, and 18.5 mm the fifth pack from the inside towards the end with hard pressure with fingers (fig. 1). The way they are placed these packs do not change the basic magnetic flow, but they short circuit the axial flows from dispersing on the end parts of stator winding with cutting from pressure cooper screen. For better ventilation of the magnetic shunt, magnetic shunt itself is separated from basic core with pressure fingers.

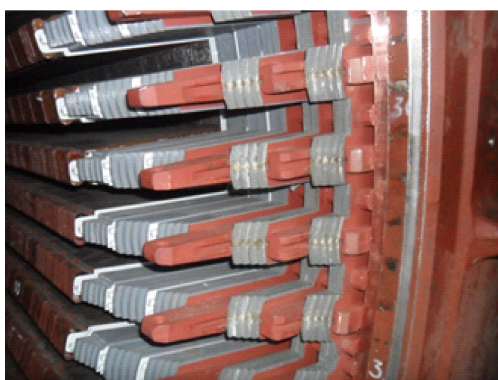
On fig. 3 modernized end part of the magnetic stator core of turbo-generator n.1 in TPP Bitola is presented.

Figure 3. Modernized end part of the magnetic stator core of turbo-generator n. 1 in TPP Bitola

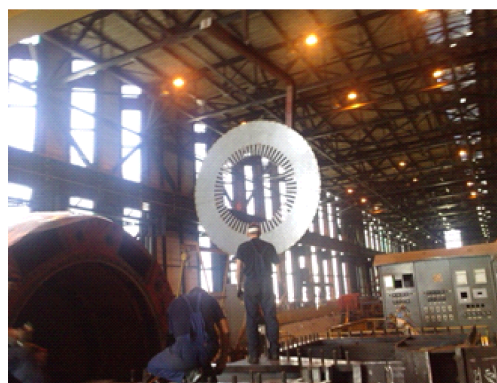
Figure 4. Monolithic end pack of the stator magnetic core in the process of mounting for turbo-generator n. 1 in TPP Bitola

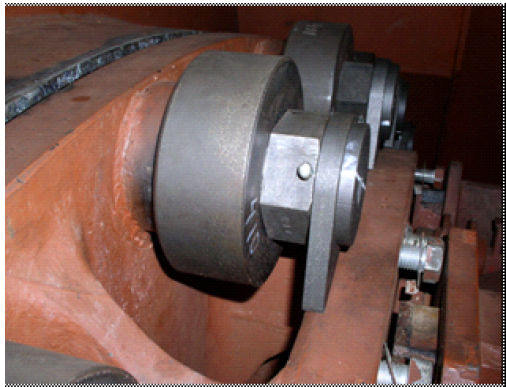
On fig. 6 one pressure accumulator which has been mounted on turbo-generator n.1 in TPP Bitola is presented.

**Figure 6. Pressure accumulator mounted on turbogenerator n. 1 in TPP Bitola**

The efficient method of restoring the active steel tightening force at the first and the second loosening stages is the installation of special spring devices having the specified and adjustable pressure under the core tightening nuts (fig. 5).

The spring blocks (pressure accumulators all together 20 from each side of the core) are mounted after carrying out the works on the teeth local repairs and additional works ensuring the core pressure rings movability.

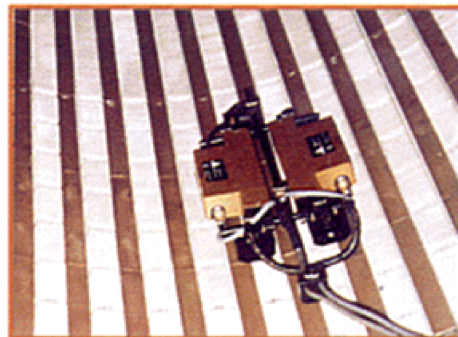
**Figure 7. Instrument ELCID and probes in process of electromagnetic control of stator core**

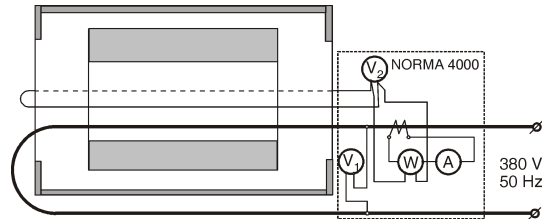
The examinations were carried out with current of 400 A, 50 Hz from 0.4 kV source with one magnetization winding around the core, one control winding and induction of 1 T in duration 72 minutes according to the following scheme.

Figure 8. Connection scheme for core ring flux test

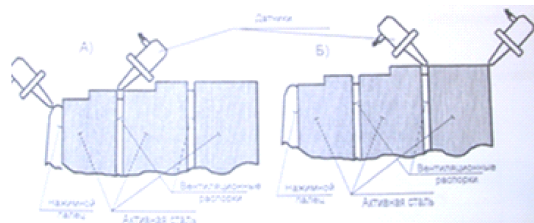
Figure 9. Handling the probes for measurement of: (a) pressure finger – pack and (b) pack from tooth
