Evaluation of surface characteristics of new rotary nickel-titanium instruments – SEM-EDS analysis

Milica Jovanović Medojević¹, Alena Zdravković², Mina Medojević¹, Đorđe Stratimirović¹

¹University of Belgrade, School of Dental Medicine, Belgrade, Serbia;

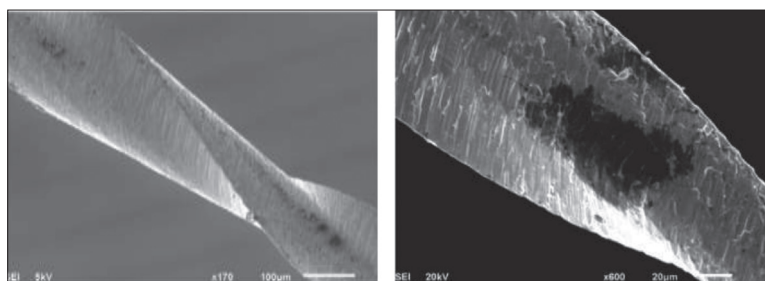
SEM analysis of Mtwo instruments indicated the presence of metal strips in apical (50%) and middle third (22.2%). The corrosion was observed only on one instrument (the thinnest one) (10 / 0.4) in its middle third (Figure 4).

Figure 4. SE image of new Mtwo instrument: a) surface of middle third (10/0.4) with the presence of corrosion ($\times 170$); b) detail from the previous image at higher magnification ($\times 600$)

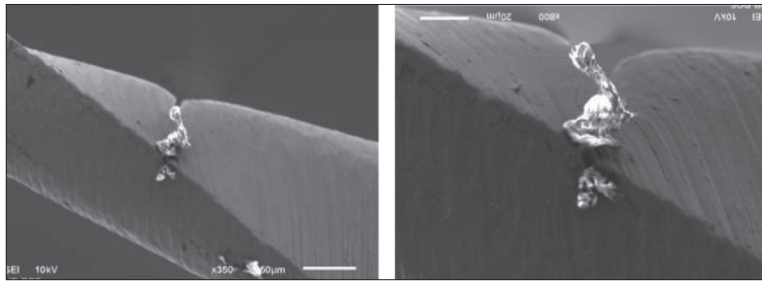
Blunt cutting edge of Mtwo instruments was observed on apical surface of one instrument (25 / 0.6) and defect in the form of disruption of cutting edge in middle third of

the instrument (20 / 0.6) (Figure 5). Debris (confirmed by EDS analysis) was observed on all instruments, both in the apical and middle third (100%).

Figure 5. SE image of new Mtwo instrument (20/0.6): a) area of middle third with a disruption of cutting edge defect ($\times 350$); b) detail from the previous image at higher magnification ($\times 800$)

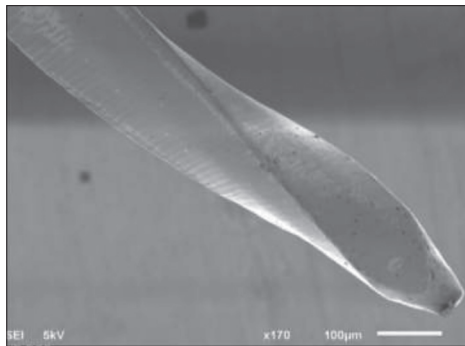
Figure 7. SE image of apical third of new ProTaper instrument (Sx) with corrosion and discontinuity of cutting edge (apart from the presence of pitting and fretting) ($\times 170$)

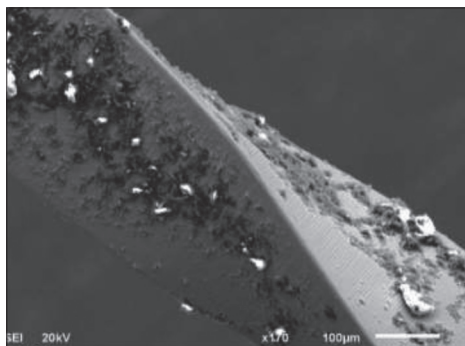
The results of SEM analysis of BioRaCe sets show the most frequent occurrence of metal strips (apical 50% and middle third

Figure 9. SE image of the surface of new BioRaCe instrument (No. 3) i.e. its middle third with the presence of metal strips and fretting ($\times 170$)

38.8%) and fretting (apical 33.3% and middle third 27.7%) (Table 4, Figure 9). Debris contamination detected by EDS analysis was observed on the apical (11.1%) and middle surface (22.2%) of the instruments.

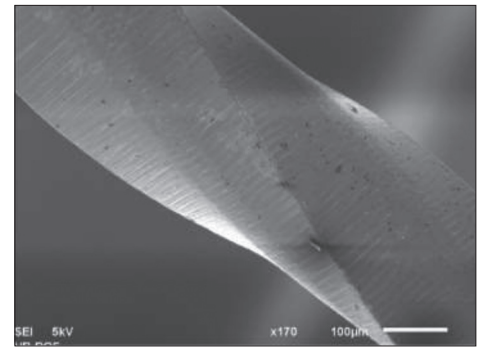
The most common defects on the working surface of new ProTaper Universal instruments were changes in the form of fretting (apical and middle third, 100%) and pitting (apical third 83.3% and middle third 88.8%) (Table 4, Figure 6). Metal strips were detected on the apical (50%) and middle third (38.8%). A defect on the cutting edge (disruption of its continuity) was observed on one, the most conical instrument (Sx) (apical and middle third), and corrosion on the apical (11.1%) and middle part (11.1%) (Figure 7). Contamination in the form of debris was noticed in apical third (100%) and in middle third of slightly more than a half (55.5%) of ProTaper Universal sets. The most common defects on new HyFlex instruments were the appearance of fretting in the form of debris on apical and middle segments of all instruments (100%) (Figure 8). A defect in the form of a microfracture was observed on the apical part of the instrument (25-0.08) as well as the appearance of metal strips (25-0.04).

Figure 6. SE image of middle part of ProTaper Universal instrument (F2) with pitting and fretting ($\times 170$)

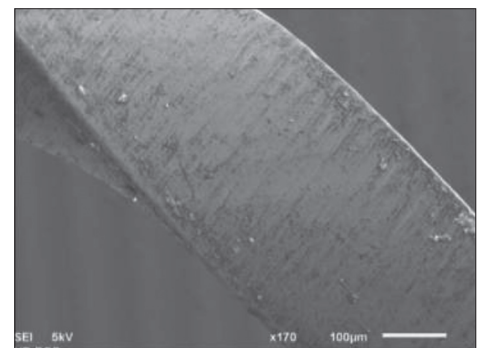
Figure 8. SE image of the middle third surface new HyFlex instrument (30-0.04) with the presence of fretting and debris ($\times 170$)
