# INVESTIGATION OF THE ENERGY EFFICIENCY OF THE MILITARY MUSEUM BUILDING BY INFRARED THERMOGRAPHY

Slavica S. Ristić, GOŠA Institute, Belgrade,  
Suzana R. Polić-Radovanović, CIK – Central Institute  
for Conservation, Belgrade,  
Bore V. Jegdić, GOŠA Institute, Belgrade

FIELD: Energy Efficiency  
ARTICLE TYPE: Professional Paper

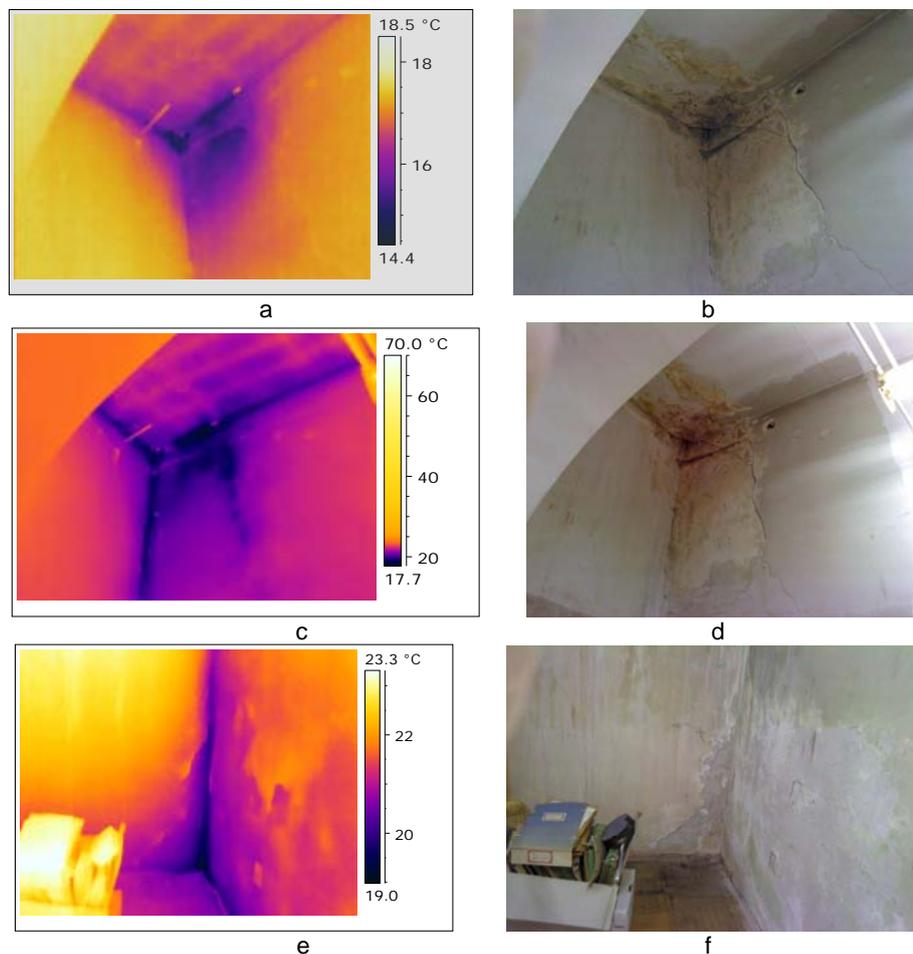
perature falls to 10.8°C. The analysis of the thermogram shows that optically visible stains on the wall are larger than the area of the currently active moisture. In this corner, an electrical wire is surrounded by a wet wall (Fig.1).

The next thermographic inspection was done at the end of November, two days after a heavy rain, at the following conditions:  $T_{ou} = 5^{\circ}\text{C}$ ,  $T_{in} = 11^{\circ}\text{C}$ , weather conditions: Overcast, no wind (Figs.1c and 1d). Active, visible moisture and leakage through the building originated from the terrace above this part of the room, covering the big wall area.

*Figure 1* – Moisture in the far left corner of the library in relation to the front door, a,b-thermogram and the photo in the October test, c,d-thermogram and the photo in the November test, e and f- the lower part of the same corner during the second test

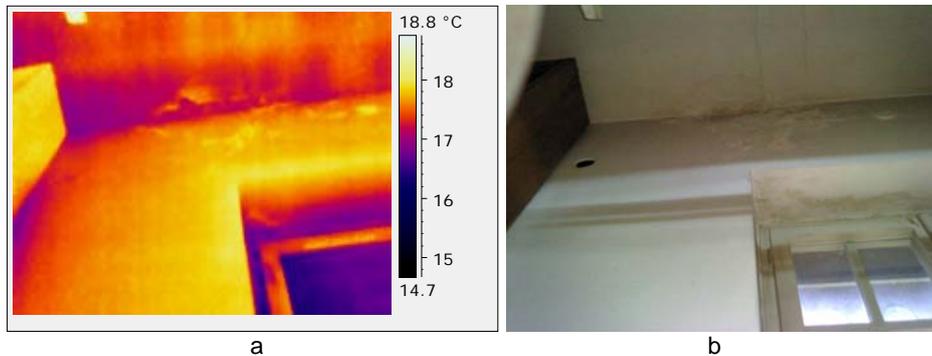
The moisture was not detected in the wall above the first (from left) window (Fig.2a). Poor sealing of the windows was recorded. Brighter parts of the thermogram represent the parts of the wall with a layer of plaster disbonded. The air under the plaster is a good insulator; therefore, these parts were warmer (brighter) than the rest of the wall.

Figure 2 – Part of the wall above the first left window  
Slika 2 – Deo zida iznad prvog levog prozora

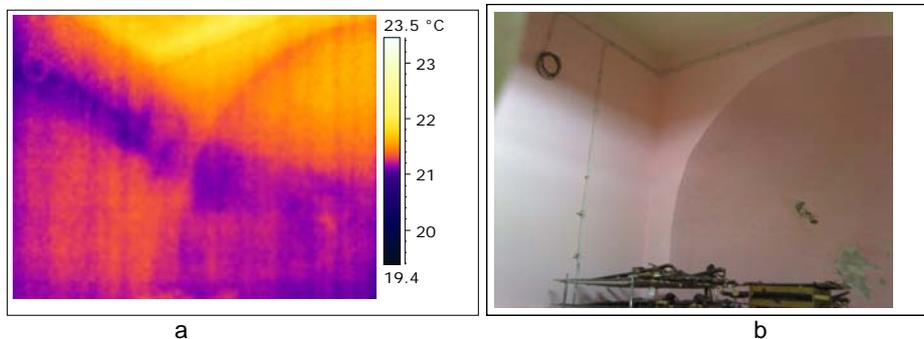
In the weapons depot, the temperature during the October test was  $T_{in} = 21^{\circ}\text{C}$ , humidity 60%. Under these conditions, the dew point would be when the temperature reaches  $13^{\circ}\text{C}$ . The concrete bridge (Fig.3a) is colder than the rest of the wall. It is a potential place for the condensation of moisture.

Figure 3 – Visible cold zones and the concrete beam in the weapons depot  
 Slika 3 – Vidljive hladne zone i betonska greda u depo naoružanja

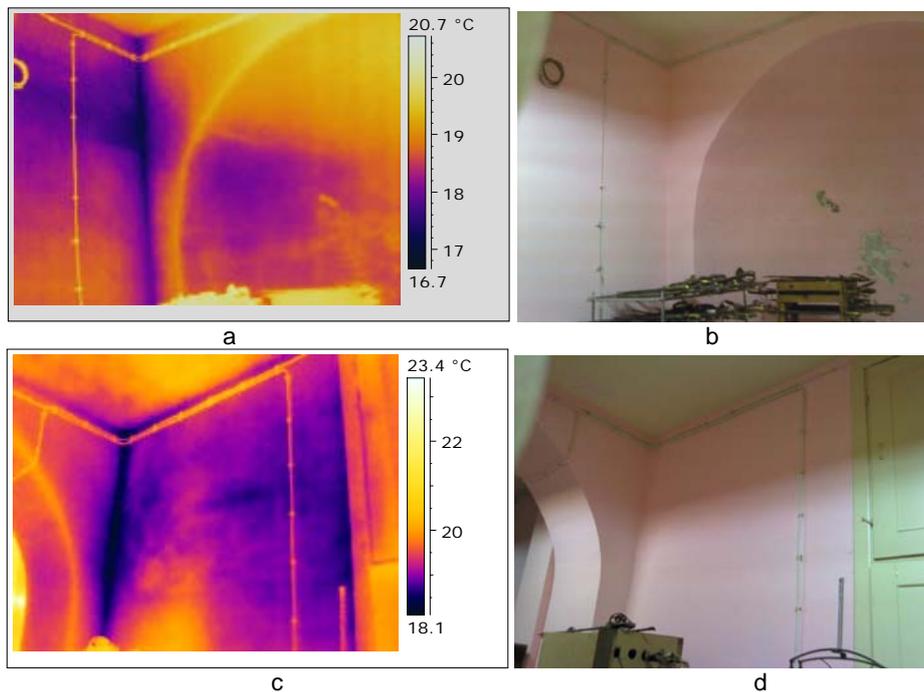
The second set of thermographic tests, performed two days after a heavy rain, ( $T_{ou}= 5^{\circ}\text{C}$ ,  $T_{in}= 20^{\circ}\text{C}$ ), displays the extent of the moisture intrusion in the weapons depot (Fig. 4). In the upper left corner (Fig. 4a), beside the cold concrete bridge, there was damp penetration since the depot is in the basement, below the ground level. A similar case is in the right corner, too. The electrical installations are visible as bright lines on both thermograms.

Figure 4 – Thermograms and the photos of the weapons depot with visible moisture  
 Slika 4 – Termogrami i fotografije depoa naoružanja sa vidljivom vlagom

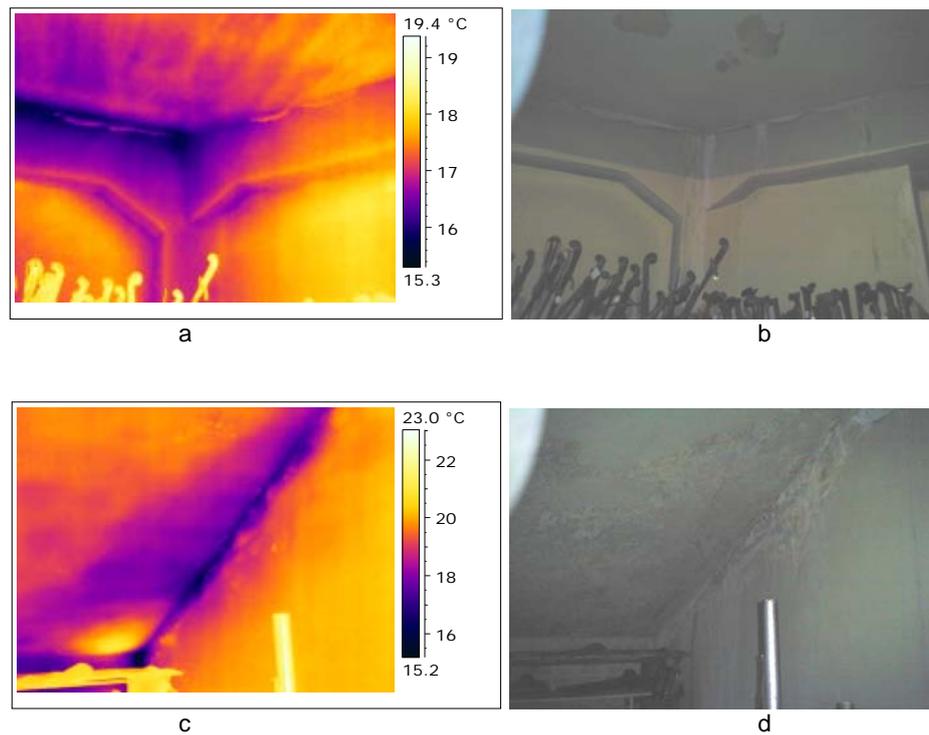
The presence of moisture in the depot where old metal artifacts are kept, contributes to the acceleration of corrosion and deterioration of exhibits. The thermographic inspection shows that moisture is penetrating from the roof and from the poor leakage location (Fig. 5).

Figure 5 – Some details of the old metal artifacts depot  
Slika 5 – Nekoliko detalja depoa sa zbirkom starih metalnih eksponata

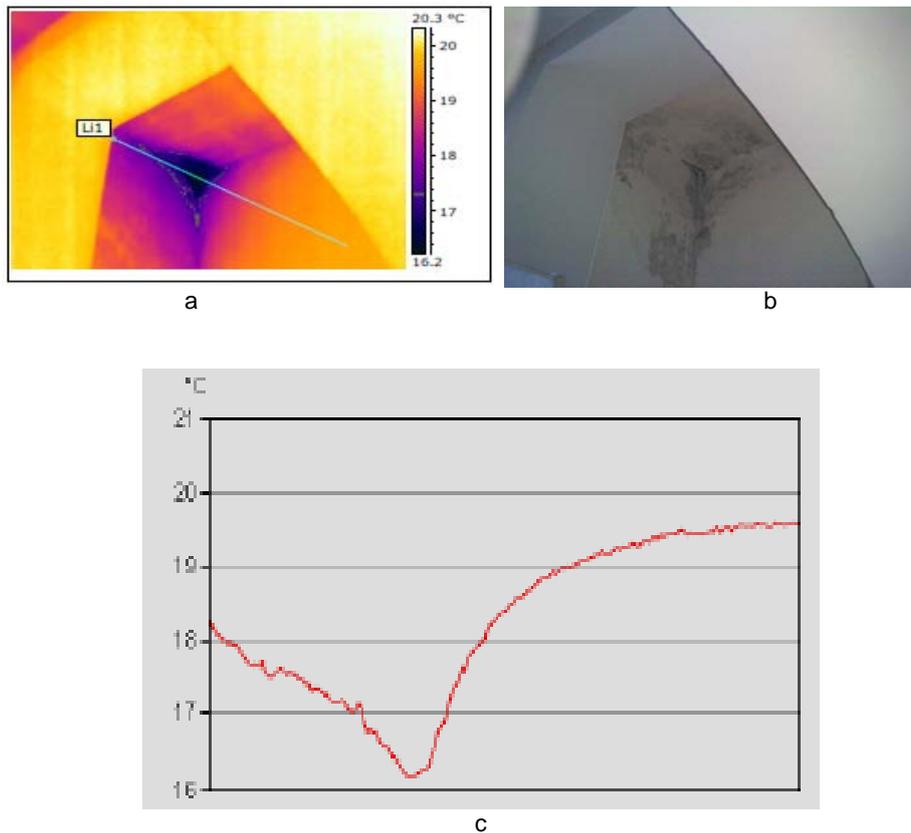
Moisture intrusion was detected in most of the inspected museum depots and other rooms,. The active moisture was detected in the depot of gifts, too. During the thermogram recording, the measured temperature was  $T_{in}=20.8^{\circ}\text{C}$  and moisture was 53.7%. If the measured moisture retains, and the temperature lowers to  $T_{in}= 10.8^{\circ}\text{C}$ , then the condensation of moisture from the air appears on the walls. Figs. 6 show a part of the ceiling in the right upper corner with a-thermogram, b-digital photo and c-diagram of the temperature changes along the line tool.

Figure 6 – Part of the gifts depot  
 Slika 6 – Deo depoa sa zbirkom darova

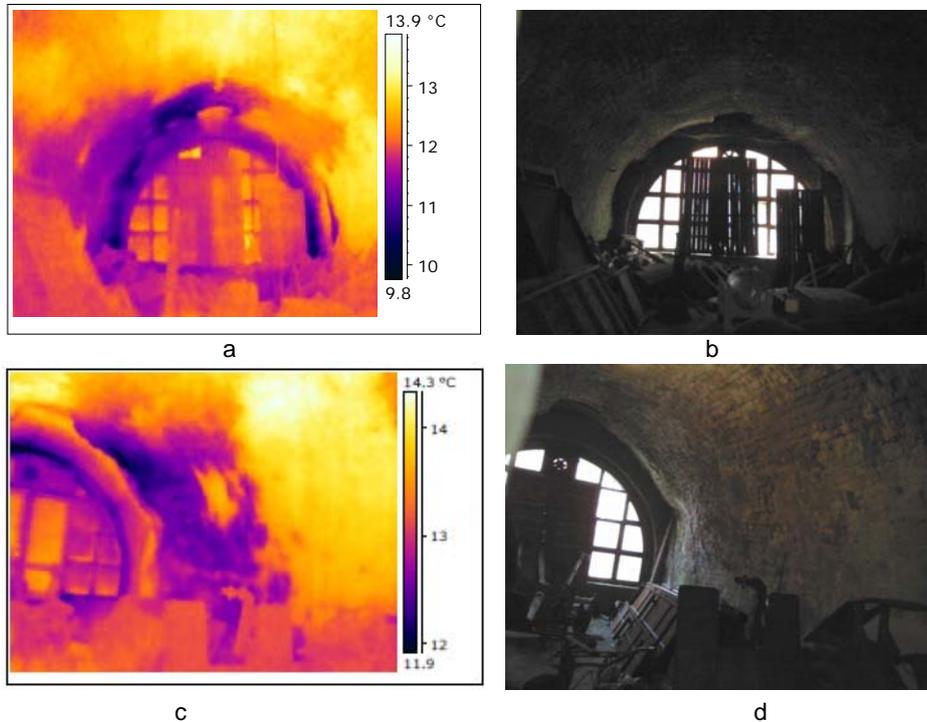
Fig. 7 shows the presence of moisture in the museum Casemates. The inspection was performed under these meteorological conditions:  $T_{ou}=19^{\circ}\text{C}$ ,  $T_{in} = 15.4^{\circ}\text{C}$ , humidity of 67%, dew point temperature  $9.3^{\circ}\text{C}$ . Metal objects have been kept in the dungeons of the Military Museum at Kalemegdan, and the present moisture has a beneficial effect on the development of corrosion (Polić-Radovanović, Ristić, Jegdić, Nikolić, 2010), (Polić-Radovanović, 2010, p.161), (Jegdić, et al, 2011, pp.50-56), (Jegdić, et al, 2012, pp.169-182).

Figure 7 – Moisture in the museum Casemates, a,b – the first casemate  
 c,d – moisture in the second one  
 Slika 7 – Vлага u muzejskim kazamatima, a, b – prvi kazamat,  
 c,d – vлага u drugom kazamatu

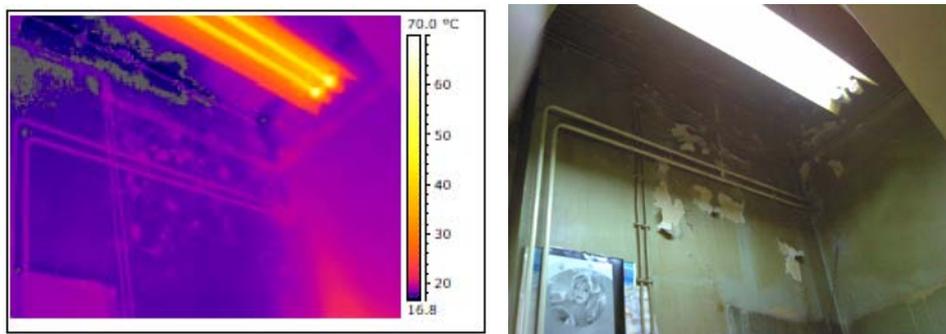
The workshop for metal conservation was investigated by thermography. The cold and damp workshop walls are presented in Fig. 8, (a thermogram-, b-digital photo, c-isotherm indicating that moisture covered the area).

Figure 8 – Appearance of the cold wall in the workshop for metal conservation  
Slika 8 – Izgled hladnog zida u radionici za konzervaciju metalnih eksponata

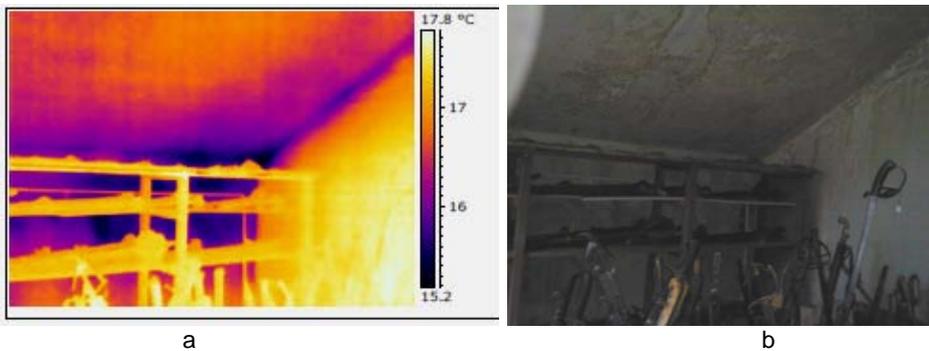
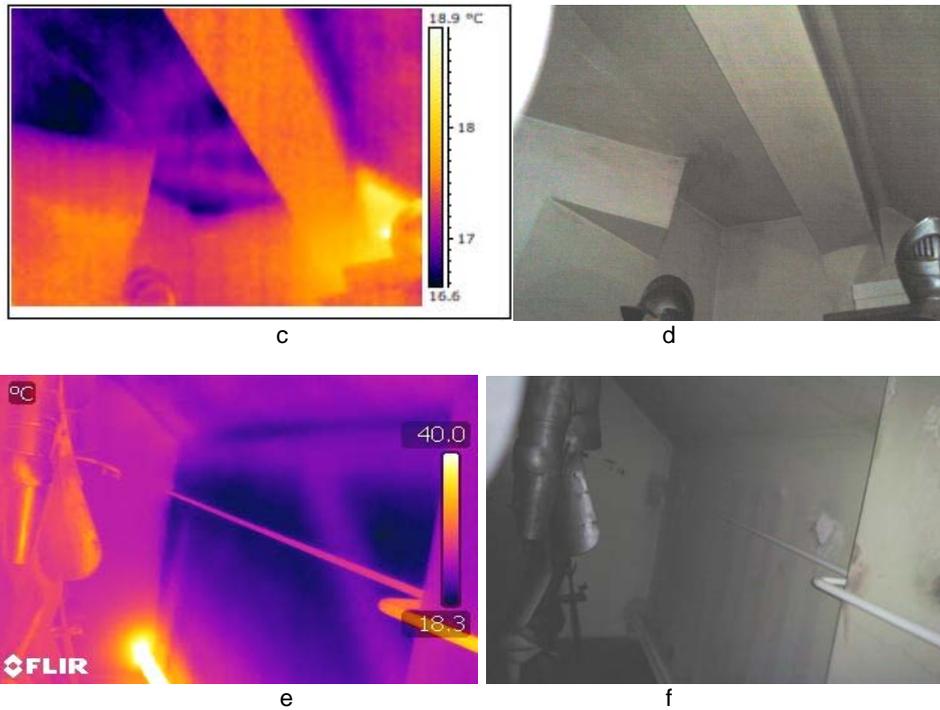
The collection of old metal artifacts is stored in the depot where the wall and the roof have poor thermal insulation. Figs. 9a to 9c show the

right corner of the depot. There are stains, but currently there is no moisture in the walls. The wall behind the shelves which restrict the access for thermographic inspection is colder than the other walls because of poor thermal insulation. The part of the door and the poor roof insulation are shown in Figs. 9c and 9d. The same situation is in the depot with the collection of non-European weapons.

Figure 9 – Depot of old metal artifacts, a,b – side wall, c,d – roof, e,f – wall of the depot with the collection of non-European weapons  
 Slika 9 – Depo zbirke starih metalnih eksponata, a,b-bočni zid, c,d – krov, e,f – zid depoa sa zbirkom neevropskog naoružanja

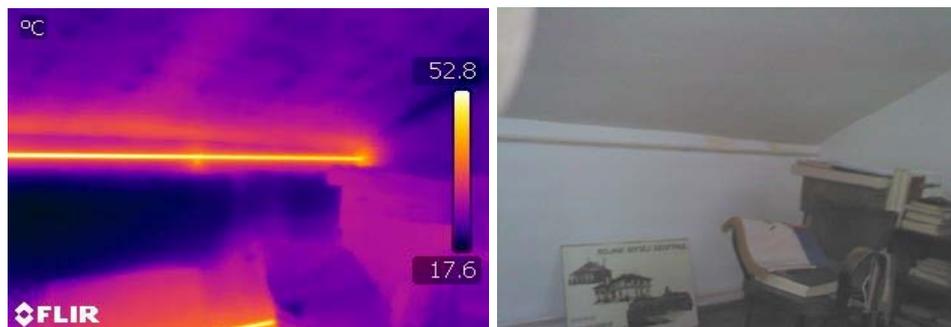
The thermal insulation is also very poor in the museum offices. Fig. 10 shows the thermogram and the photo recorded in the museum office located in the attic.

Figure 10 – Office in the attic, poor thermal insulation  
 Slika 10 – Kancelarija u potkrovlju, loša termalna izolacija

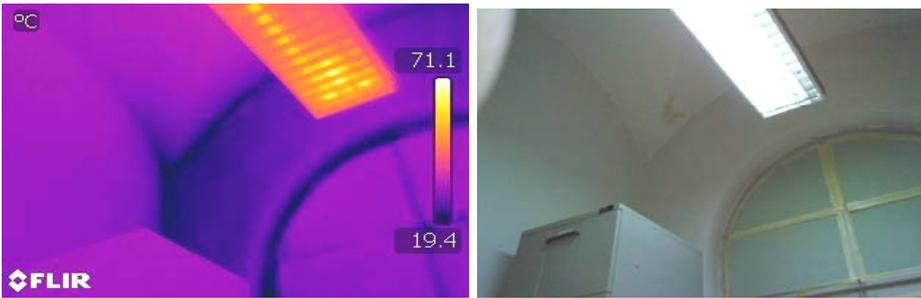
The thermographic tests of the photo collections depot confirm that there is no potential leak, penetration or condensation of moisture, only poor thermal insulation (Fig.11).

Figure 11 – Poor thermal insulation in the photo collections depot.  
Slika 11 – Loša termička izolacija u depou sa zbirkom fotografija

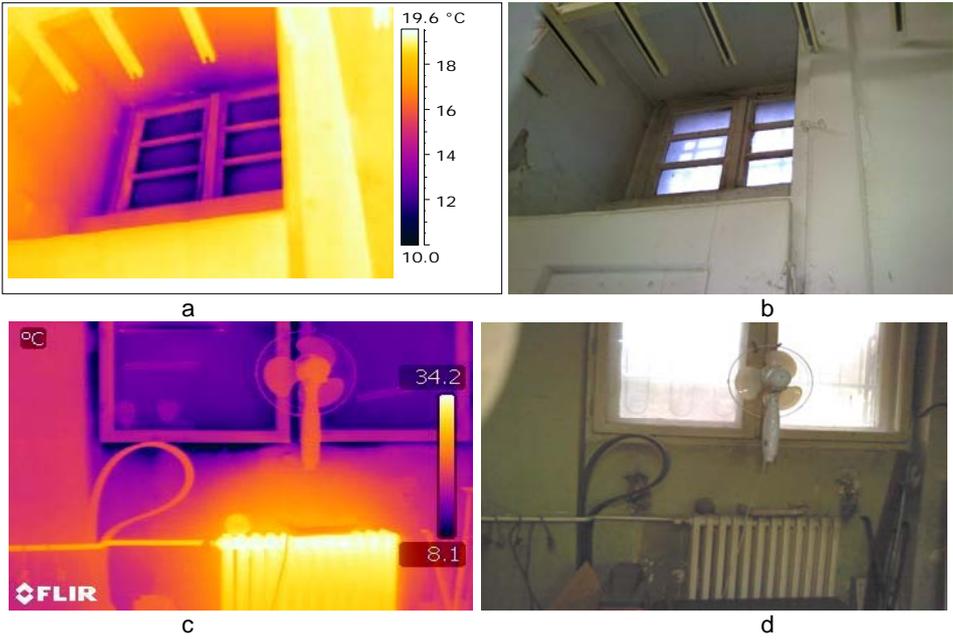
Visual and infrared images of some windows and doors of the museum building show the poorly sealing windows, with an air leakage. This is a very important malfunction for the energy efficiency of the building (Fig 12).

Figure 12 – Poorly sealing windows, cold air leakage, a,b – banners depot and c,d – in the workshop for metal conservation  
Slika 12 – Lošo zaptivanje prozora, prodor hladnog vazduha, a,b – depo sa zbirkom ratnih zastava, c,d – radionica za konzervaciju metalnih eksponata
