### БРЗА ДИЈАГНОСТИКА КАТАСТРОФАЛНОГ ДОГАЂАЈА КОЈИ СЕ ДОГОДИО 3. АВГУСТА 2015. ГОДИНЕ У ПОЛОШКОЈ ОБЛАСТИ

### RAPID DIAGNOSTIC OF THE CATASTROPHIC EVENT HAPPENED ON 3<sup>RD</sup> AUGUST 2015 IN THE POLOG REGION

<sup>1\*</sup>Ss. Cyril and Methodius University in Skopje, Faculty of Forestry

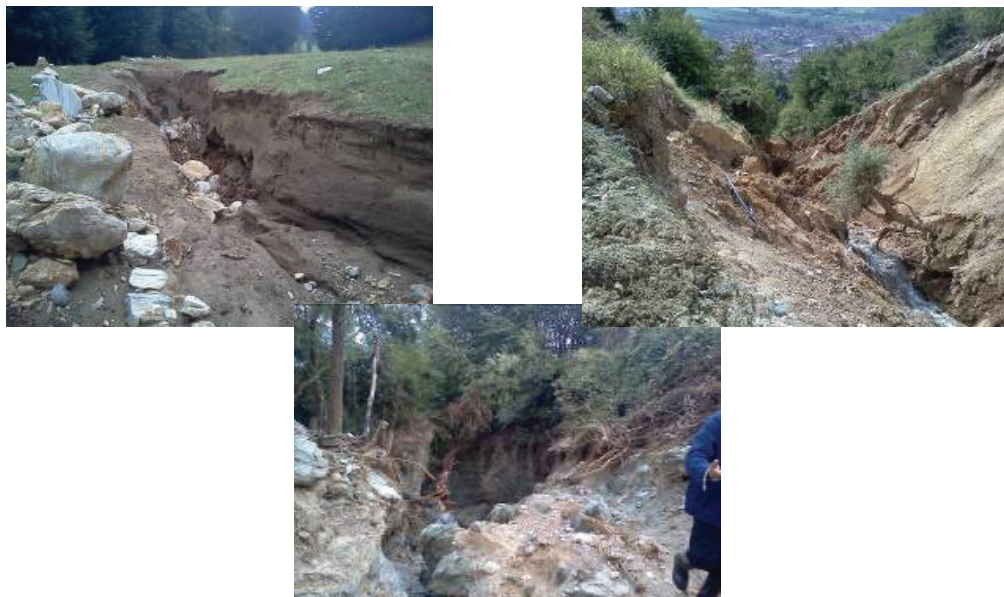
Taking in consideration catchment areas, length and slopes and land cover especially in the upper parts, time for concentration is so short. IN the upper part of the catchments was created the flood wave. Grassland on very shallow soil couldn't retent the water. Excluding river Pena, other scenarioc are very similar. Huge water discharge formed in the upper part cause strong fluvial erosion processes, deepening of the beds and lateral erosion. This lateral erosion process cause landfalls, landslides, rock falling i.e huge quantity of solid material into the beds. All this fluid travel downstream, somewhere the biggest boulders stop, but somewhere boulders achieve even the foot of the slopes.

**Figure 8.** Fluvial erosion processes and landfall into the bed  
(Shipkovica central, Shipkovica 3, Recica)

Absence of cross structures - barrages and steep slope as well as bed shape enable free way for this fluid downstream. The most quantity of sediment was deposit from the Poroj stream.

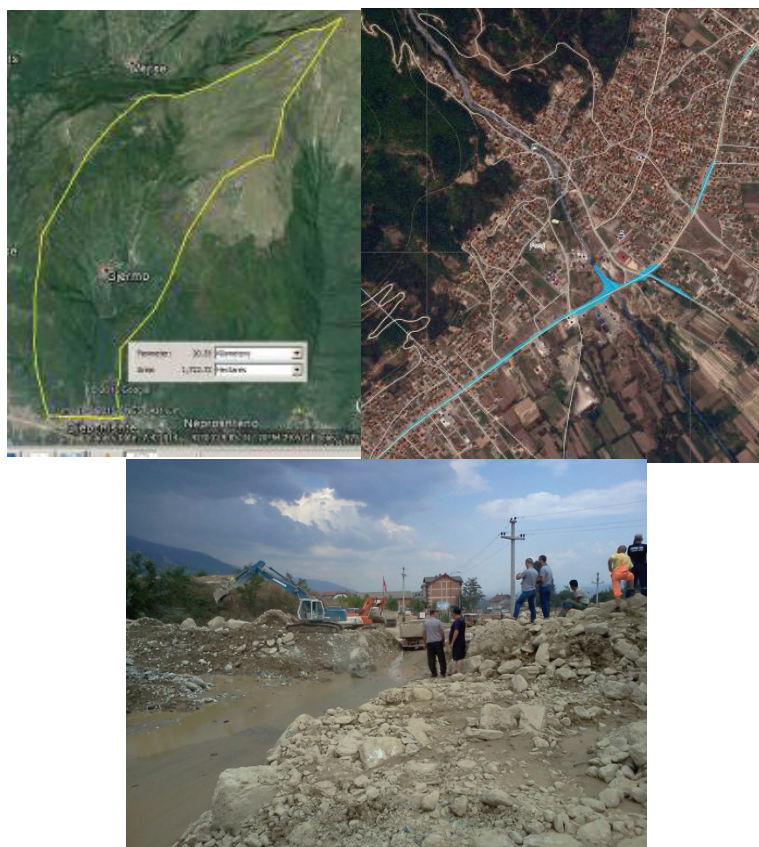
This torrent permanent attack mainly the road Tetovo-Jazince and the bridge. Several times in the recent history Poroj did huge damages. The first time was trained in the 30's after huge flood. Later were constructed classical stone check-dams that were destroyed ion flood in 1979. After that were constructed 4 screw check-dams - Herheuldize type. Taking in consideration that these dams were constructed on –field, they were destroyed later when a great boulder of cca 25 m<sup>3</sup> broke them. There was a massive gravitorial check-dam upstream from the screw-dams.

**Figure 9.** Poroj Catchment, flooded area by torrent and deposits

The width of flooded area along the road was 800 m. Significant quantity of sediments were deposited near the bridge and width of this area was 150 m and length 200, (upstream and downstream form the bridge). In the provisional critical zone there is only 1 facility

(petrol station) and the pavement was flooded and depth of sediment achieved 0,5 m. Taking in consideration [past events, houses in the village of Poroj are so far of the critical zone. Great part of the catchment area is covered with grasslands where soil is shallow. Even in the mid part around the village of Germa dominate cultural landscape. Slope inclination is extreme steep. Erosion intensity is so high, the highest in the region and one of the highest erosion intensity of any torrent area in Macedonia. Beside it, there are rock-falls, weathering, landslides, stream bank erosion is huge. It generate huge quantities of sediment. The torrent Poroj has on average a moderated steepness however, at one point, it reaches a maximum level of 47.7%, which is to be considered as high (name Brza voda – fast water). For that reason this torrent has huge transport capacity. Transported huge amount of sediment leaving large amounts (sand, sediment, rocks etc.). Huge quantities of sediments are not stopped behind ruined check dams and deposit sediments when the torrent bed slope radically decrease. Bridge on the road Tetovo – Jazince contribute to the flooding too. Landslide in Germa is different problem but contribute to torrential floods.

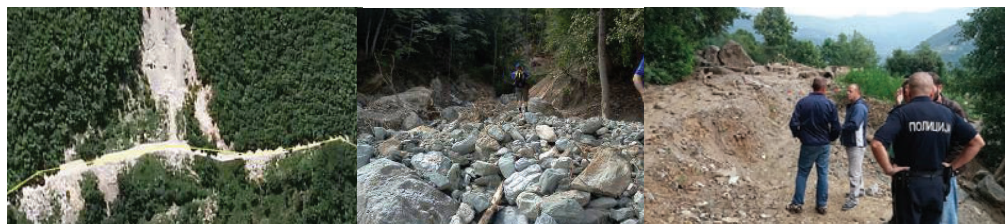
Origin form the high mountain region. Very small and narrow torrent but very dangerous. Long profile of this torrent is specific and enable deposition of sediment in certain areas. One of this areas is just above the road Shipkovica – Brodec. Characterize is extremely big boulders some of them with volume  $> 15 \text{ m}^3$ .

**Figure 10.** Shipkovica torrent 3 - Sediment area, boulders 2015 and damaged road 2016

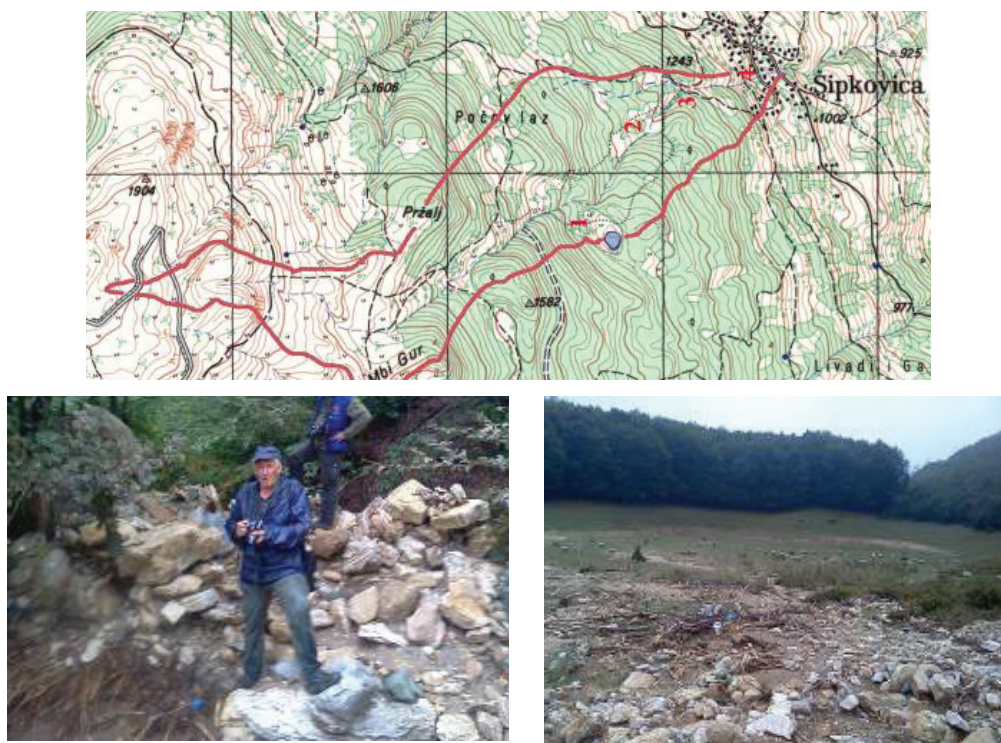
**Figure 11.** Shipkovica central torrent- catchment area- Collapsed dam (1) and sinkhole (2)

In past, after the flood in the 1932 dam were constructed on location 1 and channel to the sinkhole (assigned as lake on the map). With these interventions a catchment area was amputee and decrease on 1/3. Water flowed to the sinkhole and infiltrated in the ground. During the event on 3<sup>rd</sup> August, a dam collapsed and the flood wave continues to Shipkovica. Part of the debris was deposited near the location 2 where torrent bed changes the slope and width. From the section between location 3 and 4 are the highest processes and the biggest sources of sediment.

The last 350 m above the Šipkovica (section 3-4 on the map) the deep erosion processes produced providing the material for the damages in Šipkovica itself. The slope angle ranges between 30 to 40° to NE. On the both sides of the gully which has depth up to 20 m is visible only soil (weathered bedrock). It seems that the gully eroded in to former debris flow deposits. The largest boulders have a diameter up to 7m.

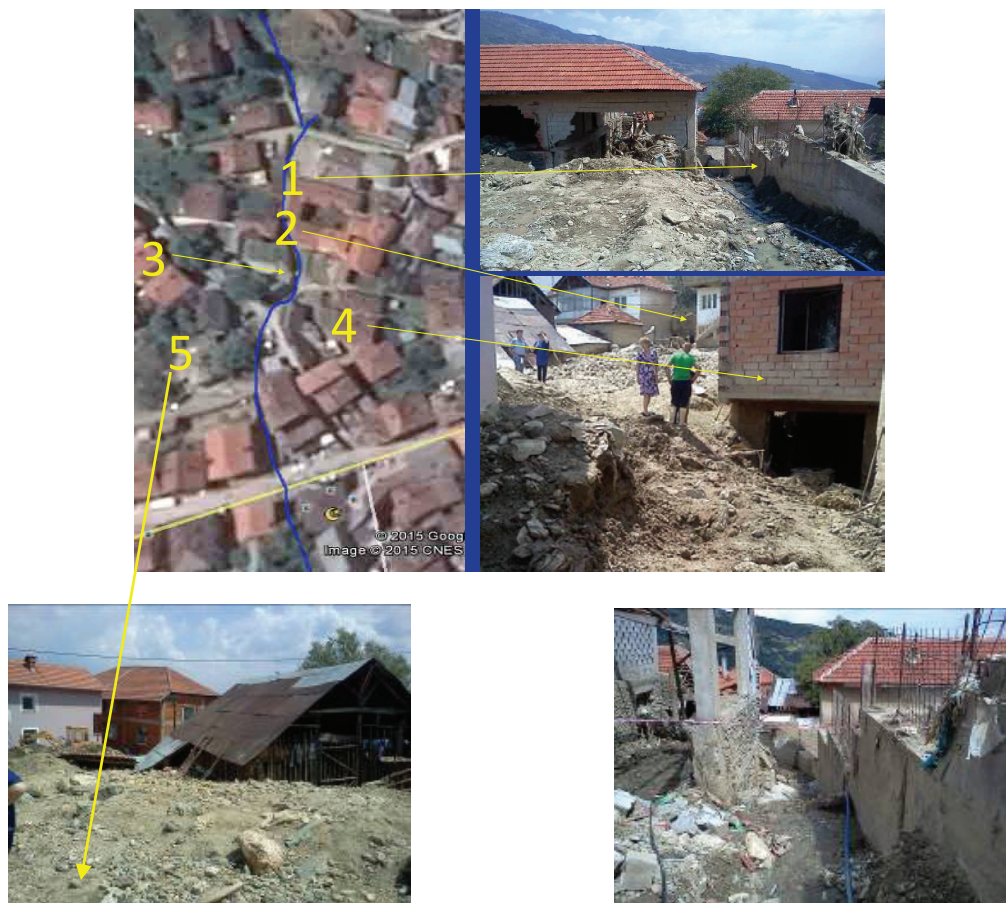
When torrent enters in the village the first problem was no.2 (very narrow channel). House nr.1 was barrier and started deposition before it. The huge power of water demolishes the walls on 2 rooms of the house (1) and passed away. After that the flood wave demolishes the back wall of the side room in the house no.3 and outflow through the door and window. There was 1 died in this house. After the outflow from the narrow channel there were additional problem – an arch wall (no.4) and parked car and farm house. Then water change direction and together with water that pass through house no.3, hit the houses near house no.5. They were barriers and deposition started even into the houses. The first floor of the house no. 5 was fully fulfilled with debris. There were 3 died in this house. Rest of the debris continue to the main street where deposited huge quantity of sediments.

**Figure 12.** Location of structures along the torrent

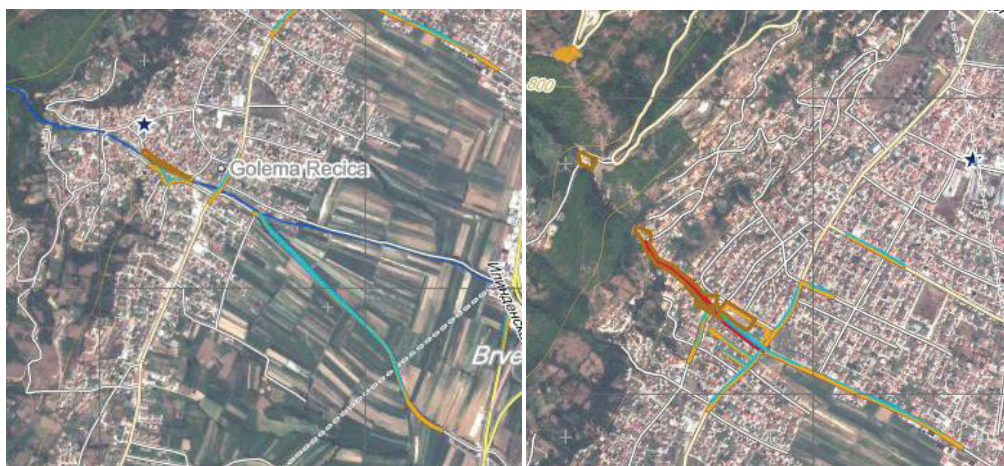
High altitude difference (1500m), high bed slope (>25% even partially >50%), low coverness and soil, contribute to huge peak of discharge. Erosion process in the catchment contributes to creation of significant quantity of sediment that cause torrential flood in the village of Golema Rečica. There are a lot of structures located in possible vulnerable zone to flooding. Bigger particles of the sediment even boulders were deposited in the part before the begging of the channel.

**Figure 13.** Delineated flooded area in Golema and Mala Rečica (Source: *Copernicus EMS*)

Due to the vicinity of settlements, catchment area of Mala Rečica characterizes with a low forest cover (on the left side probably overexploited in past) and a significant grassland area. Beside it denudation processes on the slopes and deep erosion processes together with weathering are reason for generation of big particles of sediment (visible on the right photo). There aren't cross structures into the torrent bed in this area. Beside the road to Rasadishte, are illegal landfills of various constructive wastes. There is a constructive waste. In the same area happened landslide. All this material through the torrent bed was transported to the village Mala Rečica. It was combination of mud flow and debris flow. Bigger particles were deposited in the upper part and then mudflow deposited significant material in the other part.

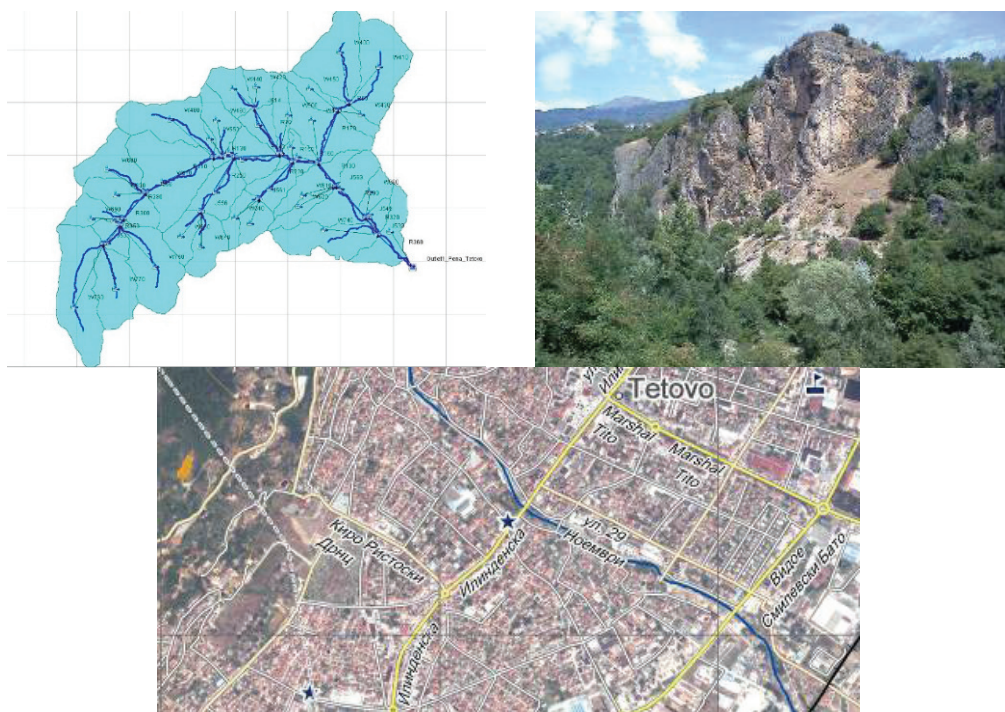
The river of Pena is the biggest tributary to Vardar formed on Shar Mountain. Catchment area of Pena is 191 km<sup>2</sup>. It has the longest mountain watercourse with 29,7 km from the source to Tetovo. Its altitudinal difference is 1.914 m. Catchment shape, catchment area and slopes contribute to appearance of coincidence of discharge from 2 parts near Brodec and huge quantity of water and energy. The most erosive part is located 12-13 km upstream from the mouth. Into the river bed there is a lot of sediment and boulders result of various processes in the tributaries and the direct streambank as weathering, landfalls, rockfalls, streambed erosion etc. Six screw-dams upstream from Tetovo are functional although some of them are significantly damaged. During the storm event (strong wind), a lot of debris (woody, plastic even mineral from street runoff) achieve river bed of Pena and together with material that Pena transported from upstream part blocked the bridges in the city of Tetovo. Definitely, there were past sediments deposited in the river bed that decrease the profile of the river bed. Bridges were blocked by debris, create backwater and out flowing of river Pena that cause flooding of parts of the Tetovo city.

**Figure 14.** Pena river catchment, weathering and critical areas in the city (bridges)
