Analysis of the causes of fracture of the main gas pipeline

A complex of research has been conducted to establish the causes of the accident of the main gas pipeline made of 1420x15.7 mm X70 steel after 20 years of operation. It is found that pipe destruction was initiated by the longitudinal crack with a length of 470 mm and a maximum depth of 6.8 mm, oriented in the direction of the pipe and perpendicular to the outer surface of the pipe identified as stress-corrosion cracking. The crack initiation is due to the disboundment of the tape protection coating, the high corrosion activity of the soil, and the complex stress-strain state caused by deviations from the design objectives during construction. The chemical composition the base metal of all investigated pipes corresponds to the requirements of the technical conditions for steel pipes in category X70; pipes welding are performed with the typical materials used in pipe welding plants. Despite the differences, the structural and mechanical characteristics (yield strength, ultimate strength, and impact strength) of the steel and weld metal of the studied pipes are identical. The relative elongation (δ_5) of the operated pipes i

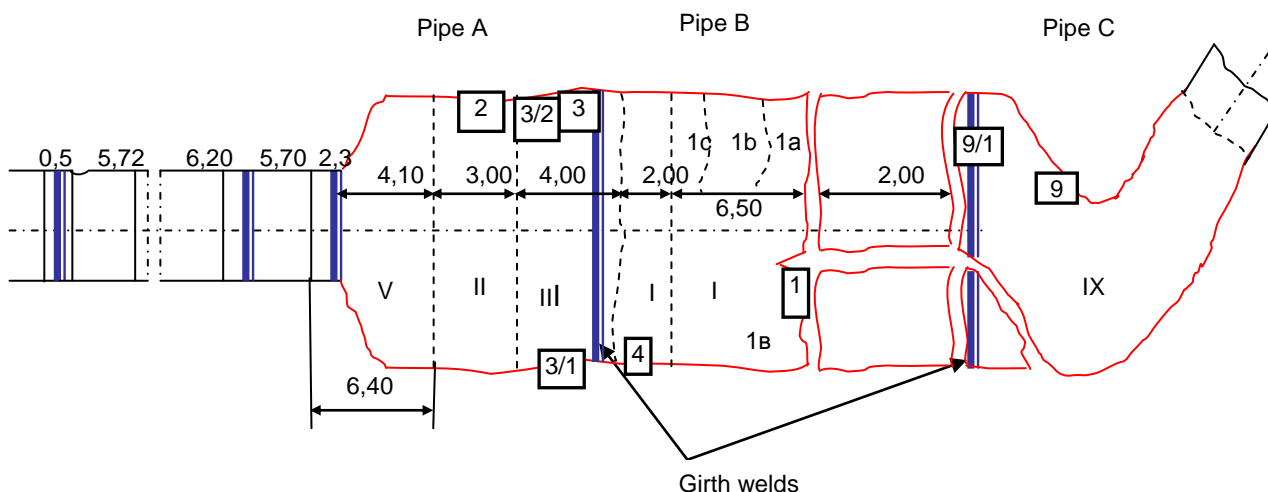
Figure 1. Scheme of the destroyed part of the main gas pipeline

1, 2, 3, 3/1, 3/2, 4, 9, 9/1 – cites of selection the specimens for investigations
I, II, III, IV, V, IX – fragments of destroyed pipes for transportation; - breaking line

As a result of the inspection of the accident site, it was found that 3 pipes conditional markings A, B, and C were fractured (Fig. 1). The crack propagated along pipe A and the section of pipe C to about 8.5 m length and changed its direction to the circumferential. Further, pipe B in the section of about 2 m in length was ruptured into two semi-cylinders as a result of the formation of two cracks, and after crossing the circumferential weld between pipes B and C, two cracks passed on a spiral line. Pipes A and B were for some time in the area of gas burning.

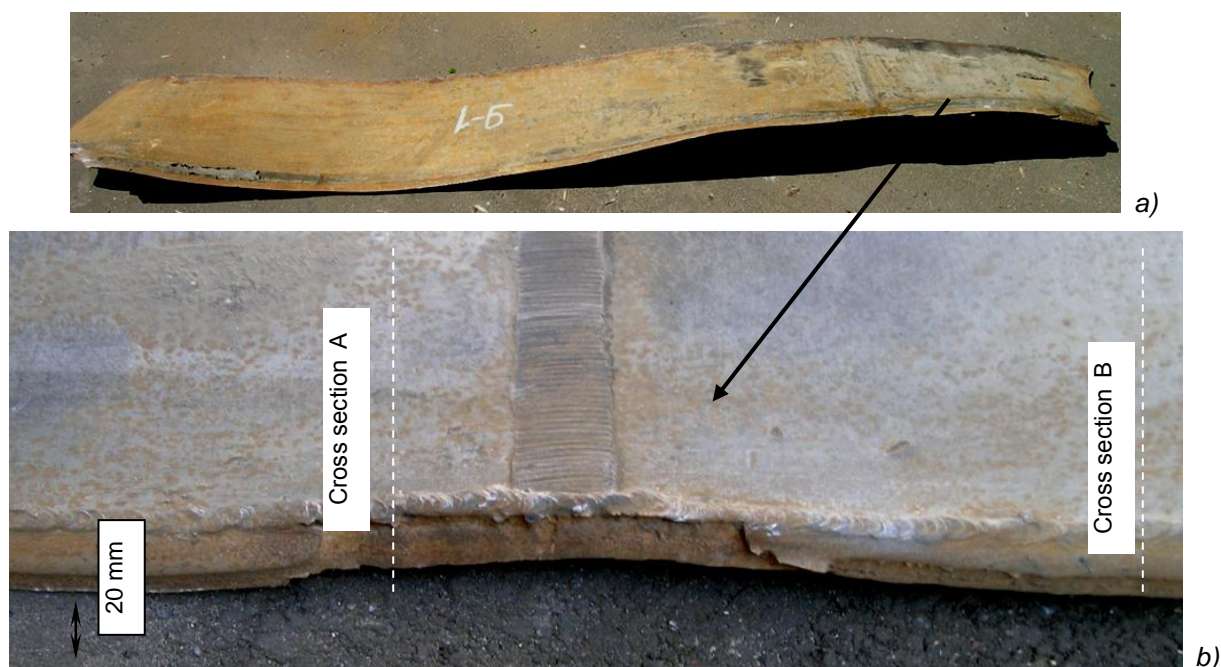
Figure 2. The fragment of the broken pipe C with girth weld joint (templet 9/1): a – appearance; b – region near the fracture edge along the fusion line of girth weld

For investigations, the specimens were selected in the sections where based on the results of the preliminary inspection, cracking of the gas pipeline could be initiated Fig.2 (specimens 2, 3, 3/1, 9/1). Also, the specimens for determination of mechanical properties and structural features of the metal (specimens 3/2, 4, 9) were selected.

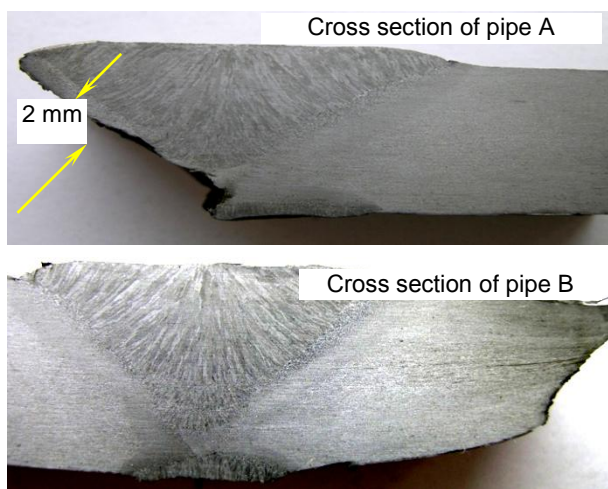
The fracture of the pipes occurred in the direction of the generatrix of the gas pipeline at a distance of 0-20 mm (fragments 2, 3, 3/1, 3/2), and at a distance of 30-60 mm from the fusion line of the longitudinal weld (templet 4). On one of the pipes (templet 9/1), the rupture line passed at a distance of ~25 mm from the circumferential weld, and on the section of ~130 mm length, it passed at a distance of 2 mm from the fusion line of the circumferential weld (Fig. 2), intersected the root layer of the circumferential weld and extended over the heat-affected zone of the backup layer (Fig. 3).

Figure 3. Macrosection of girth weld joint (specimen 9/1)

at the time. Defects of welding origin in the facing layer were not detected. There were separate minor defects in the root layer: slag inclusions (up to 0.5 mm in size) and lack of fusion (from 1 to 2 mm depth, exceeding the permissible value (1 mm according to HS&R III-42)). The nature of the fracture, location of the section, and number and size of detected defects do not allow for considering this section as a probable fracture site.

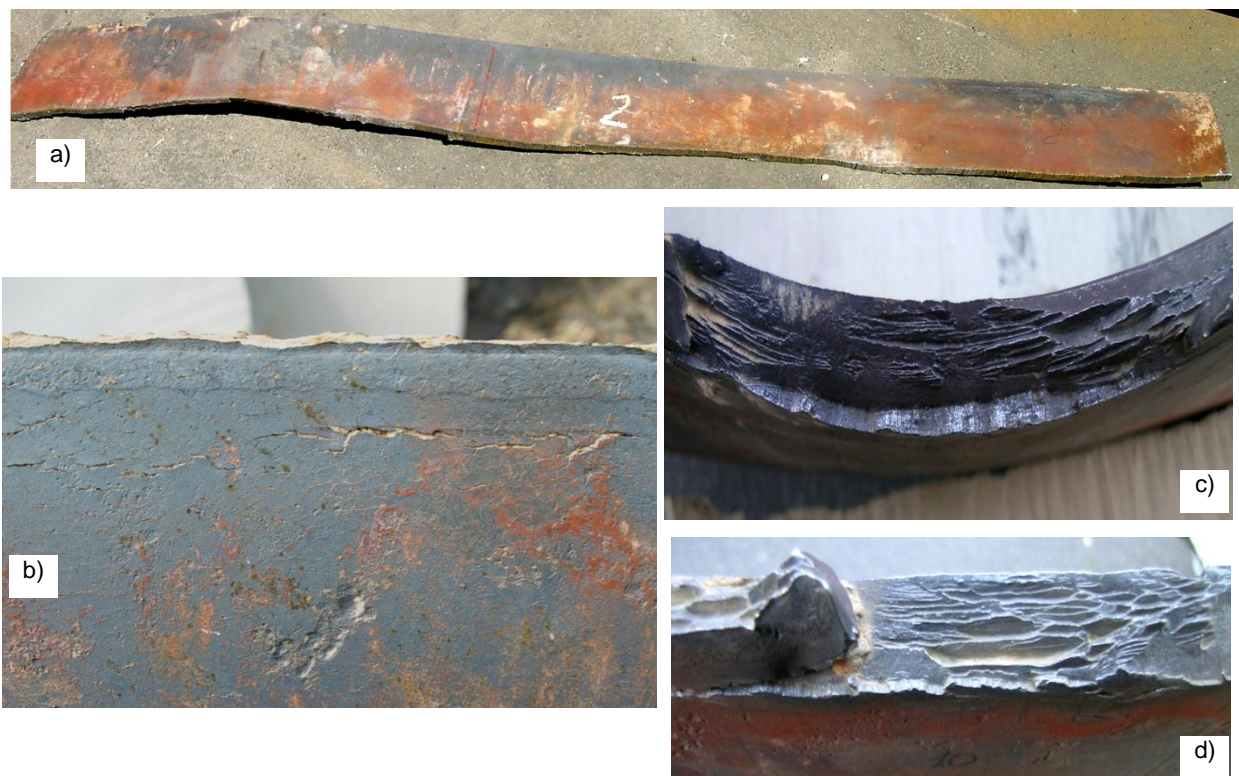
On the surface of templat 2 and 3 of pipe A, at a distance of ~45 mm from the edge of the fracture, numerous crack defects of up to ~30 mm were found, which were oriented in parallel to the edge of the fracture (Fig. 4). The cracks are located outside the heat-affected zone. On specimens 4, 9, and 9/1 of pipes B and C, cracks on the outer surface are absent.

A similar crack of ~130 mm in length and ~2 mm depth was revealed in templet 3 at a distance of ~400 mm from the first crack. On templet 2 of pipe A, cracks of the same character of ~ (80-90) mm length and from 2 to 5 mm depth were recorded (Fig. 5). In the fracture of other specimens (pipes B and C), cracks were not detected.

Figure 4. The fragment of broken pipe A (templet 2): a – appearance; b – cracks near the broken edge; c, d – stratification in the rupture

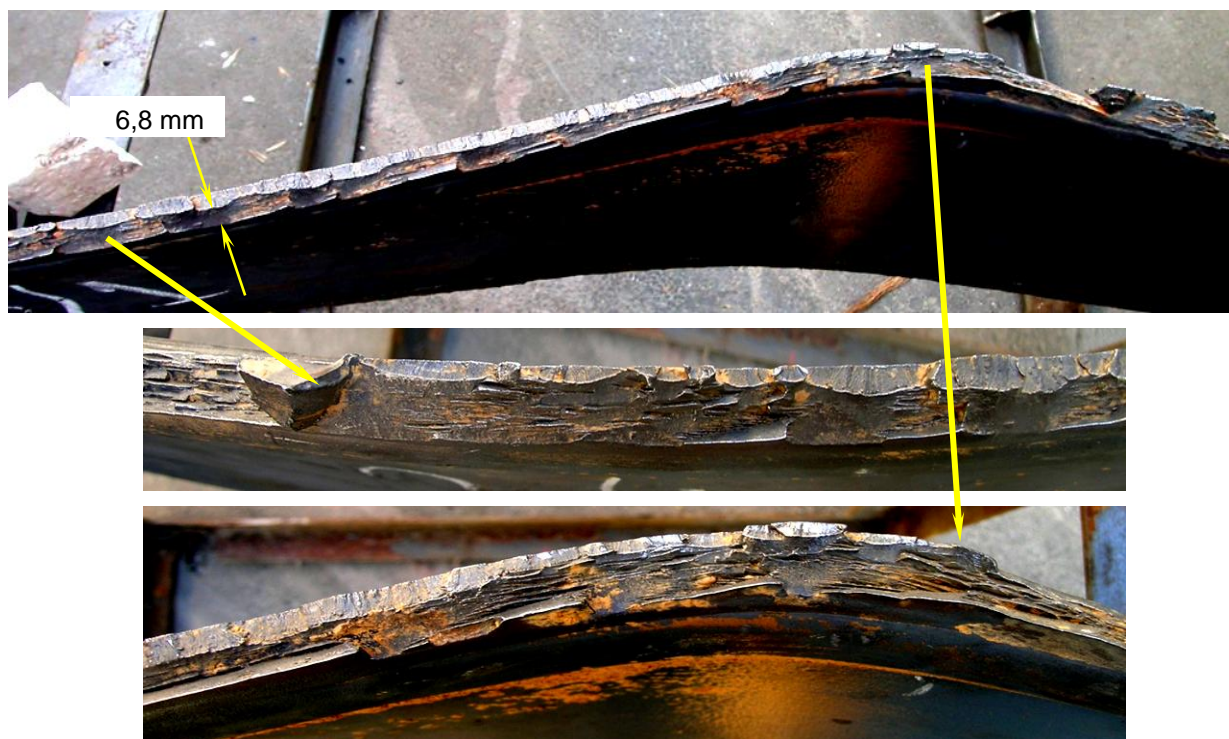
In specimen 3, a long crack (Fig. 5) with a length of ~470 mm and a maximum depth of ~6.8 mm is present, which was formed as a result of the coalescence of small cracks ~(12-30) mm long. A thinning of the pipe wall was detected, the maximum residual thickness of which was ~11.5 mm. The mentioned factors indicate an increased plastic deformation near the crack's edge, which may indicate the beginning of fracture.

Thus, it can be assumed that the fracture of the pipes on the section of the gas pipeline was initiated by a crack defect of ~ 470 mm in length with a maximum depth of ~ 6.8 mm, detected in the fracture in the direction of the generatrix of the pipe A at a distance of ~ 20 mm from the fusion line of the longitudinal weld of the pipe.

Figure 5. Sharp bend of pipe A (templet 3/1) ~470 mm long and ~6,8 mm maximum depth
Slika 5. Oštra krivina cevi A (tempor 3/1) ~470 mm dužine i ~6,8 mm maksimalne dubine

1. It was found that the accident on the section of the main gas pipeline was initiated by a stress-corrosion defect of ~ 470 mm length with the maximum depth of ~ 6.8 mm, oriented in the direction of the generatrix of the pipe and perpendicular to its outer surface, whose propagation deep inside the pipe wall occurred through a mechanism of a local anodic fracture in the elastic region.

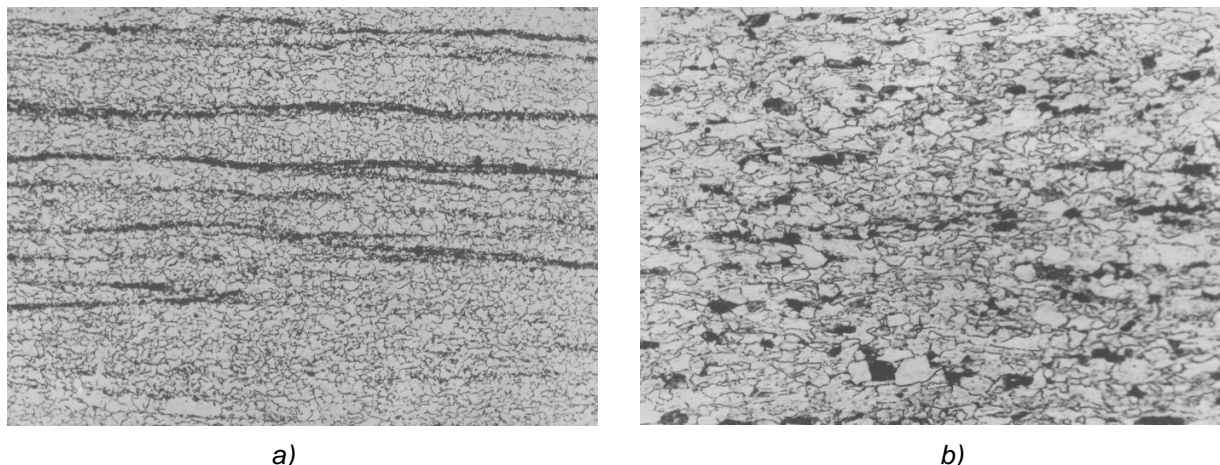
As is seen from Fig. 6, the structure of the metal of pipe A (specimens 3) near the edge of the rupture was formed as a result of heating the metal at a temperature close to the stabilizing temperature (Fig. 6a). But already at a distance of

~300 mm from the edge of the rupture, the pipe metal was heated faster to the tempering temperature (Fig. 6b). The fact of softening as a result of structural transformation is confirmed by an increased hardness of the base metal: the hardness of the metal of pipe A is (175-180) HV.

Figure 6. Microstructure of pipe A, $\times 320$: a – near the fracture edge; b – at the distance 300 mm from the fracture edge

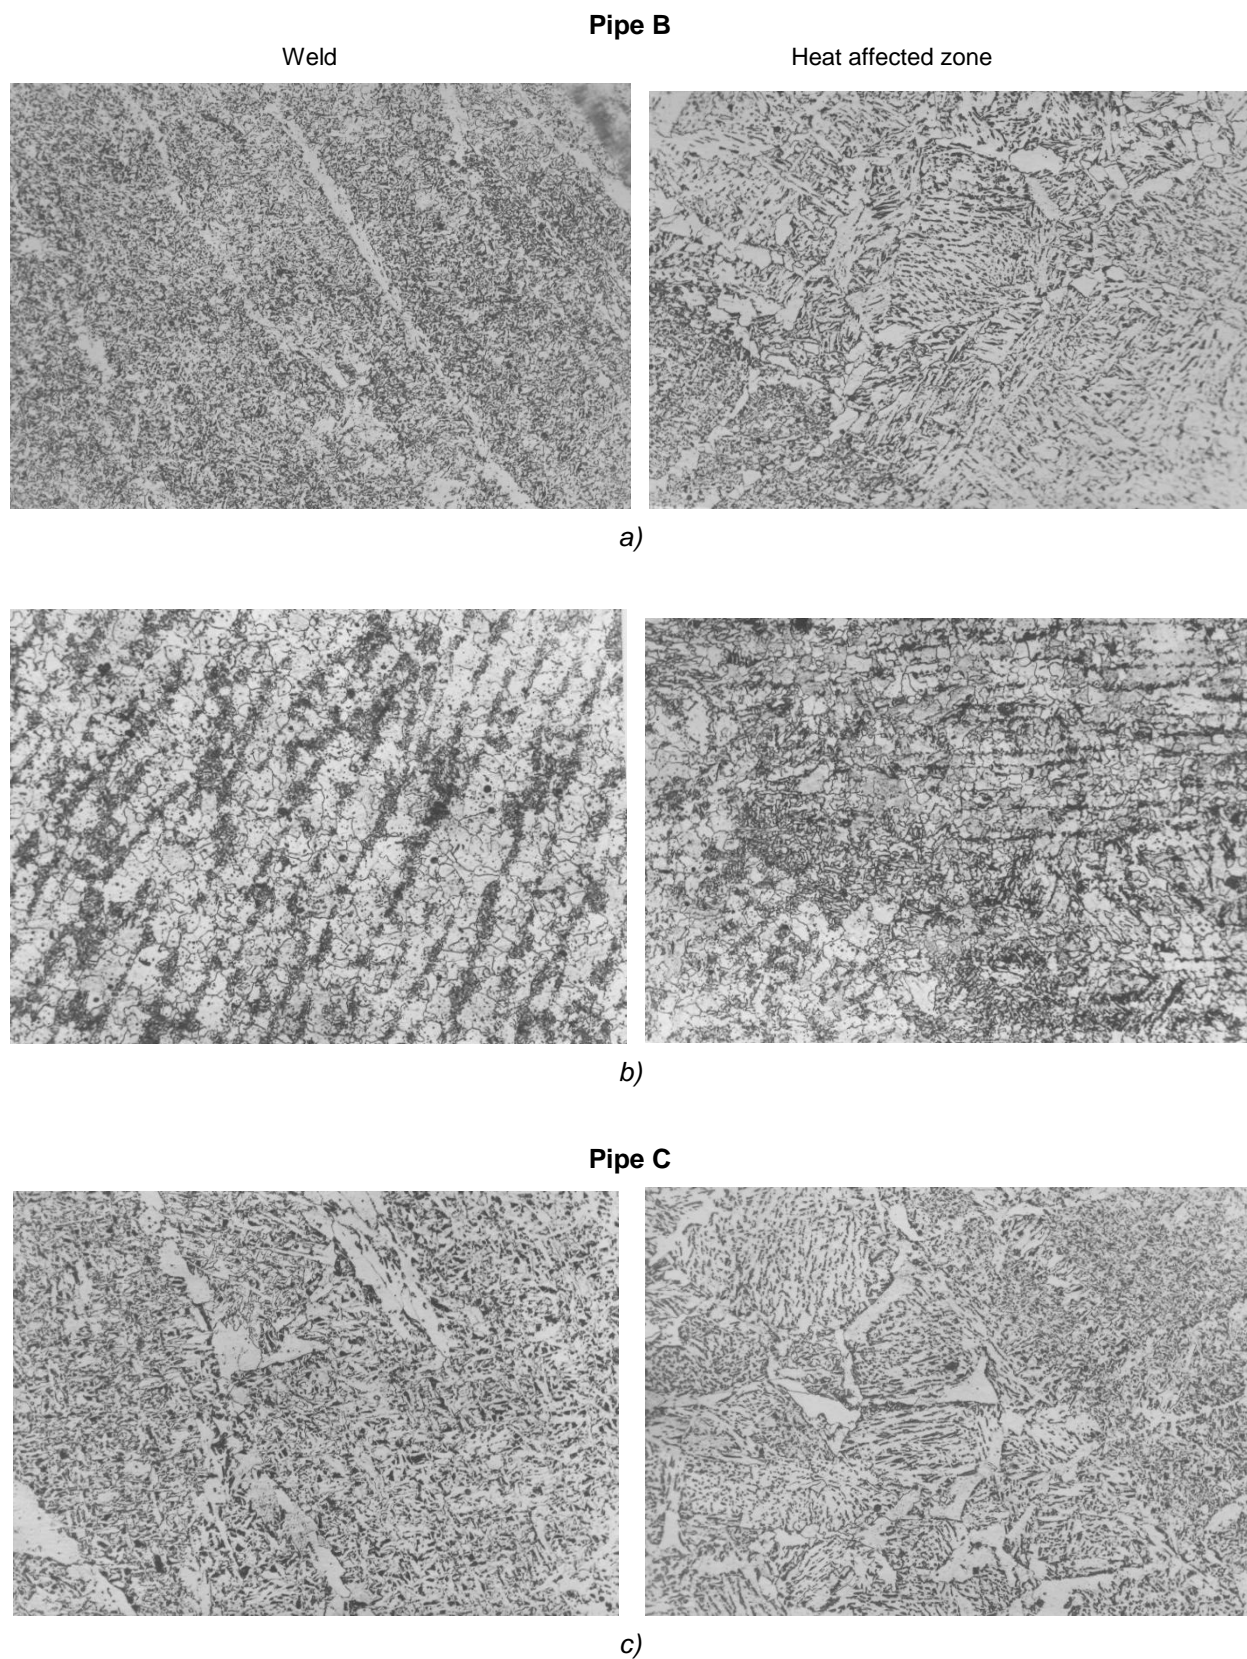
The metal of the longitudinal welded joint of the pipe B, as well as the base metal, was subjected to heat, because both the metal of the weld as well as of heat-affected zone (area of a coarse grain) underwent a structural transformation (Fig. 7b).

The structure of the circumferential site joint (specimens 9/1) consists of an acicular and polygonal ferrite in the form of a column appearance and individual polyhedral grains. The area of a coarse grain represents a mixture of a lower and upper bainite, as well as a ferritic component on the grain boundaries (Fig. 7c). The size of a coarse grain mainly corresponds to the number 4 according to GOST 5639. The length of the zone of a coarse grain is up to 0.4 mm. It can be emphasized that the fracture, which was recorded in the area near the facing layer (at a length of 130 mm, specimens 9/1), occurred outside the area of a coarse grain, which is the most brittle in the HAZ of welded joints. The hardness of the metal of the facing layer is about 215 HV, and the maximum hardness in the area of a coarse grain reaches 236 HV.

Figure 7. Microstructure of the longitudinal (a, b) and girth (c) welds of the pipes, $\times 320$

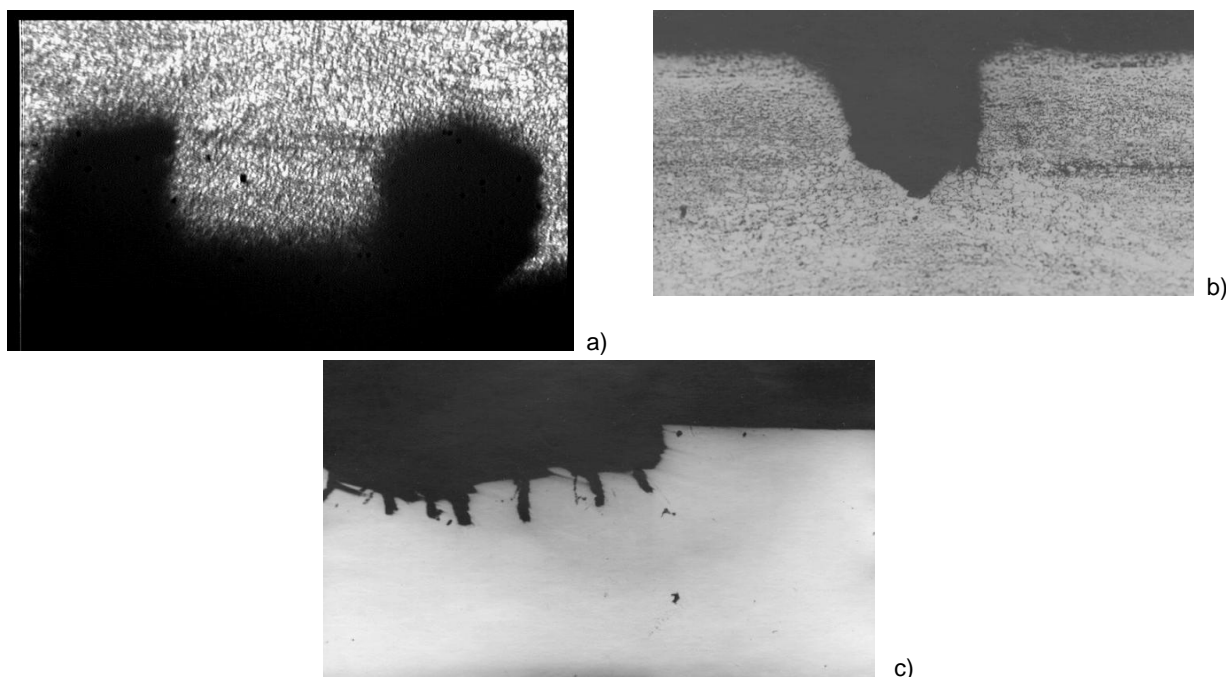
Metallographic examinations of structural features of the metal areas were carried out in the zone of crack colonies located near the main crack in order to estimate the nature of their origin. The analysis of microsections cut perpendicular to the trajectory of the crack propagation, showed that their depth is small (not more than 0.2 mm). The faces of the cracks are almost parallel to each other. The bottoms of the cracks are rounded, and their walls are smooth without branching, which is typical to the corrosion process occurred through a mechanism of a local anodic dissolution. Closer to the edge of the fracture, in the zone of deformation (thinning of the pipe wall during fracturing), such cracks almost have no ruptures and did not propagate into the depth (Fig. 8a).

Figure 8. Micro polished sections: a – cracks at the distance ~20 mm from break edge, $\times 200$;
c – crack at the distance ~10 mm from break edge, $\times 100$

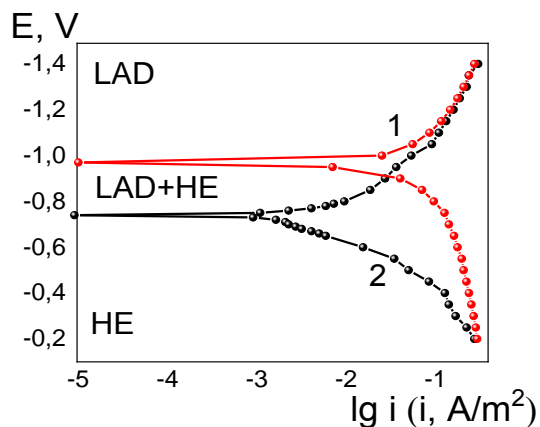
Under such conditions (pH 8.2), the layer of FeCO_3 is porous and loose, its protective properties are low, so the passivation of the steel surface was not observed (Fig. 9).

Figure 9. Polarization curves at different scanning potential rate (1 – 0.5 mV/s; 2 – 200 mV/s). LAD – local anodic dissolution; HE – hydrogen embrittlement

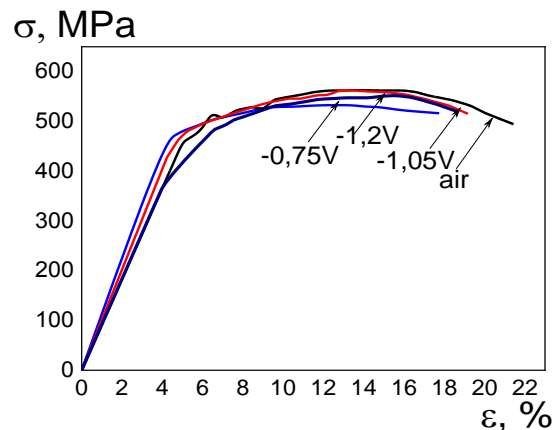
According to the results of electrochemical, corrosion-mechanical studies and fractographic examinations (Fig. 9-11), ranges of potential were established, in which the mechanism of SCC is varied. At the potentials that are more positive than -0.75 V, corrosion cracking occurs mainly through a mechanism of a local anodic dissolution (Fig. 8), the specimens are featured by a tough morphology of fracture (Fig. 10).

Figure 10. The curves of mechanical fracturing of X70 steel specimens in air and corrosion-mechanical fracturing in the solution at different potentials

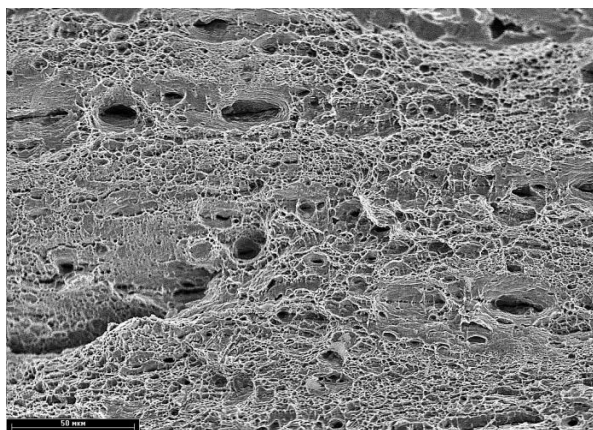
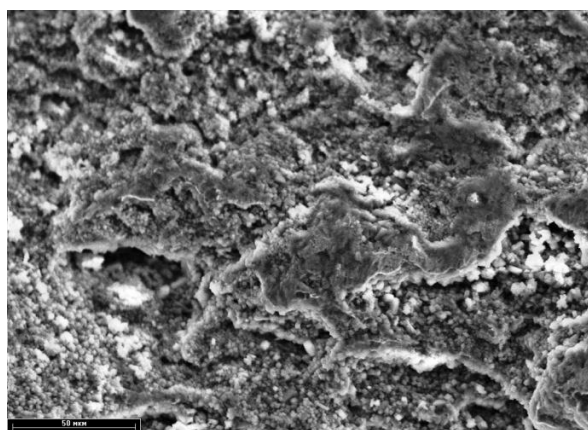
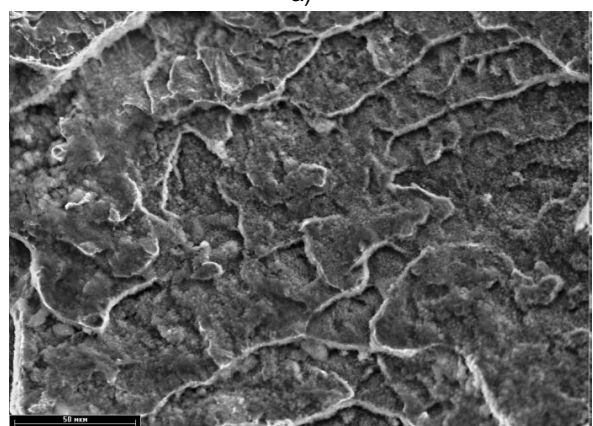
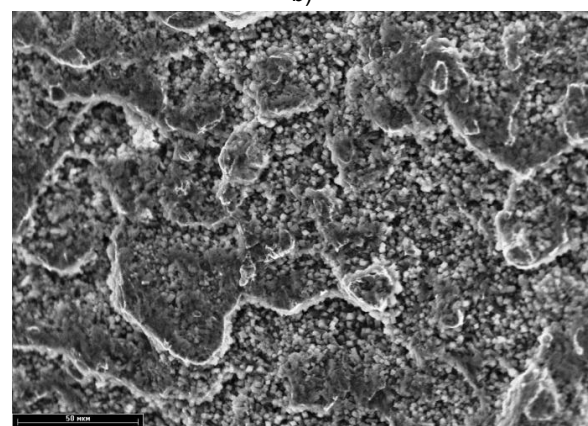
Figure 11. Fractured specimens and morphology of breaking surface after testing in air (a) and solution at potentials: b – $E = -0.75$ V; c – $E = -1.05$ V; d – $E = -1.2$ V

In the range of potentials from -0.75 to -1.05 V, a local anodic dissolution and hydrogen embrittlement occur simultaneously and this fact correlates with a decrease in the plastic properties of steel and up to 15...30% increase in the fraction of quasi brittle delaminations in the fracture morphology (Fig. 11). In the range of potentials, which are more negative than -1.05 V, the mechanism of corrosion cracking is hydrogen embrittlement with a subsequent loss of ductile properties by the metal and an increase in the fraction of quasi brittle delaminations in the fracture morphology (Fig. 11).
