Investigations on the Oxidation of Zn-coated Steel Cables

The automotive component industry has been constantly being studying to improve its performance. Bowden cables are present in opening doors, moving windows and others. In braided cables formed by galvanized wires with Zn steel exposed to the usual environmental conditions, the generation of ZnO appears, a phenomenon known as "white corrosion". The investigation consisted of mitigating the causes of the ZnO formation. Scanning electron microscopy (SEM) and Electron Probe Micro-Analyzer (EPMA) technology, allowed to detect that the generation of ZnO was induced by the presence of nucleating elements of ZnO on the surface of the steel cable before galvanizing with Zn. The S, Cl and O became visible in the interface between coating and substrate. This allowed concluding, under the coating, there were harmful products capable of triggering the ZnO nucleation reaction. So, the storage and cleaning of the steel wire before galvanizing is essential to prevent the ZnO formation.

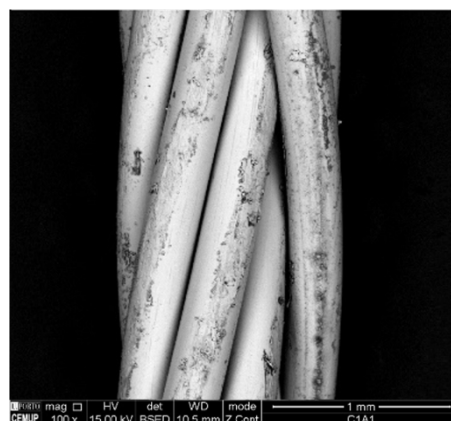
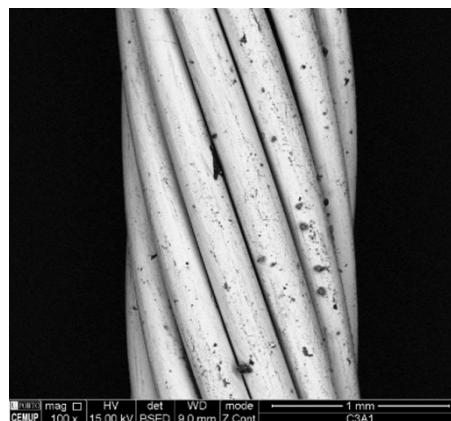
Figure 2. Two new cables in area 1, (a) CN1A1 and (b) CN3A1.

After the observations made by SEM, and analyzing the three cables in area 1, it was possible to observe that:

- No corrosion was detected in area 1.
- In areas not affected by corrosion, the presence of these trails allows claiming that this fact cannot be considered as one of the causes of the corrosion.
- The presence of some dark stains on and between the wires, which will be shown in detail later, revealed a strong C peak, detecting or not the presence of K. It was also studied the composition of the internal polymer tube to understand if these stains could be originated by cable friction on the polymer or if it was another product. No correlations were found between the stains and the polymer tube. Possibly these stains would be leftover lubricants from the wire, which can result from the manufacturing or assembly process of the Bowden cables, where the wires are conducted by some pulleys subjected to lubrication before being cut.

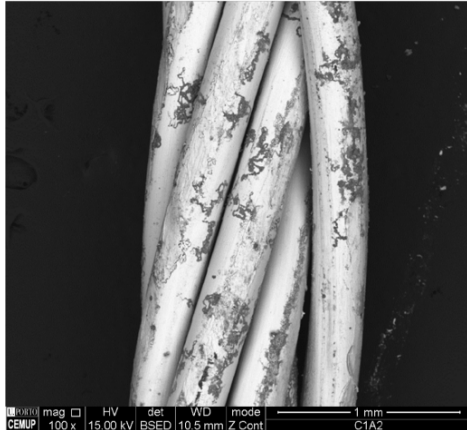
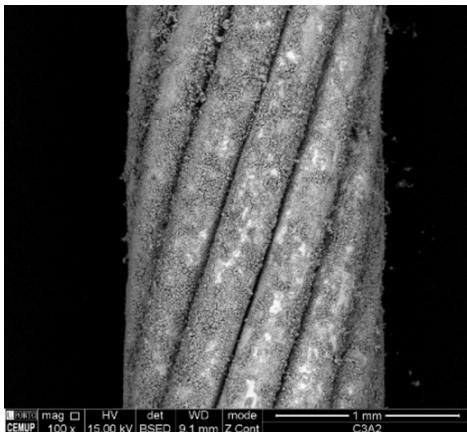
Figure 3. Two new cables in area 2, CN1A2 (a) and CN3A2 (b).

Using SEM in area 2, on the three new cables, it was possible to conclude the following:

- The studied samples behaviour, from the same area, but from different cables, were very different.
- The presence of lubricant in the samples, in this area, was zero or extremely low. This confirms that lubricant found in area 1 provides accidentally from contact with the mechanical devices allocated to the manufacturing and assembly operations of these cables.
- Cable 2 showed some small ZnO aggregates. Cable 3 showed a uniform layer of fine ZnO formation, which easily leaves the wires as white

- The adhesion of some small clusters of ZnO was very poor. It was possible to see the weak contact of the Zn surface layer with the substrate, particularly in cable 3, see figure 3.
- The ZnO appeared around all the wires. This phenomenon did not appear just on the external cable area. Thus, this suggests that ZnO formation is not induced by contact with any external body, being a problem induced by the environment where the single wires or the metallic cable are inserted during the cable manufacturing process.

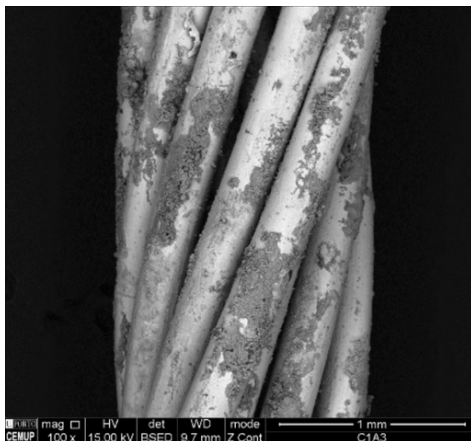
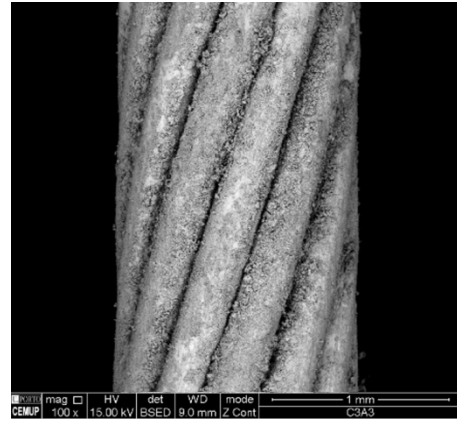
Figure 4. Two new cables in area 3, CN1A3 (a), CN3A3 (b).

After the observations of the area 3 of the cables, figure 4, it was possible to observe that:

- Taking into account the previous analysis performed on area 2, it was possible to conclude that in the area 3, just the cable 1 presented an increase in terms of ZnO formation.
- Cable 3 presented behaviour extremely similar between area 3 and area 2.
- Just cable 1 showed a consistent increase in the ZnO formation from area 1 to area 3, revealing a possible way of beginning ZnO formation.
- In a few cables, some aggregates of ZnO seemed stand-alone. These aggregates can be easily extracted when in contact with a carbon tape.

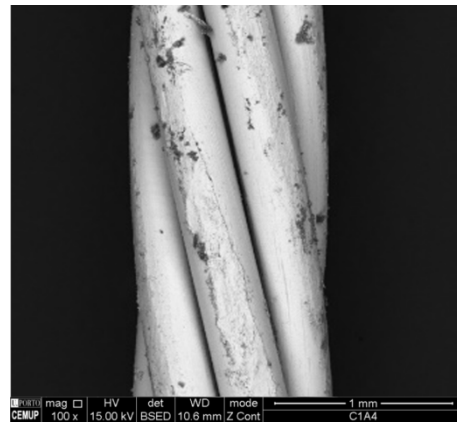
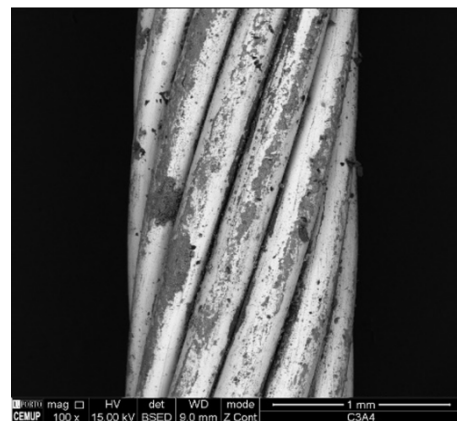
Figure 5. Two new cables in area 4, CN1A4 (a) and CN3A4 (b).

Considering the observation of area 4, as can be seen in figure 5, it was possible to conclude that in this area, the results were like in area 1, and much better than areas 2 and 3.

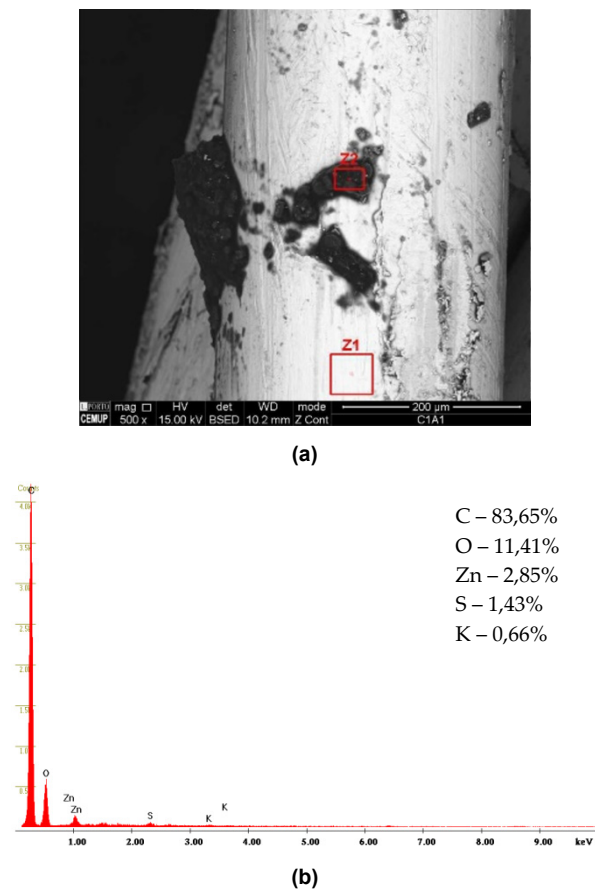
The presence of dark areas over the wire coating deserved further study. Thus, it was observed and defined the dark areas most suitable to perform the micro-analyses. It will be noted that the concentration of these dark areas, considering the four areas in analysis, is a little bit more pronounced in area 1, as can be seen in figure 6.

Figure 6. Dark areas on CN1A1 (a); and Zone 2 micro-analysis (b).

The areas highlighted, with Z1 and Z2 marked in figure 6 correspond to microanalyses carried out with a beam potential of 15 kV. Zone 1 corresponds to the wire coating (Zn), figure 6(a), and Zone 2 can be some lubricant or polymer substance, due to the strong peak of C, figure 6(b). Regarding the shape of the dark area, the most likely is that cable had contacted with the exterior polymeric tube and some fragments of the tube have adhered to the steel coated cable, because lubricant stains present a less defined shape. Observing

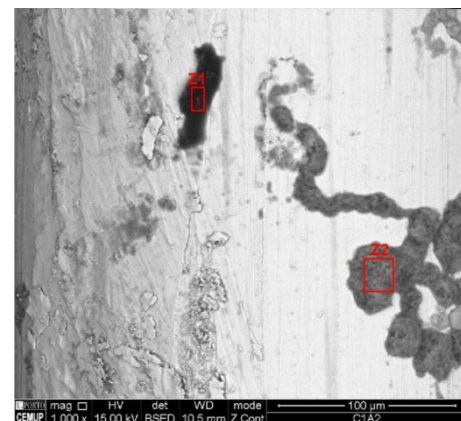
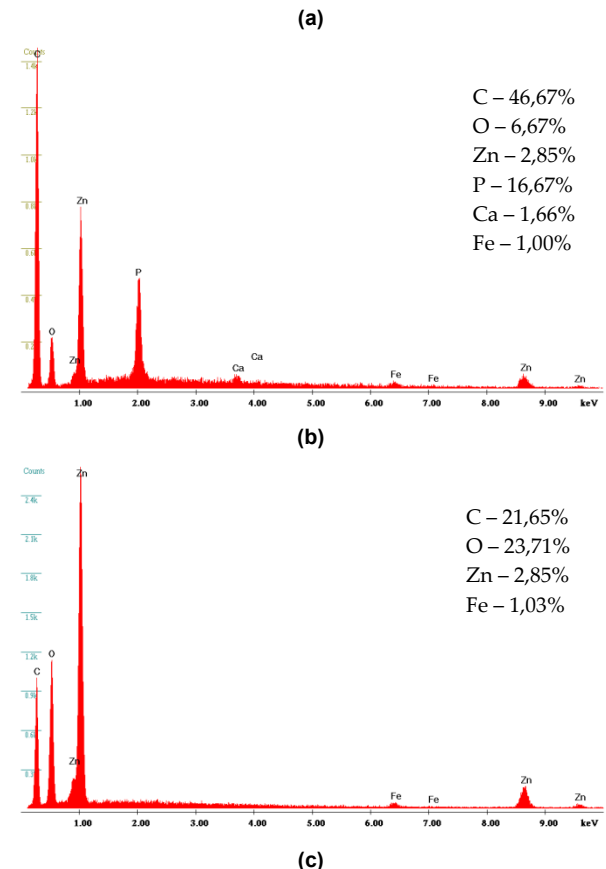
- There were two different kinds of grooves on the wire surface: the vertical and the inclined grooves. The first one, perfectly organized, generated by the wire drawing process, and the other one, randomly distributed, which cause some surface cracks.
- In these surface cracks, no ZnO formation took place or nearby them, even though the coating has been affected. Thus, ZnO formation did not seem to be related to wire protection due to Zn coating lack.
- The randomly distributed grooves and deformations did not seem to be generated by the wire drawing process, having been formed due to high stress.
- It was found that the ZnO formation took place as an external body, easily detachable under the powder form.

Figure 7. Different morphologies on CN1A2 (a) and micro-analysis zone 1 (b) and zone 2 (c).

Zone 1, figure 7b, showed the substances or C-rich and P products, strange to the wires, and in the zone 2, figure 7c, showed the presence of ZnO with an unexpected peak of C. To understand the behaviour of the dark substances in and out the trail along the cable, a fourth zone was studied, as can be seen in figure 8.

- Considering the left side of the figure 7(a), it can be observed some grooves, which may have as source one of the following mechanical processes: (a) Wire drawing or (b) Matting process. In the

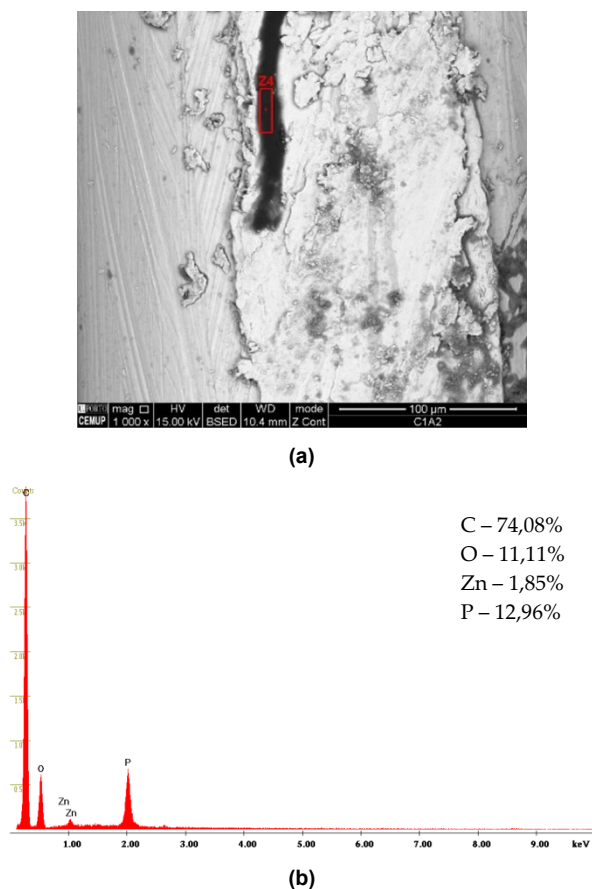
Figure 8. Dark substance analysis on the trail, in CN1A2 (a), and Micro-analysis (b).

- It was detected the presence of some strange substances over the wire coating, independently of the area considered.
- Micro-analysis performed allows concluding that these substances had the origin of the internal polymer tube used in this kind of pipe or from lubricant got during the cable manufacturing or assembly process. After the first analysis, the two hypotheses remained open because just C was detected. However, the second analysis led to observe that also P can be found. Hence, two situations can occur: the dark substances provided from different situations or products.

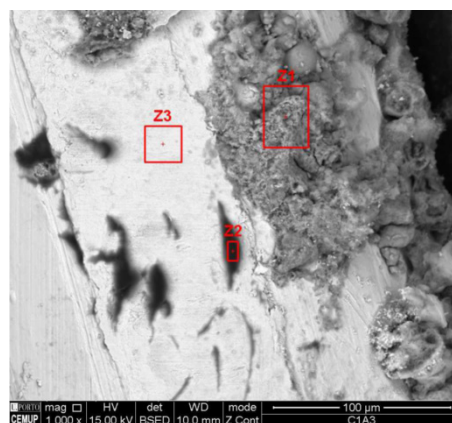
The presence of ZnO was more intense on cables 1 and 3. The figure 9 shows the first stage of ZnO formation (cable 1, area 3) generalized over the Zn coating.

Figure 9. ZnO formation on CN1A3.

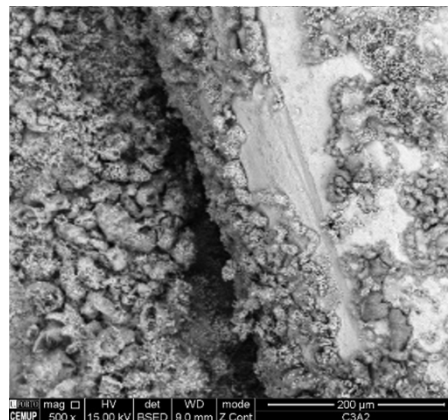
It was found that the evolution of the ZnO layer does not seem to follow any pattern, leaving some spaces to detach itself from the formation of ZnO at this stage. It was also found that there were several stages due to the different grain sizes, figure 10. After these observations, it is possible to conclude that the ZnO growth occurs around the particles themselves. In the analysis carried out, it was observed that: (a) the protection given by the zinc coating is effective because no trace of iron was found, (b) ZnO showed a continuous growth around the small crystal, but the larger these particles were, the weaker were these connections to the wire coating, (c) although the thickness of the Zn layer was not measured, the level of iron detected shows that the thickness of this layer is thick. For Fe detection, a 15 kV electron beam potential was used through the Zn layer.

Figure 10. ZnO formation generalized stage CN3A2.

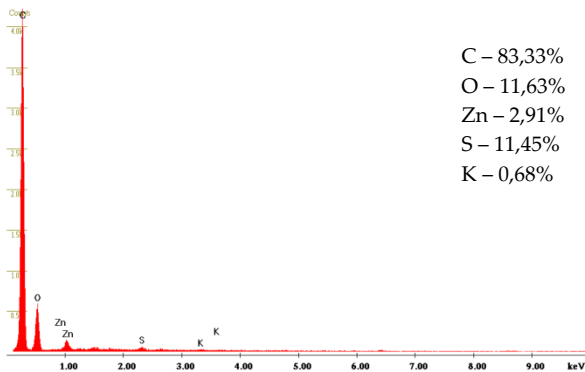
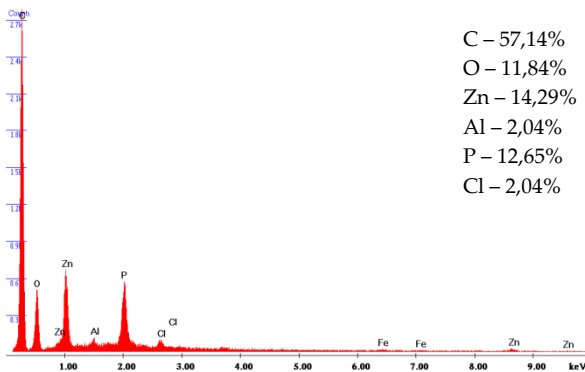
Figures 11 and 12 show the presence of C, however, C was not always linked to phosphorus and other elements in very small amounts. As can be seen in figure 11(a), P was not detectable in the sample from area 1, however, in the remaining samples it was detected.

Figure 11. Analyses of different areas containing C from the cable 1.

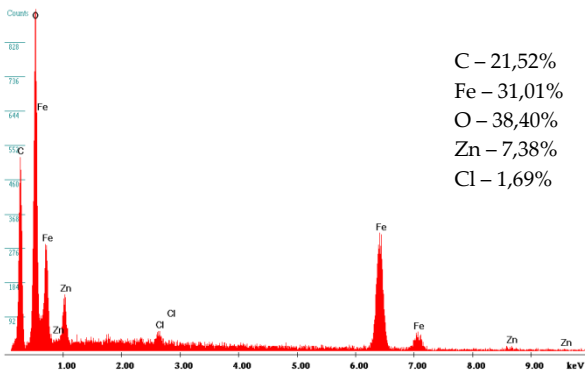
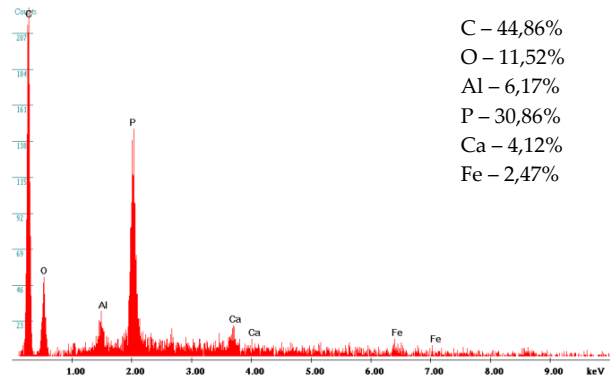
The spectra, in figure 12, allowed to understand that there are different types of dark particles (spots) in the same area, some of them containing P and others only C or C and other small contents of other elements, such as Ca and / or Cl. In cables 1 and 3, area 1 did not have any P content, allowing to conclude that in this area it seems to be preserved from the P content. In the remaining areas they appear to contain different types of dark particles, coming from the inner polymer tube or the lubricant used during cable production.

Figure 12. Analyses of different areas containing C from the cable 3.

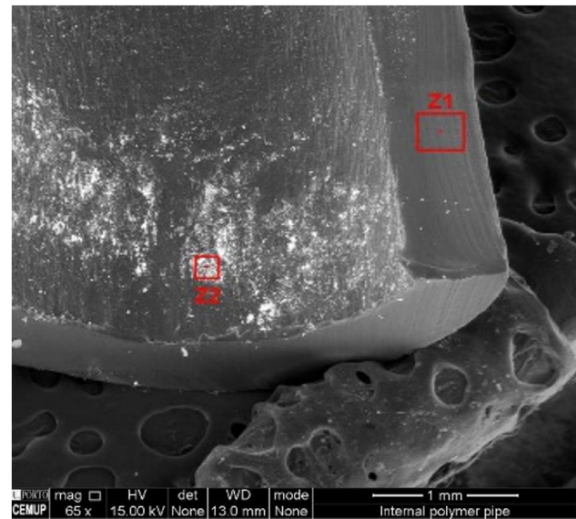
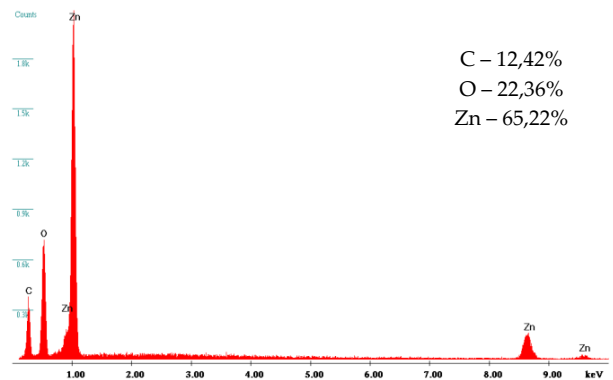
In figure 13, it can be seen a cable sample. To verify the cable influence with the polymer tube, an analysis was made. Small particles, with a lighter colour, were detected internally. To detect the type of particles, a microanalysis was carried out to discover its composition. Most of the particles found were ZnO, the wall of the tube contained only C and the hypothesis of the polymer to contain P or other content was discarded.

Figure 13. Internal polymer tube (a) and Micro-analysis (b).

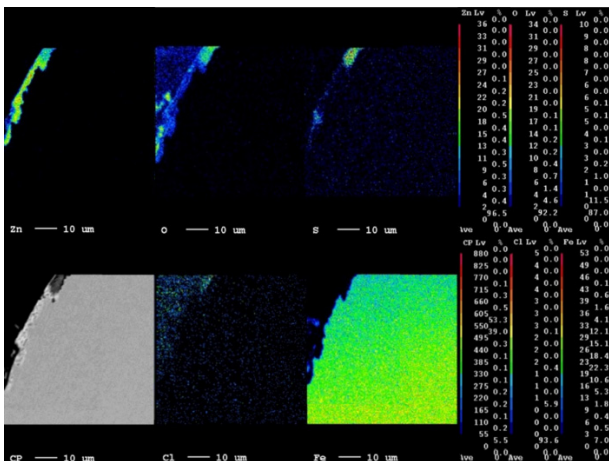
The use of Microanalysis by Electron Probe (EPMA) served to support the verification of possible foreign contents between the steel wire and the Zn coating, through a deep analysis of the cross-section, because any analysis made by the exterior of the wires do not allow to conclude how the ZnO is nucleated, showing evidence of its origin. Here, it was possible to obtain a generic spectrum through EPMA made to a set of samples referring to the cable area. This analysis allowed to obtain information about the elements present in the samples. As can be seen in figure 14, it is possible to state that Zn and O are almost always together, although when the intensity of O is more pronounced than that of Zn. It was also found that the presence of S was notorious, and its presence was clearly related to the incidence of O. Although the presence of Cl is quite reduced and dispersed at the coating/substrate interface, this amount should not be negligible. Cl has clear influence on the formation of ZnO [27].

Figure 14. Spectra of the detected elements.

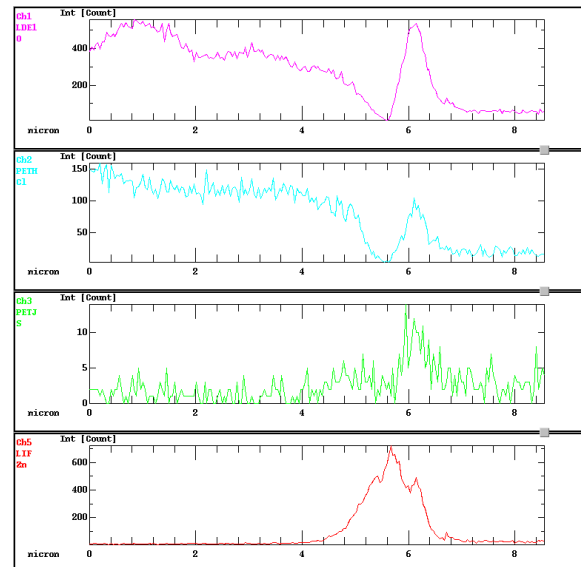
The results can be seen in figure 16, where four channels were used in order to divide the intensity and location of each element present along the line, considering that the left side of the images is the external resin and the right side the substrate of steel. Each channel was linked to a specific element: pink to O, cyan to Cl, green to S and red to Zn. Cl and O were present in the external resin (assembly process). After that, Zn became visible (coating layer) and S, Cl and O were again visible at the interface between coating and substrate. This ensures that, under the coating, there were harmful products capable of triggering the ZnO formation.

Figure 16. EPMA analyses, following a line from the outer resin to the steel substrate of figure 15.

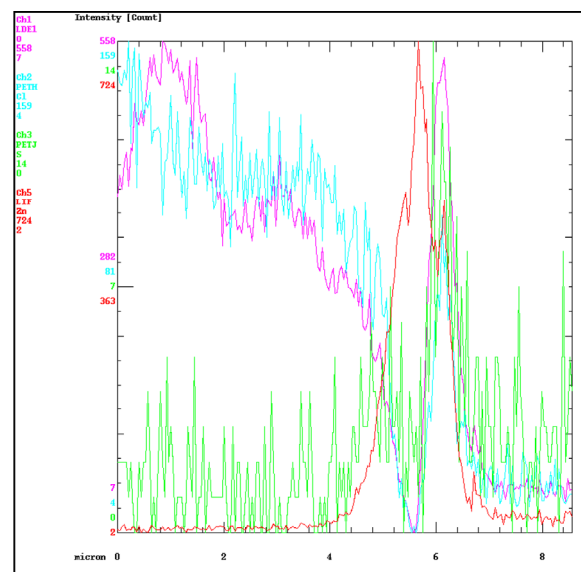
The spectrum presented below (figure 17) makes it possible to clearly analyse the phenomenon described above. The highest peak of the green line (Sulphur) is to the right of the red peak, corresponding to the Zn coating, meaning that the Sulphur is present between the coating and the steel substrate, which leads to the perception that it is present on the surface of the wire steel, that is, before the Zn coating process.

Figure 17. EPMA analysis following a line from the outside to the steel substrate - composite spectrum.
