## INVESTIGATION OF POTENTIAL LANDSLIDES DUE TO LIQUEFACTION ON THE BALAROA ROAD SECTION USING THE LIMIT EQUILIBRIUM METHOD

The earthquake on September 28, 2018 in Palu city triggered liquefaction. The liquefaction affected several areas, including Balaroa. Some parts in Balaroa experienced landslide such as the road section which formed the slope. The purpose of this study was to identify the potential of landslides due to liquefaction in Balaroa road section based on numerical modeling using the limit equilibrium method. This study was conducted in Balaroa, West Palu sub district, Palu City, Central Sulawesi Province. The slope stability analysis modelled three locations prone to landslides using the limit equilibrium method assisted by Slide 7.0 program. The results showed the safety factor value of those three locations in Balora road section using methods of Ordinary, Bishop and Janbu was  $FS < 1$ . It indicated that the slope is in unsafe condition and vulnerable to landslides, therefore the government should take this study into consideration.

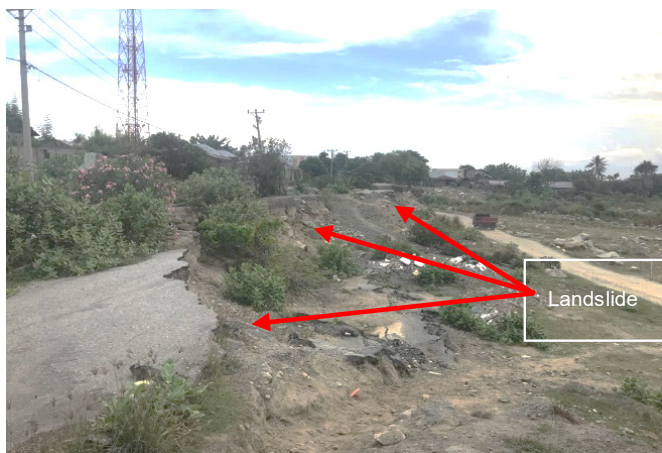
(a)

densely populated area. The 7.4 SR earthquake on September 28th, 2018, struck Balaroa and caused the occurrence of liquefaction. The liquefaction then triggered landslides on the road section of Balaroa as showed in Figure 1. The road section is located on a hilly topography, hence the landslide forms an increasingly steeper slope which has a very high level of vulnerability of landslide hazards.

Figure 1: Landslide on the Balaroa road section due to the 28th September 2018 earthquake. a) Palu City alternative road to Donggala regency and b) Palu City alternative road to Sigi regency.

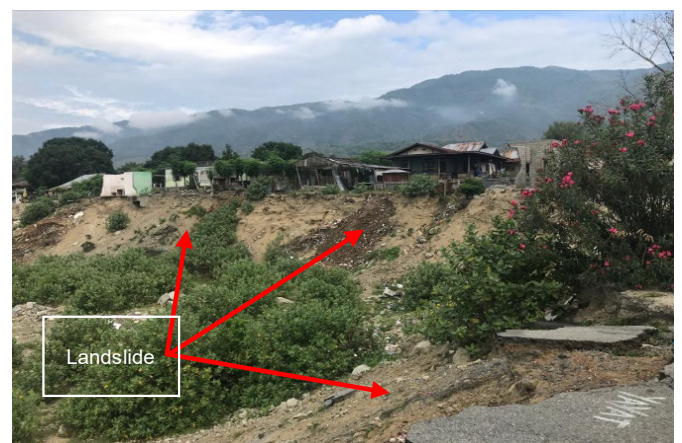
(b)

Palu City with Sigi Regency (Figure 1.b). There are still many buildings on top of the slopes that formed due to liquefaction including residential houses, schools and offices such as Balaroa village office. The condition of slope illustrates that if the slope is unstable it would threaten the people safety and their settlements as well. As it is well known that Balaroa is an area where the Palu Koro fault passes and it is considered as a red zone area (ZRB 4) based on Disaster Prone Areas map [4].

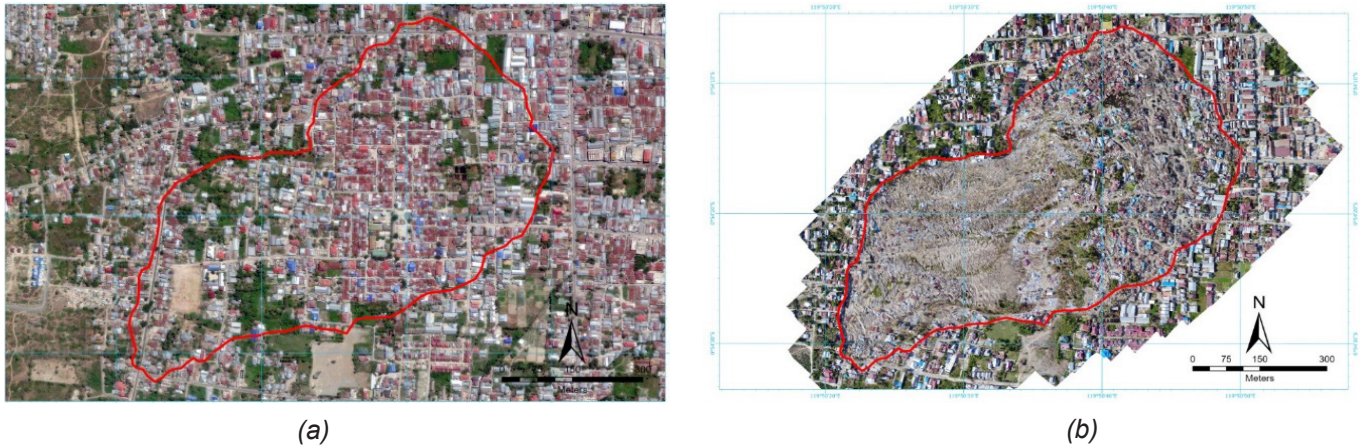
The landslide occurred in Balaroa was different from other locations since it has steeper slopes. The landslides covered the area about 0.4 km<sup>2</sup> width and 980 m length. The landslide area was a high density settlement as showed in figure 1 before the liquefaction and figure 2 after the liquefaction [3].

Figure 2: Balaroa sub district map. a) before liquefaction and b) after liquefaction [3]

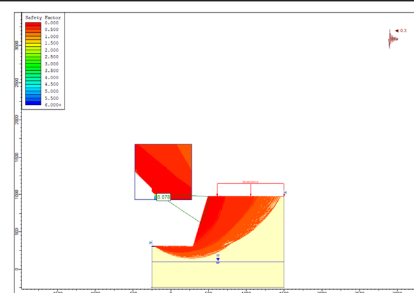
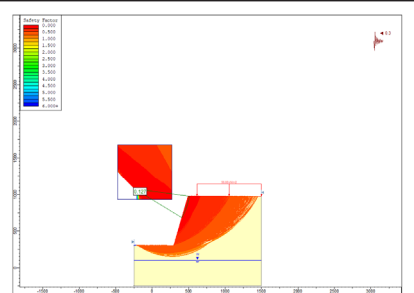
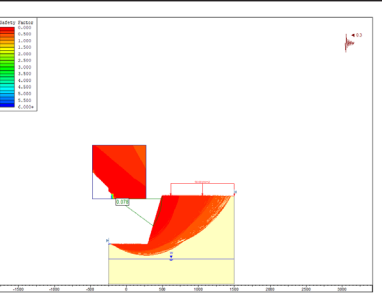
Loc.	Slope modeling results without an earthquake load		
	Ordinary Method		
1

Location	Lithology	Slope height (m)	Angle (°)	Safety Factor		
				Ordinary Method	Method	Janbu Simpli-
1	Sandy Silt	6.5	73	0.237	0.275	0.237
2	Sandy Silt	12.32	81	0.226	0.300	0.226
3	Sandy Clay	13.65	84	0.147	0.168	0.146

Table 6: Appearance of the analysis of the existing slope modeling without an earthquake load

The results of slope stability analysis above explain that the existing slope conditions at location 1, location 2, and location 3 are in unsafe conditions both before and after an earthquake load with a value of  $FS < 1$  [13].

The results show that slope condition on the Balaroa road section is unstable. The instability slope is due to the geometry of the high and steep slopes as well as the condition of Palu City which often occurs in earthquakes, therefore it needs to be treated. These results can be used as a reference for the government of Palu City to treat the slopes on the Balaroa road section, for there are still many residential areas on the slopes. The slope treatment either by making slopes or providing reinforcement to the slopes.

is  $FS < 1$ , this indicates that the slope is in unsafe or in critical conditions, therefore, the government should take it into consideration by sloping the slopes or providing reinforcement to the slopes.

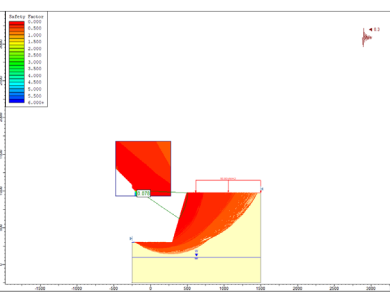
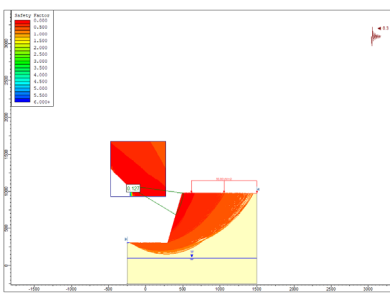
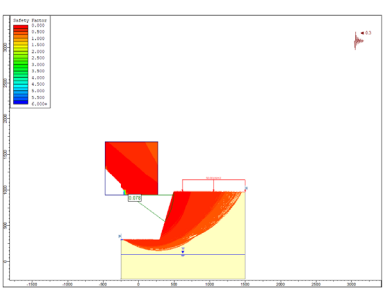
Loc.	Slope modeling results without an earthquake load		
	Ordinary Method		
1

Location	Lithology	Slope height (m)	Angle (°)	Safety Factor		
				Ordinary Method	Method	Janbu Simpli-
1	Sandy Silt	6.5	73	0.078	0.127	0.078
2	Sandy Silt	12.32	81	0.022	0.109	0.019
3	Sandy Clay	13.65	84	0.019	0.110	0.016

Table 7: Appearance of the analysis of existing slope modeling with an earthquake load
