Fracture Analysis of Vehicle-Mounted Telescoping Communications Mast

In this paper a fractured connector plate for a telescoping antenna mast made of aluminum alloy EN-AW 2007 was examined. The goal of the investigation was to determine the cause of fracture which occurred during attempting to raise the antenna. Specimens taken from the mast were visually examined, and the fracture surface was examined using a scanning electron microscope. Chemical analysis, microstructural analysis, electrical conductivity measurements, tensile test and hardness test were performed in order to investigate the properties of the material. Fracture occurred fast and visual and fractographic examinations showed that there is no visible plastic deformation near the fracture surface, which are characteristics of a quasibrittle fracture. It was shown that the mechanical properties of the examined specimens do not satisfy the minimal values defined in the standard for this material. All conducted tests indicated that the material had not been heat treated and mechanically worked, so applied stress during handling/raising the antenna led to the rapid quasibrittle fracture.

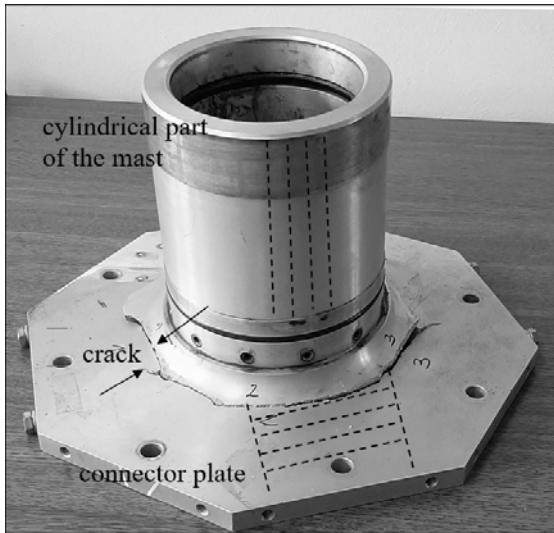
Figure 1. The fractured antenna mast. Dashed lines represent the location of samples for tensile testing.

Visual examination of the fractured part showed that the fracture was initiated on the outer surface of the plate, close to the plate-to-cylinder radius, Figures 1 and 2. No visible plastic deformation near the fracture surface was observed. The fracture initiation point was identified by following the chevron pattern at the fracture surface, as shown in Figures 2 and 3. The chevron pattern pointing to the fracture initiation point is shown in Fig.3. Several secondary cracks were also visible, as shown in Fig.3. The crack propagated from the surface of the plate gradually in circumferential direction, around the cylinder, as well as, throughout the plate.

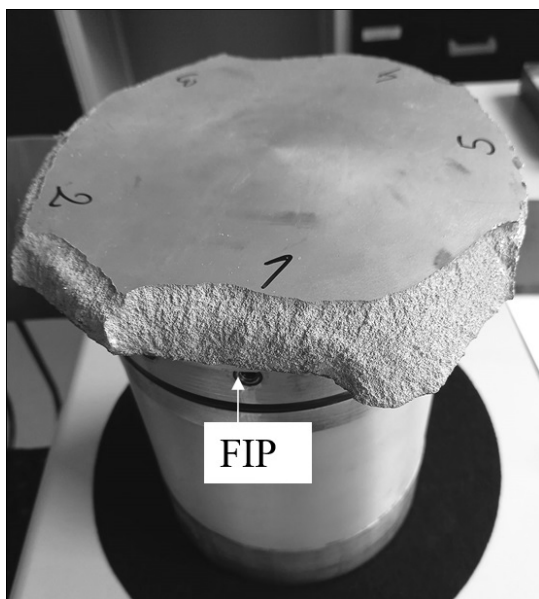
Figure 2. The fractured antenna mast, indicating the fracture initiation point - FIP.

Visual examination of the fractured mast antenna revealed that crack was initiated on the outer surface of the plate, close to the plate-to-cylinder radius (Figures 1 and 2). It is evident that the crack was initiated in a region of high localized stress, and propagated circumferentially, around the cylinder, as well as, throughout the plate.

The observed chevron pattern on the fractured surface, pointing to the fracture initiation point is characteristic of macroscopic brittle behaviour of materials [8, 9].

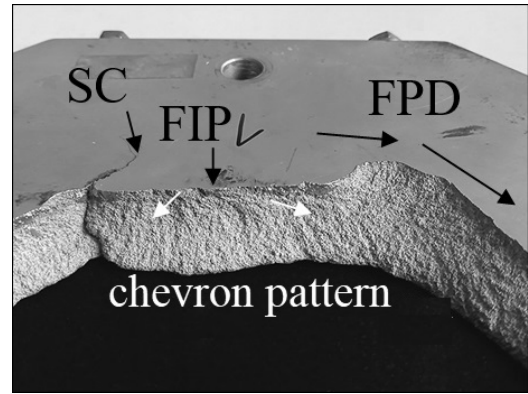
Figure 3. Plate-side fracture surface. FIP - fracture initiation point, FPD - fracture propagation direction, SC - secondary crack.

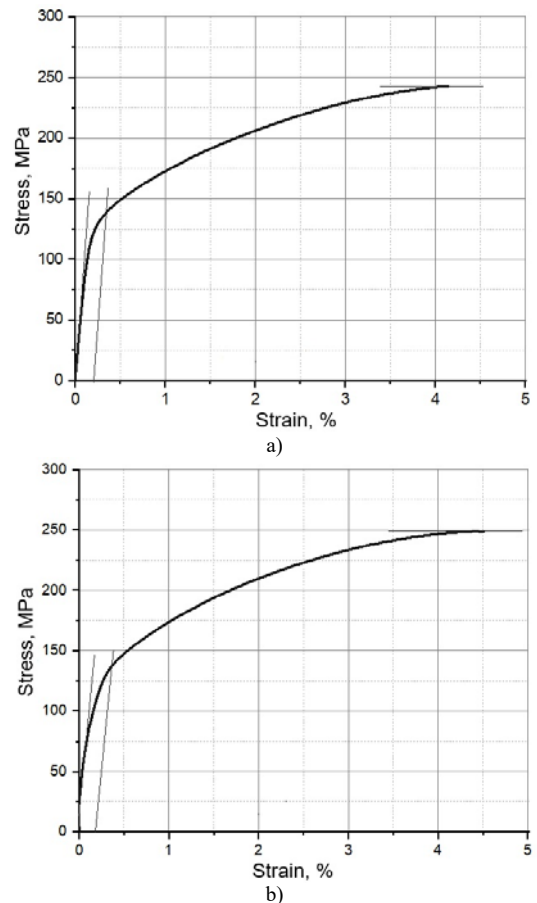
The average values of the yield strength (YS), ultimate tensile strength (UTS) and elongation (A_5) observed during tensile testing of specimens taken from the antenna mast are shown in Table 3. Characteristic stress-strain curves are shown in Fig.4. The diagrams indicate that the fracture occurs immediately after reaching the maximum force, with no posthomogenous elongation observed.

Figure 4. Characteristic stress-strain curves of tensile specimens taken from (a) the cylindrical part, (b) the connector plate of the antenna mast.

The low tensile elongation and the lack of posthomogenous elongation (Table 3 and Figure 4), as well as the macroscopically brittle appearance of the fracture, all suggest that the material was not appropriately heat treated after casting. This is also supported by the higher electrical conductivity than the typical values given in literature for EN AW-2007 in T4 condition ($18 \div 22$ MS/m i.e. $30.96 \div 37.84$ %IACS) [15, 16].

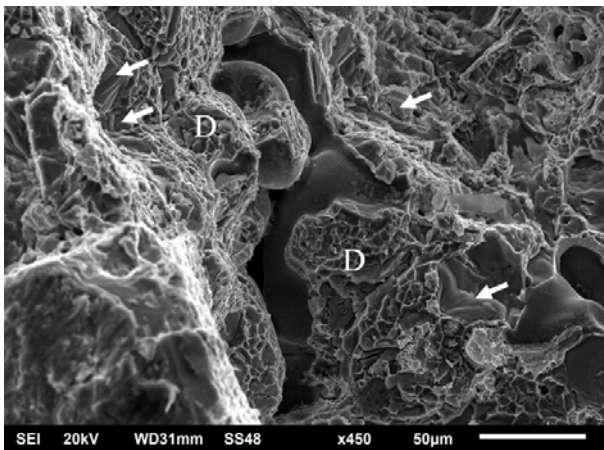
SEM analysis of the fracture surface of tested tensile samples revealed areas of transcrystalline fracture alongside with dimple areas, fractured coarse particles, as well as porosity with visible dendrites Figures 5-7.

Figure 5. Fracture surface of tensile specimens as observed by scanning electron microscopy. Areas of dimpled fracture (D) Arrows indicate the fractured particles. Interdendritic porosity is visible in the middle of the microphotograph.

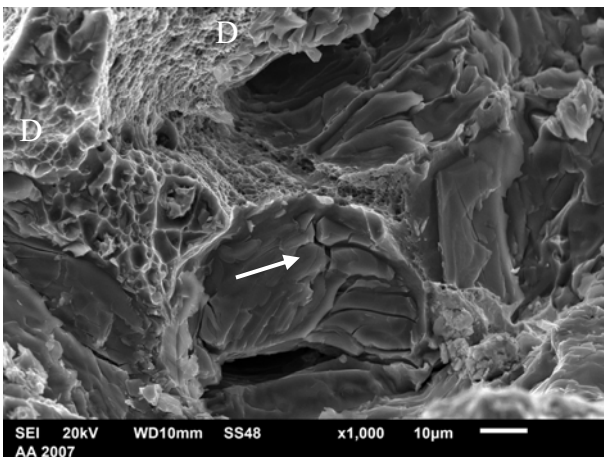
Figure 6. Fractured particles indicated by the arrow. Areas of dimpled fracture are also observed (D).

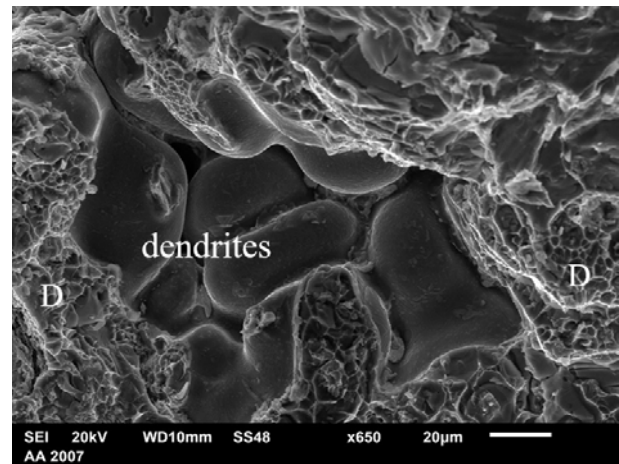
Figure 7. Fracture surface of the tensile specimens showing dimpled fracture (areas D) and exposed dendrites.

Microstructural examination has shown that mast antenna was produced of cast material. Observed dendritic grain morphology is typical for alloys in as cast condition [10]. Interdendritic porosity was observed by the light microscopy (Fig.8), and by the SEM on the fracture surface of the tensile specimens (Fig.7).

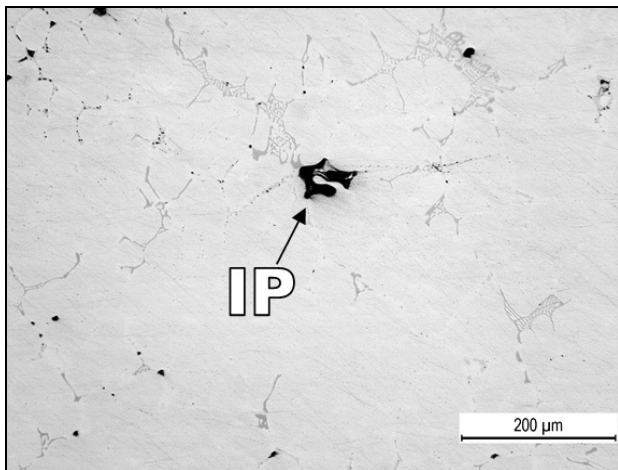
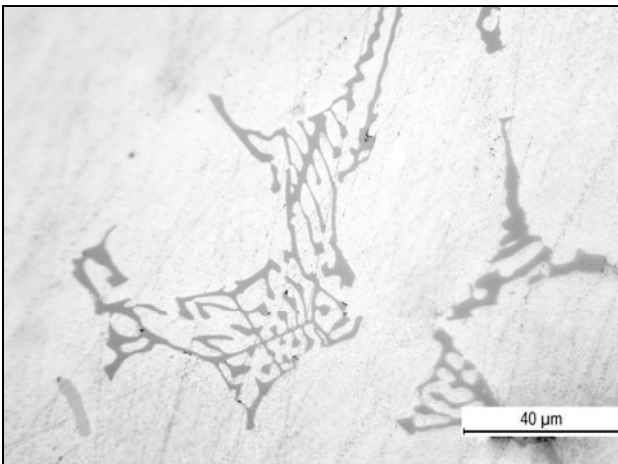
Fig.8 shows the microstructure of the specimens as polished. Large interdendritic porosity (IP), as well as large amount of shrinkage porosity (black spots) were observed in the cast microstructure. Fig.9 shows the microstructure as etched. A dendritic grain morphology was revealed.

Figure 8. Microstructure of the specimen, as polished: (a) Interdentritic porosity (IP) and shrinkage porosity (black spots), (b) shape of particles within the metal matrix. Light microscopy.

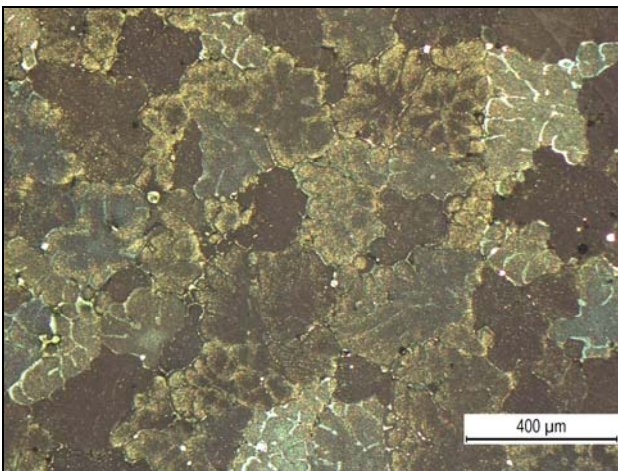
Figure 9. Microstructure of the specimen taken from the cylindrical part of the mast in perpendicular direction, etched. Dendritic grain morphology is present. Light microscopy under polarized light.
