## Performance of RC frames in 26.11.2019. Albania earthquake: effects of irregularities and detailing\*

### ABSTRACT

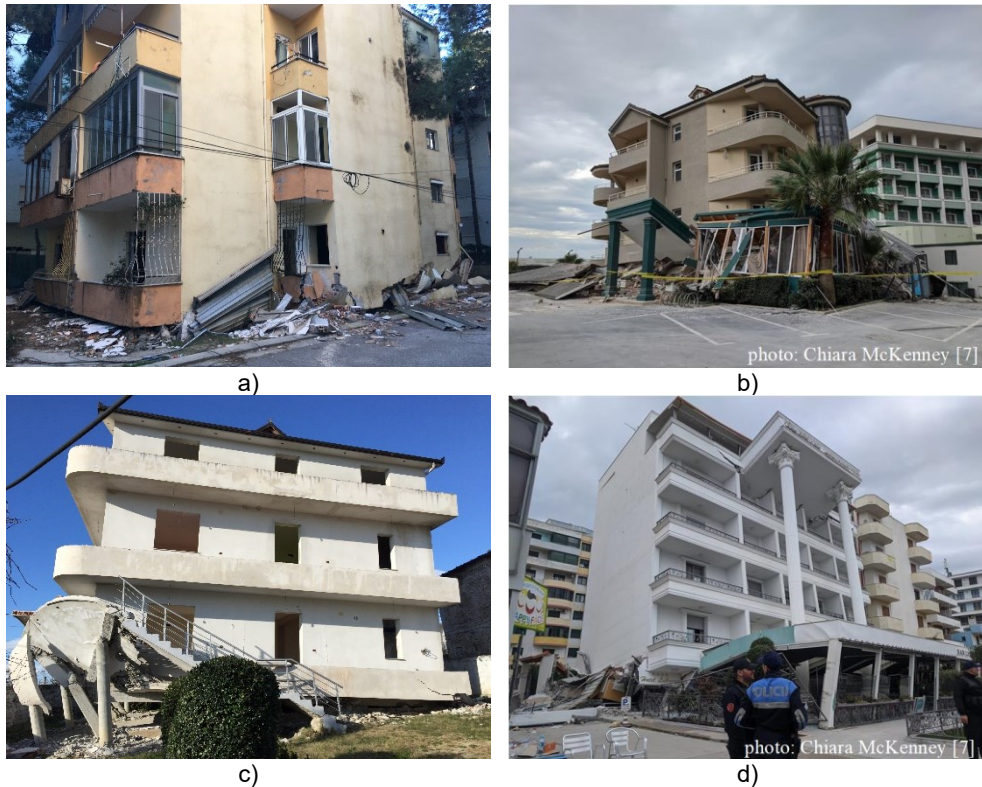
Examples of collapsed buildings in Albania due to the November 26 earthquake are shown in Fig. 3. The "soft storey" collapse was caused by a large difference in the lateral stiffness between adjacent floors-usually ground floors that were more flexible than upper floors. This behaviour is typical for flexible RC frame systems, which are common in Albania. Vertical irregularities were caused by unevenly distributed masonry infills in buildings, with open spaces at the ground floor level (garages, office space, shops, restaurants, etc.), while at the other floors there was a masonry infill (usually housing units). Due to presence of masonry infills and the resulting increased stiffness at higher floor levels, deformation demands on RC columns at open lower floors were significantly increased, which most likely resulted in structural damage and collapse. It should also be noted that Hotel Ljubljana (see Figure 3(d)) had three added floors (vertical extension). The other cause for significant damage of RC columns is their smaller dimensions compared to dimensions of RC beams, as shown in Fig. 6(a).

Figure 3. Examples of building collapses due to “soft storey” effect in the November 26, 2019

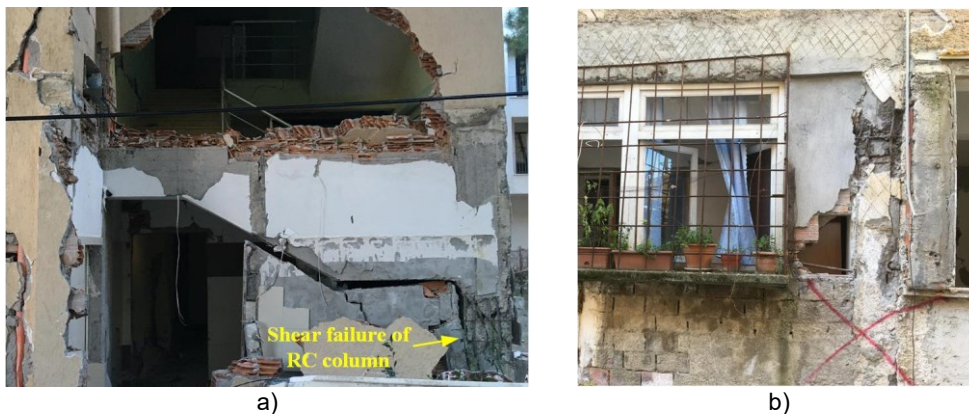
The "short-column" effect most often occurs when some parts of staircase (usually on intermediate landing) are supported by the RC columns or a partial masonry infill is constructed up to a certain height of the RC column due to openings (e.g. windows), acting as a lateral restraint along the column height. Damaged RC columns caused by this effect are presented in Figs. 4(a) and 4(b), respectively. Due to the lateral restraint of RC column provided by the staircase or the partial masonry infill, the column height is smaller. Shortening of RC column leads to increased localized stiffness and internal forces in the column itself (usually shear forces), for which RC column is usually not designed.

Figure 4. Examples of RC column damage due to “short column” effect in the Albania earthquake caused by: a) intermediate staircase landing, b) partial masonry infill due to openings

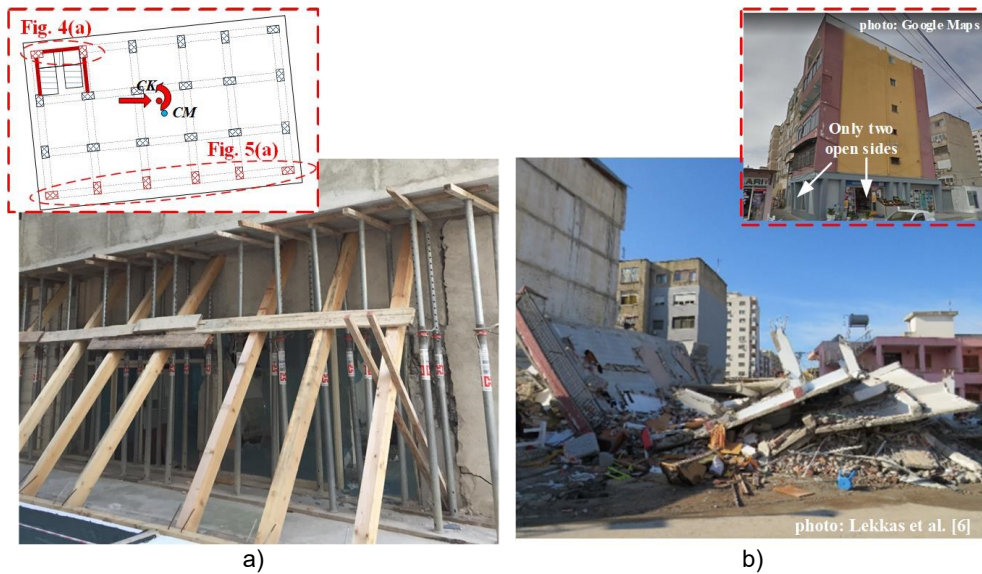
Fig. 5 shows significant earthquake damage and collapse of flexible structures due to torsional effects. The damage was caused by "secondary elements", specifically masonry infills and stairs, which are often neglected in seismic design practice. Fig. 5(a) illustrates the effect of shifting the position of the centre of stiffness of the structure due to the restrained RC columns at the stair support locations. Torsional effects caused an increase of forces in elements on the opposite side, and significant damage of the RC columns along the façade. The damage of an RC column which supports the staircase in this building is shown in Fig. 4(a). The building also had an open space at the ground floor. Fig. 5(b) shows the collapse of a corner building that had two adjacent open sides at the ground floor level with masonry infill walls along the other two sides. The ruins were cleared before the authors' reconnaissance, but it is believed that the collapse

was primarily due to inadequate detailing of RC members and torsional effects caused by a significant increase in stiffness on sides with masonry infill and an eccentricity of the centre of mass (CM) relative to centre of stiffness (CK).

Figure 5. Examples of damage and collapse of a building in Durres due to torsional effects: a) shifting of centre of stiffness due to the corner staircases, b) the influence of masonry infills

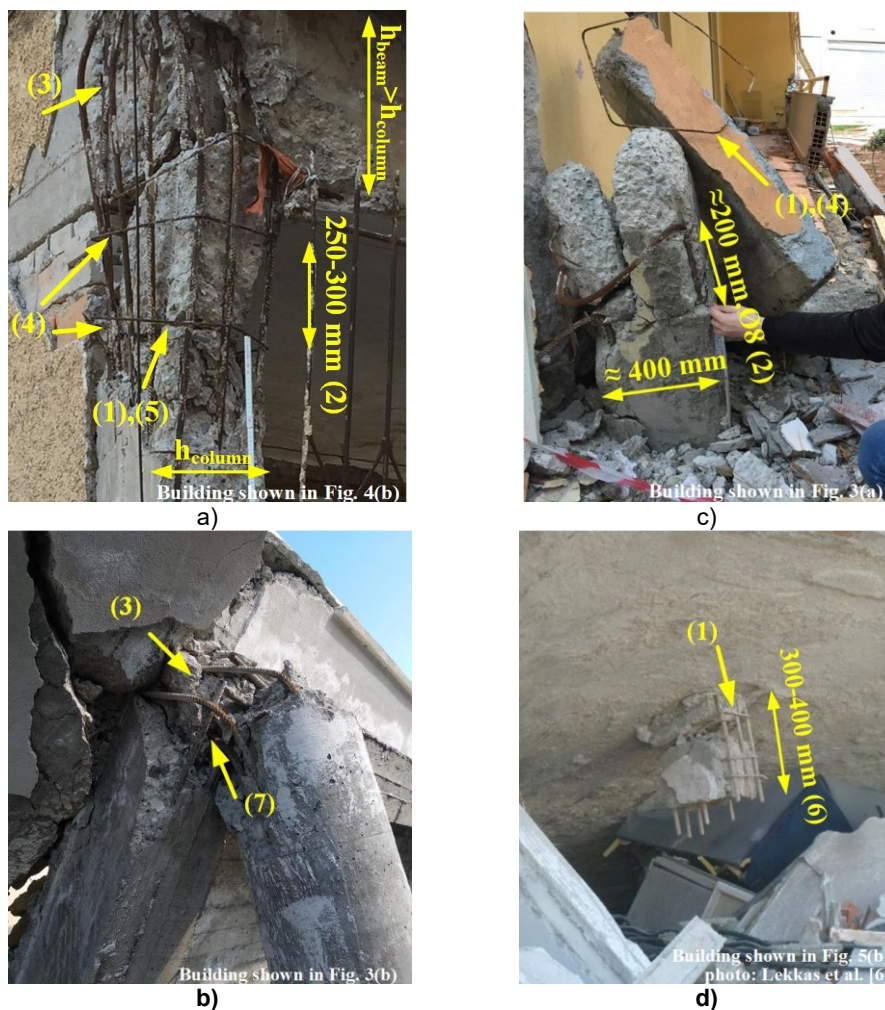
Apart from structural irregularities, several typical flaws in reinforcement detailing for the local ductility of the elements of RC frames (columns and beams), were observed in most of the damaged and collapsed buildings. Examples of these flaws are shown in Fig. 8. The authors believe that the most common detailing flaws were:

- (1) A single perimeter tie in RC columns in “critical” regions (according to [5], for RC columns with cross section dimensions larger than 30 cm, there should be at least 2 ties);
- (2) Widely spaced stirrups/ties in “critical” regions and/or outside the “critical” regions of beams and columns (according to [5], for IX seismic zone spacing of ties in RC columns should be less than 8 diameters of longitudinal bars or 10 cm);
- (3) Lack of or complete absence of stirrups in beam-column joint regions;
- (4) Ties with 90° hooks and insufficient anchorage length (according to [5], 135° hooks with straight part not shorter than 10 tie diameters are mandatory);
- (5) Ties with 6 mm diameter in RC columns (according to [5], for seismic zone IX diameter of ties should be at least 8 mm);

- (6) Insufficient lap splice length when (often 100% spliced reinforcement at one floor);
- (7) Insufficient anchorage length of longitudinal beam reinforcement (without hooks).

Figure 6. Examples of inadequate detailing of reinforcement in RC columns and beams

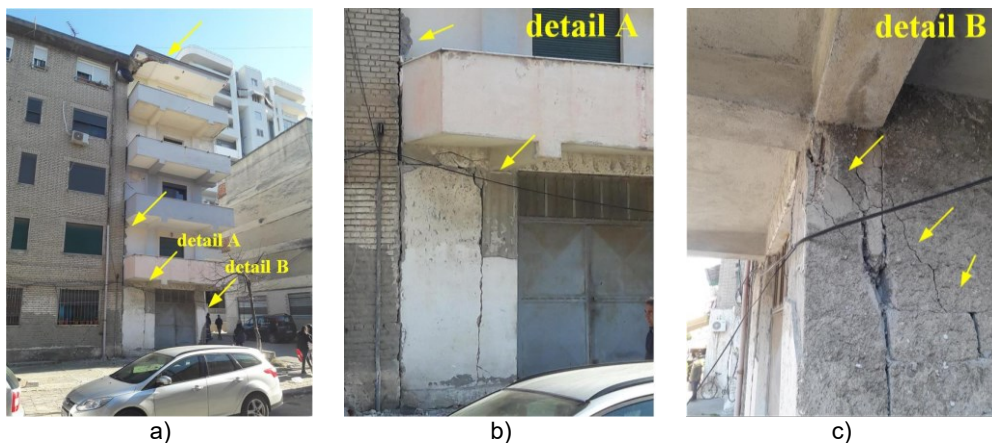
Several buildings suffered minor damage in the earthquake due to pounding, which was caused by insufficient width or absence of seismic gaps. An example of damage caused by this effect is shown in Fig. 7. In this case, the building experienced permanent inter-storey drifts. The interaction caused damage such as crushing of concrete cover (see Fig. 7(b)) and cracking of infill walls made out of concrete blocks as well as RC columns (see Fig. 7(c)) is the result of their interaction. This mechanism is explained in detail in [8].

Figure 7. Example of damage caused by pounding of adjacent buildings (a, b) and interaction between RC frames with infill walls (c)

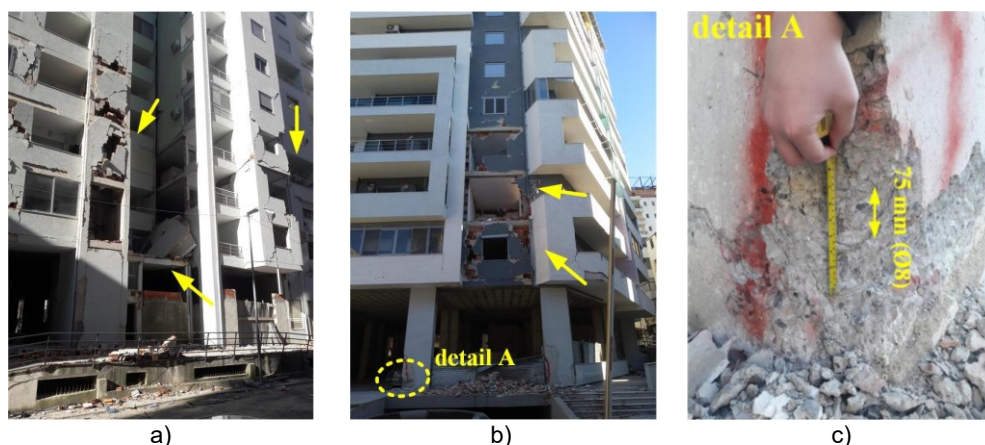
Most of the buildings that sustained significant damage or collapse during the November 26 earthquake were built between 1990 and 2010. Although the buildings built after 2010 also sustained damage in the earthquake, the level and extent of damage to the structural elements of these buildings were relatively small. The masonry infills suffered most of the damage. Although these (mostly tall) buildings had flexible RC frame structures, the authors believe that RC elements with large dimensions had a significantly higher load-bearing capacity compared to the masonry infills. Therefore, due to large inter-storey drifts at lower floor levels (typical for frame structures), only masonry infills experienced significant damage (see Figs. 8(a) and 8(b)).

Minor damage of RC elements can be attributed to adequate detailing of reinforcement for local ductility (see Fig. 8(c)).

Figure 8. Examples of damage to modern buildings with RC frame structure
