GEOMECHANICAL TESTING ON THE LANDSLIDE AT THE ČUKARU PEKI FLOTATION TAILING DUMP***

During formation of the flotation tailing dump Čukaru Peki, a landslide was activated above the mentioned location, which led to a standstill and endangerment of works. In order to obtain the geotechnical bases for designing the measures for its rehabilitation, the landslide tests were performed. Geomechanical works included the field research and testing, laboratory geomechanical testing and cabinet work.

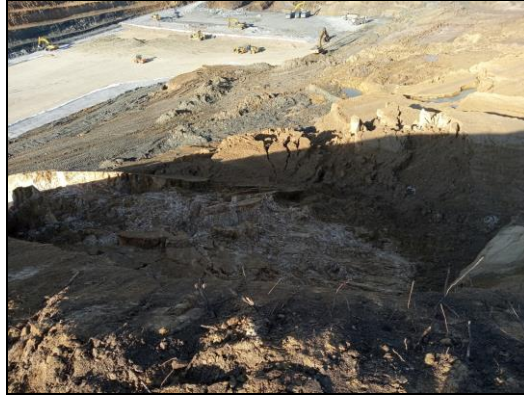
Works on the terrain preparation for dam construction and formation the flotation tailing dump Čukaru Peki, are performed according to the Main Mining Project for preparation the mineral raw materials and landfills for mining waste and pyrite concentrate from the Čukaru Peki deposit - Upper Zone, Mining and Metallurgy Institute Bor, 2020. In a part of terrain where preparation for construction the flotation tailing dump is planned, the landslide was activated (Figure 1.1).

Figure 1.1 View of the landslide from the above (December 2020)

mation, which are supported and accelerated by anthropogenic action, i.e. by removal of masses at the foot of slopes during excavation. Thus, by cutting the slope, the landslide in question was activated. The sliding affected an area of approximately 60 x 45 m. The frontal scar of landslide at the top of slope is noticeable, with an average jump of 3 m. It is assumed that the thickness of driven material in the upper part is up to 12 m and that it decreases towards the lower part of slope. In addition to landslides at the site in question, the landslides and cracks in terrain were observed in a wider vicinity of the landslide.

- It is recommended that the rehabilitation of landslide in question would be performed by removal of the clay cover (layers 1 and 2) in the area covered by the landslide and its immediate surroundings, in order to fund the dam on the basic rock mass.

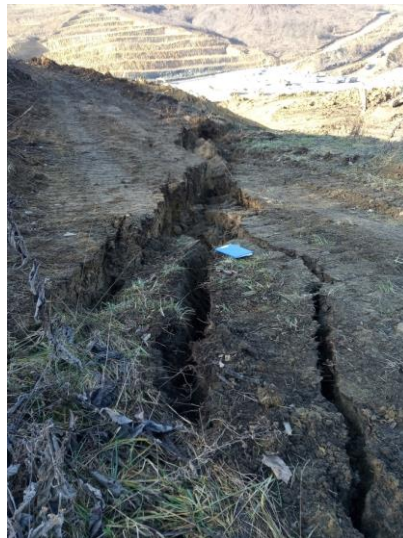
The terrain mapping was performed in order to better understand the real - real situation in the subject area, i.e. the active exodynamic process and results of its action in the field (Figure 2.1).

Figure 2.1 Crack in terrain in the immediate vicinity of landslide (December 2020)

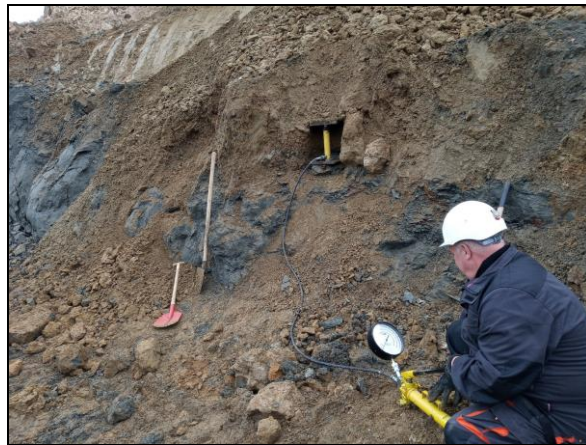
parameters along the sliding plane, i.e. mechanism of disturbed stability. It was performed in two places, according to a contact of the clay Quaternary cover with the Miocene substrate, according to the discontinuity for which it is assumed that the material slipped, Figure 2.2.

Figure 2.2 Appearance of a build-in shear equipment in the field

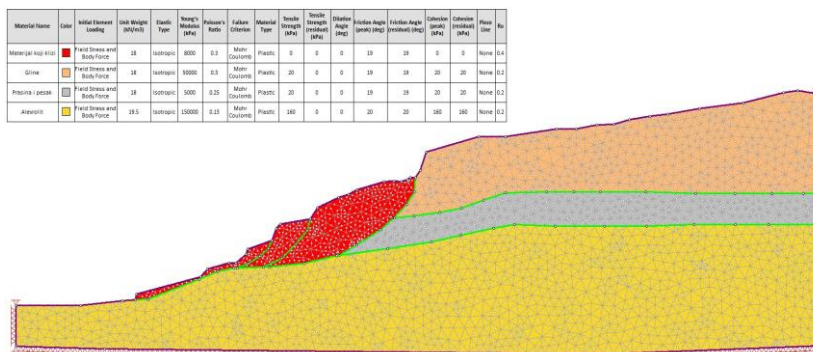
The results obtained by testing the samples were used as the input parameters for analysis the stress states of material as well as the total displacements during sliding. The analysis was done using SLIDE v6.0.

Figure 2.3 Analyzed materials with their characteristics

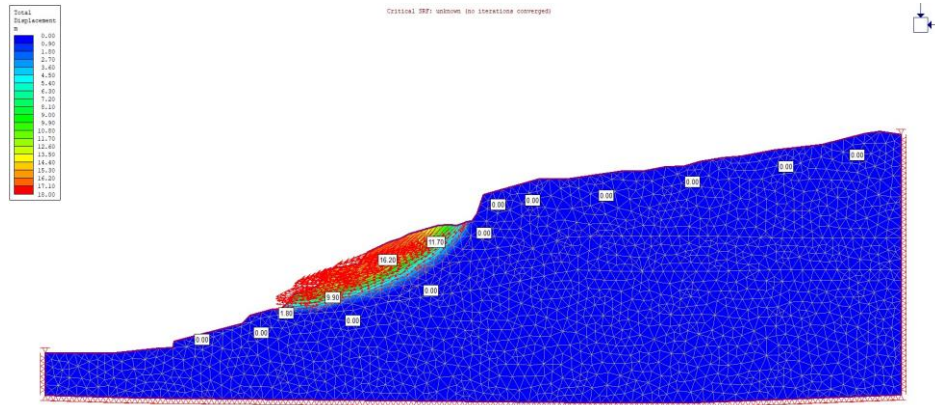
Figure 2.4 shows the sliding tendency of material with total displacements, expressed in meters.

Figure 2.4 Total displacements of sliding material, in meters

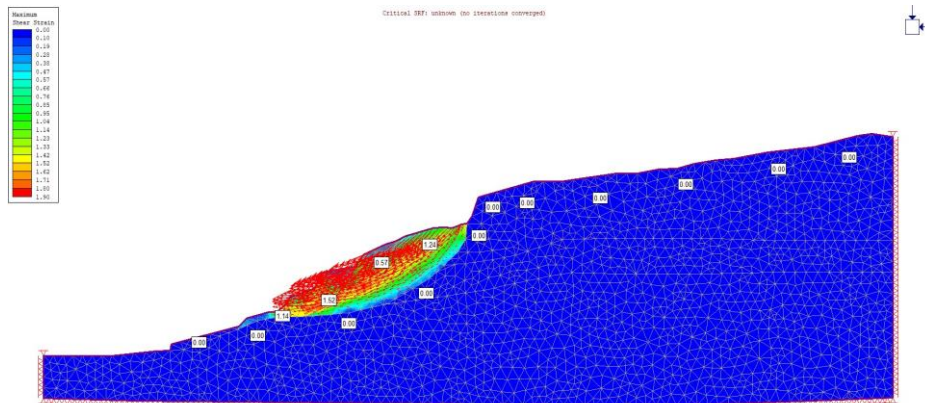
Figure 2.5 shows the maximum shear deformations of sliding material.

Figure 2.5 Maximum shear deformations of sliding material
