REHABILITATION OF THE LANDSLIDE AT THE "LANDFILL 3" IN THE ZONE OF THE ČUKARU PEKI FLOTATION TAILING DUMP**

Abstract

The "Landfill 3" was formed at the location of the flotation tailing dump "Čukaru Peki", where the earthen material, created during the dam construction of the flotation tailing dump was placed. A part of the deposited material and substrate at this landfill has slipped that endangers the local road and "Kusak" stream at the landfill foot. That is why this landslide needs to be rehabilitated.

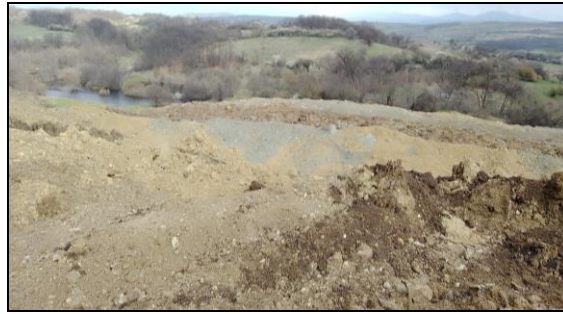
Figure 1 *Landslide on the "Landfill 3"*

for the flotation tailing dump. With the formation of this landfill, in 2021, there was a soil breach on the slope on which the landfill is located, what caused sliding of the clay substrate and deposited material, Figure 1. The moving material interrupted the local road and flow of the nearby "Kusak" stream at the bottom slopes and formed a smaller accumulation.

The cause of landslide activation is the unfavorable geometry of landfill and overloading of the base on which it rests, which caused the ground to break. The slide has covered an area with approximately size of 190 x 260 m.

As a result of pressure of the activated technogenic material and deluvial clays on the lower part of research area affected by the slide, a zone of pronounced surface deformations appears, as a result of large lateral pressures. Deformations appear in the form of accumulation of material and cracks

on the ground, which completely changed its natural geometry. The zone is developed in the middle of deluvial clays covered with humus and must be subjected to the rehabilitation measures.

The design solution is to achieve the permanent stability of endangered slope changing the geometry, and to break through a new route of the riverbed to dry out the artificially created dam.

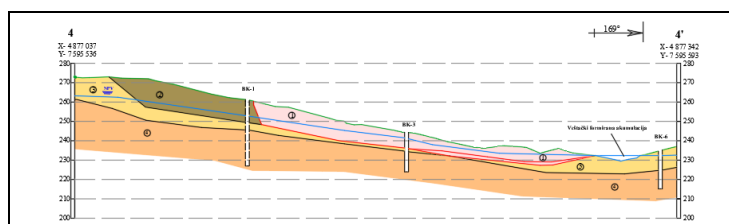
Figure 2 Characteristic geotechnical profile

Seven geotechnical profiles were defined on the site. Calculation parameters were determined for stability calculation for each working medium, as well as the level of underground water on profiles [1]. The values of calculation parameters for stability calculation are shown in Table 1, the characteristic geotechnical profile is shown in Figure 2.

It is assumed that the thickness of the activated material in the central part is up to 23 m. By mapping the field, a frontal scar visible along its entire length was observed, with a jump of an average of 2 m, with a clearly visible plane along which the movement occurred. The deposited material and part of deluvial clays were affected by sliding.

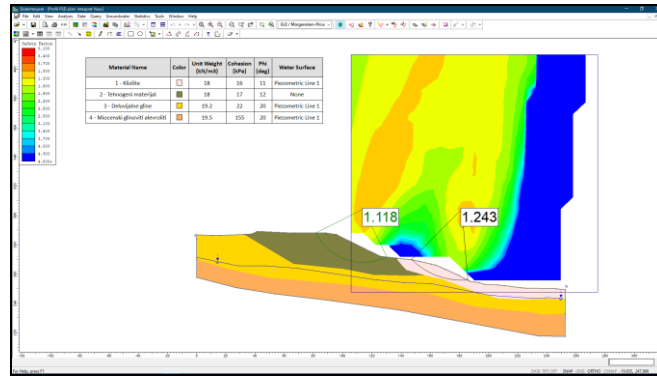
Figure 5 Calculation the existing landfill state stability in the Slide program

A stability calculation was performed on six geotechnical profiles [2]. Figure 5 shows the output interface of the Slide

Analyzing the calculation results of the existing state stability of the landfill, the areas were determined where the safety coefficient is below the legal minimum [3]. The values of safety coefficients of

the existing state confirm that rehabilitation of certain parts of the landfill is required. Figure 6 shows the areas of "Landfill 3" that require rehabilitation.

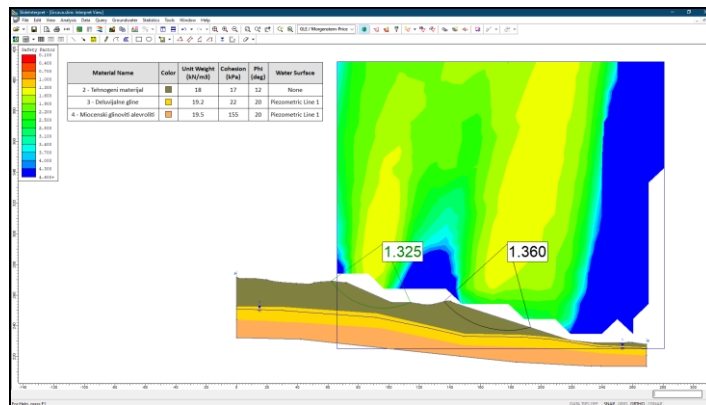
Figure 11 Stability calculation of the rehabilitated landfill in the Slide program

Analyzing the calculation results of the landfill stability after rehabilitation, the conclusion is that the legal minimum value of the stability coefficient of $F_s = 1.30$ for soft rocks on the landfill is met [3].
