*Ljubiša Obradović**, *Sandra Milutinović**, *Srdana Magdalinović**, *Sanja Petrović**

AUSCULTATION OF THE RTH FLOTATION TAILING DUMP IN BOR WITH REFERENCE TO THE STABILITY OF DAMS AND DYKES AT THE TAILING DUMP**

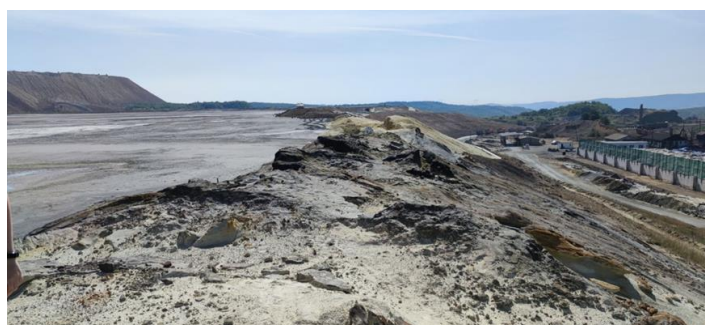
Wind erosion, as in the previous period, has the most harmful effect on the geometry of dams and embankments. Figure 2 shows the embankment on untreated part of the tailing dump between PPS and Dam 2, where a damage caused by the wind daily to the RTH tailing dump is best seen, taken in 2021. The material is removed from the dam crown and stored outside the tailing dump area. This significantly disrupts the designed geometry of the dam and embankment. During the material removal from the dam crown, large depressions up to 3 meters deep are created, what significantly threatens the dam stability. The embankment has changed its designed height and cross-section, and the embankment crown is not of designed width leading to a reduction in the safety coefficient of that section, because the designed ratio of embankment height and water in the embankment body have changed.

Figure 2 Detail of the endangered part of the embankment between PPS and Dam II, flotation tailing dump RTH, 2021

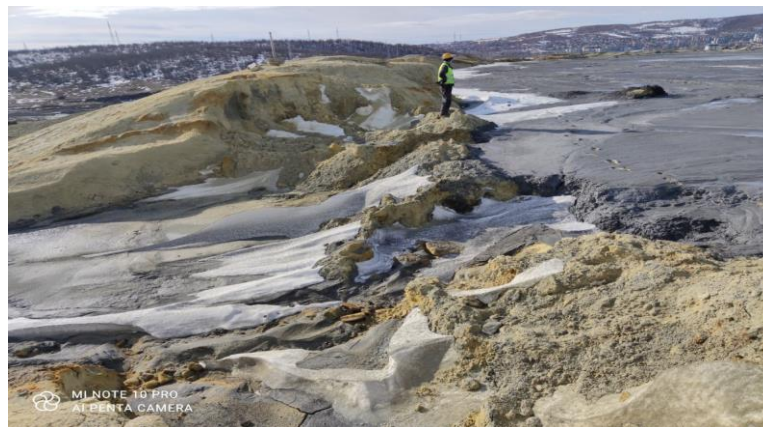
Figure 3 shows a part of Dam II where, due to erosion, the first overflow of water and sludge occurred over Dam II into the

surrounding area on 01/29/2021, which could have caused very serious problems at the flotation tailing dump. The quick re

sponse of employees at the tailings dump stopped the overflow of sludge, which was quickly localized and stopped. This part of embankment is highly threatened by the wind erosion, and here urgent interventions are necessary in terms of correcting the geometry of embankment in accordance with the current technological project, in order to prevent the harmful consequences that further erosion of the embankment can cause for the stability of this part of embankment, as well as the entire flotation

Figure 3 Completely eroded crown of the Dam 2 where the first serious overflows where the observed water and silt over the crown and downstream slope were recorded on January 29, 2021

tailing dump RTH as a unique mining facility. In order to rehabilitate the dam crowns and embankments at the flotation tailing dump and bring their geometry to the designed geometry, the Investor concluded a contract with MMI Bor for the development of the DMD of the overhang the flotation tailing dump RTH, within which Volume II.1: Technical Design of Dam Rehabilitation will be prepared, and bring it to the designed state according to the valid technological project.

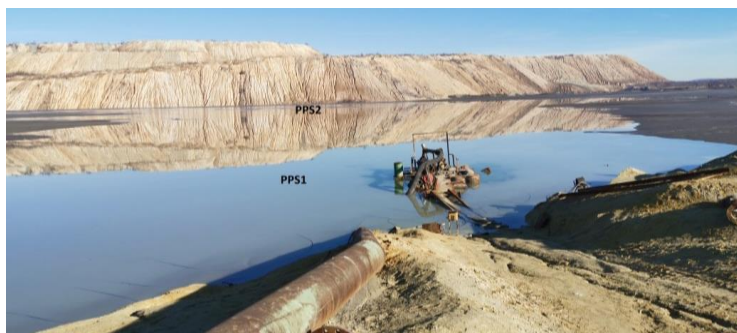
The evenness of the filling of the storage area in the case of the RTH tailings pond is directly affected by the position of storage lake and location of the floating pumping station, which was not placed at the designed location, provided in the current Technology Project from March 2008 [2]. The position of the floating pumping station in the current conditions of exploitation at the RTH flotation tailing dump is shown in Figure no. 4 as location 1 or PPS1, while the designed location is shown as location 2 or PPS2. The images were taken during regular auscultation during the annual auscultation period. The cu-

rent position of the PPS has a great effect on the inner slope stability of the embankment. Due to the proximity of the PPS embankment, the area around the PPS is exposed to the erosive action of water on the embankment. Sand particles are washed away, thus the body of the embankment and internal slope, which leads to flaking of embankment and separation of individual parts. Increasing the water level in the lake, flaking i.e., separation the parts of embankment is more and more pronounced. This reduces the weight of embankment, which directly affects the slope stability and increase the groundwa-

Figure 4 Existing and designed location of the floating pumping station, tailing dump RTH

ter level in the body of embankment. After rehabilitation the embankment crown and armoring the old inactive TIR collector, it

will be possible to move the PPS to the designed location next to Visoki Planir [4].

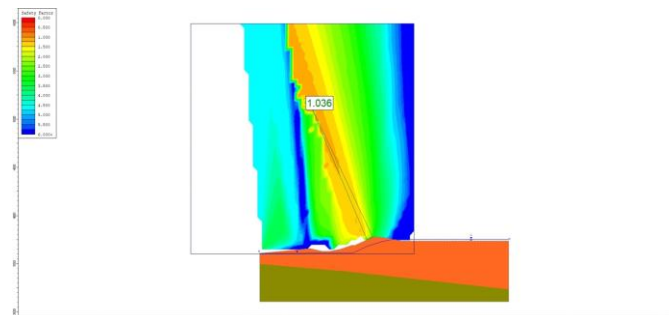
of groundwater on stability was modeled on the basis of measured water levels in the piezometers and the level of water mirror in the tailing dump. Calculation of stability according to the analyzed profiles for constant static loads and dynamic loads for seismicity coefficient $K_S = 0.13$ is shown in Figures 6 and 7 for profile 4/2, while the calculation results are shown in Table 5.

Profile	F_s static	F_s dynamic
2/1	1.846	1.231
4/2	1.036	0.783
8*/1	2.955	1.926
9/1	1.112	0.868

Figure 6 Stability coefficient by profile 4/2 for static loads, Yanbu method

By comparison the obtained safety coefficients of the flotation tailing dam with the minimum permitted coefficients, according to the current standard for dams (SRPS U.C5.020), which for embanked dams over 15 m in height is a minimum of $F_s = 1.50$ in the case of permanent static loading, i.e. $F_s = 1.00$ in the case of an occasional dynamic load for occurrence the earthquake, it can be concluded that for profiles 4/2 and 9/1, the values for both coefficients (for static and dynamic loads) are significantly below the prescribed minimums.

Based on the above, the conclusion is that it is necessary to take the remedial measures in the profile zone 4/2 and 9/1 (in the area of pumping station, i.e. the water mirror), primarily by lowering the groundwater level and removing the water mirror from the inner slope of the flotation tailing dump embankment, as well as bringing the geometric elements of the dam, i.e. the mine disposal site in the zone of profile 9/1 into the designed parameters. Also, related to the stability of the RTH tailings dams, it is necessary to constantly monitor all changes on the dams: the occurrence of cracks, landslides, and subsidence, occurrence of percolating water, as well as the geodetic recording of the dams in the event of aforementioned occurrences, to timely observe all

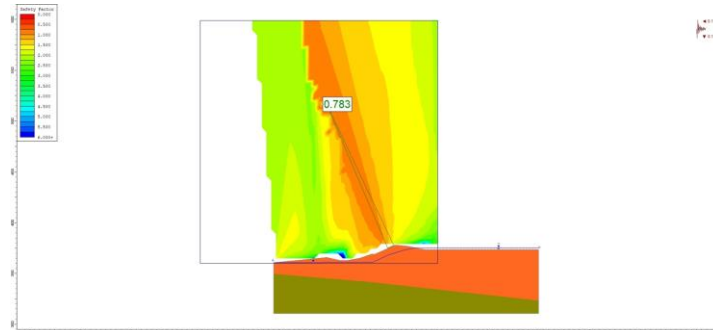
Figure 7 Stability coefficient by profile 4/2 for dynamic loads, Yanbu method
