POSSIBILITY OF REHABILITATION AND OVERHANG THE DAM 6 AT THE "VALJA FUNDATA" TAILING DUMP IN MAJDANPEK**

INTEGRATED DISPOSAL OF MINING WASTE, AN EXAMPLE OF REHABILITATION THE DAMAGED EMBANKMENT AT THE RTH TAILING DUMP BY THE MINE OVERBURDEN**

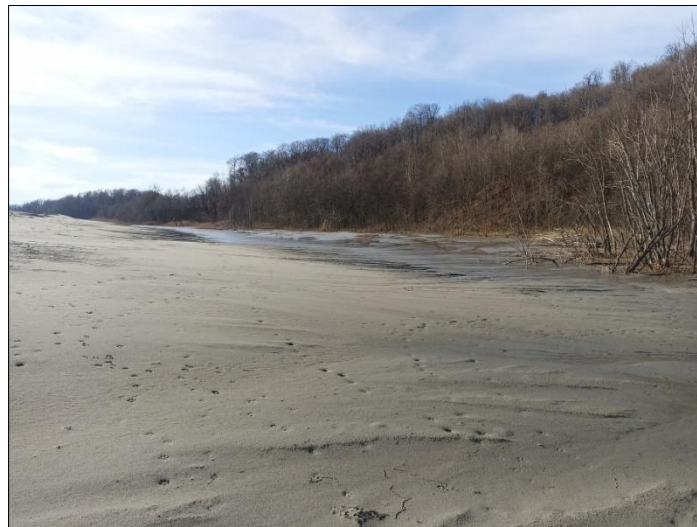
the embankment (Figure 2), terrain zones with the existing deformations, modern exogenous processes, hydrogeological phenomena and terrain stability. On the observed rock outcrops, the thickness of deluvial cover was estimated. Then, the petrological type and rock mass strength were macroscopically defined as well as the pre-

Figure 2 *State of the external slope of the embankment*

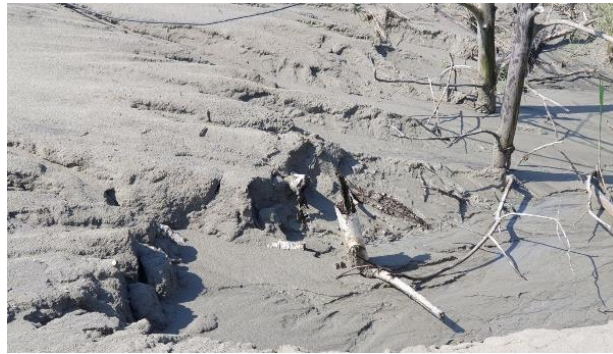
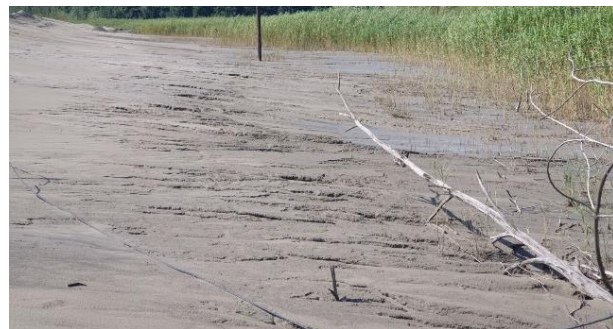
Figure 3 shows a part of the dam 6 viewed from direction of the dam 1, where the damage caused by the water and wind erosion on a daily basis at the "Valja Fundata" tailing dump can be seen. Erosion also affects the outer slope of the embankment in the Sector 6 from direction of the PS "Kaluđerica", shown in Figure 5. Erosion caused by the action of both atmospheric water and leachate from the accumulation area of the tailing dump causes the shelling of the outer slope and its collapse. As a result of the leachate action, the sand particles

are carried out, as a result of which depressions are formed, and after that, when the stability coefficient falls below the critical level, the parts of the outer slope collapse. Later, as a result of heavier rainfall, larger

or smaller ravines are formed along the entire length of the outer slope, which can both locally and generally affect the stability coefficient reduction of endangered dams and embankments [2].

Figure 3 *Effect of water erosion on the outer slope of the Dam 6, August 2023*

Due to the harmful effect of wind, it is necessary to correct the geometry of the crown of dams several times a year in all places where it is threatened, as well as corrections the external and internal slopes [4].

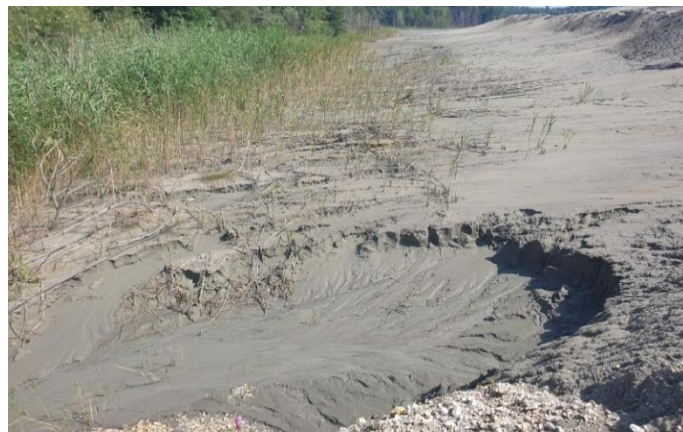
Figure 4 *Effect of water erosion on the outer slope of the Dam 6, August 2023*

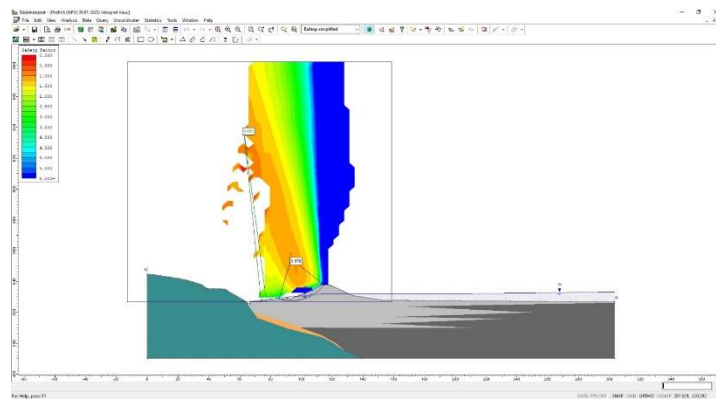
Figure 5 *Static coefficient of safety for profile 6 - 6'*

- According to the analysis profile 6 - 6', the value of safety coefficients for static and dynamic loads is below the minimum prescribed value.

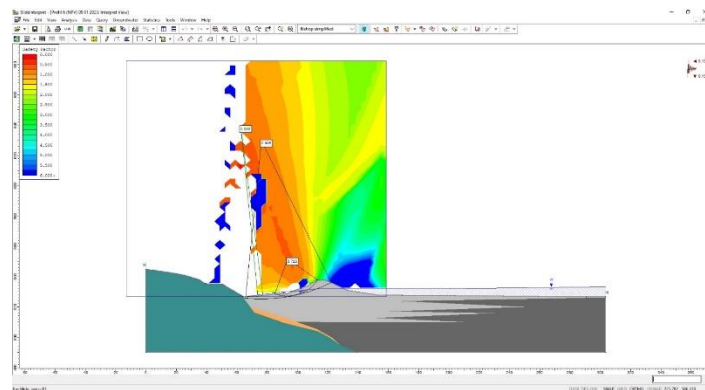
Figure 6 *Dynamic coefficient of safety for profile 6 - 6'*

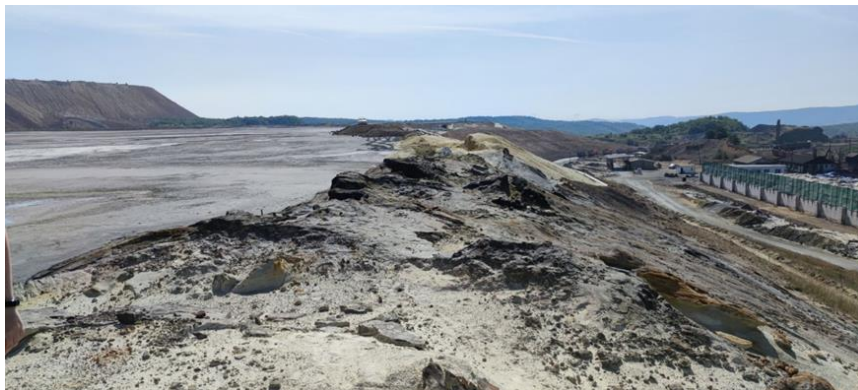
Wind erosion, as in the previous period, has the most harmful effect on the geometry of dams and embankments. Figure 2 shows

the embankment on untreated part of the tailing dump between the PPS and Dam 2, where the damage caused by the wind on a daily basis at the RTH tailing dump is best seen, recorded in 2021. The material is removed from the crown of the dam and stored outside the tailing dump area. This significantly disrupts the designed geometry of the dam and embankment. During the removal of material from the crown of the dam, large depressions up to 3 meters deep are created, what significantly threatens the stability of the dam. The embankment has changed its designed height and cross-section, the crown of the embankment is not of the designed width leading to a decrease in the safety coefficient of that section, because the designed ratio of the embankment height and water in the body of embankment has changed [3].

Figure 2 *Detail of the endangered part of the embankment between PPS and dam 2, flotation tailing dump RTH, 2021*

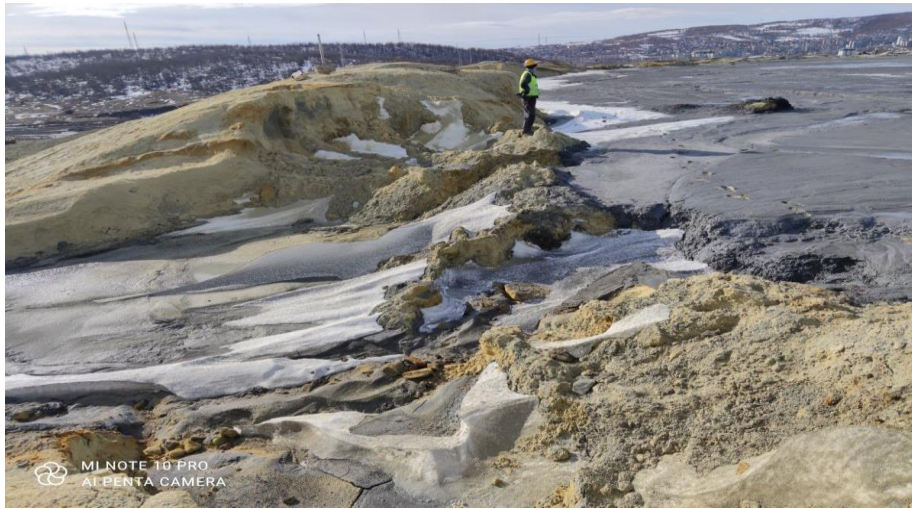
Figure 3 shows the part of Dam 2 where, due to erosion, the first overflow of water and sludge occurred over dam 2 into the surrounding area on 01/29/2021. year, which could have caused very serious problems at the flotation tailing dump. The quick response of employees at the tailing dump stopped the overflow of sludge, which was quickly localized and stopped. This part of embankment is highly

threatened by the wind erosion, and here the urgent interventions are necessary in terms of correcting the geometry of embankment in accordance with the current technological project, in order to prevent the harmful consequences that further erosion of the embankment can cause for the stability of this part of embankment, as well as the entire RTH flotation tailing dump as a unique mining object [5].

Figure 3 Completely eroded crown of the Dam 2 where the first serious overflows of water and sludge were observed over the crown and downstream slope, January 29, 2021

In order to rehabilitate the crowns of the dams and embankments at the flotation tailing dump and bring their geometry to the designed geometry, the Investor concluded a contract with MMI Bor for development the SMD for overhanging the flotation tai-

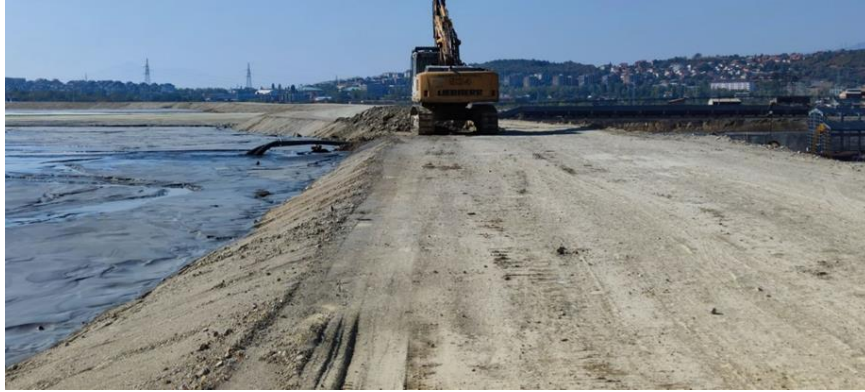
Figure 5 Embankment between the Dam 2 and high landfill, October 5, 2021

During the summer and autumn of 2021, the rehabilitation works were carried out on the field, after the works on the crown of the dam and geometry of the embankment at the tailing dump, a stable condition was brought in accordance with the valid Technological design. The crowns and embankments after the rehabilitation works are present in Figures 5 and 6.

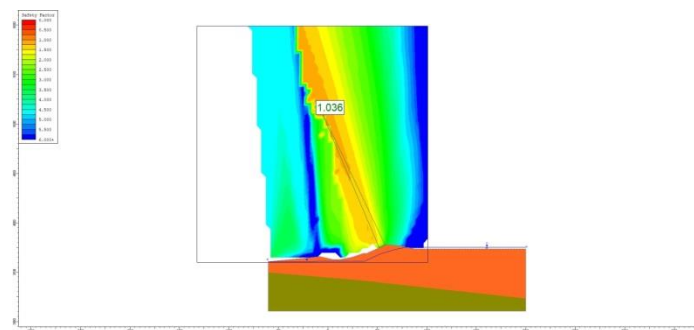
Figure 7 Stability coefficient according to the profile 4 for static loads, Yanbu method

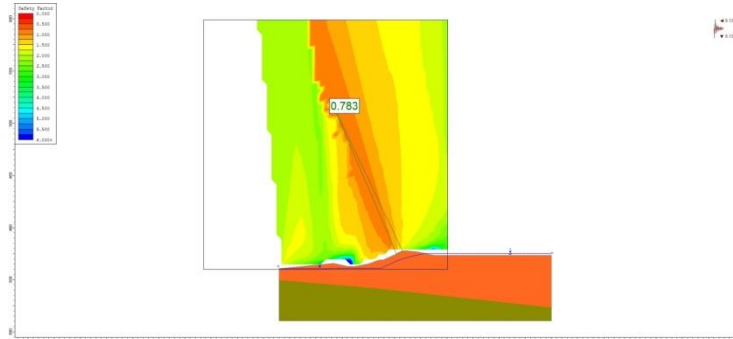
Figure 8 Stability coefficient according to the profile 4 for dynamic loads, Yanbu method

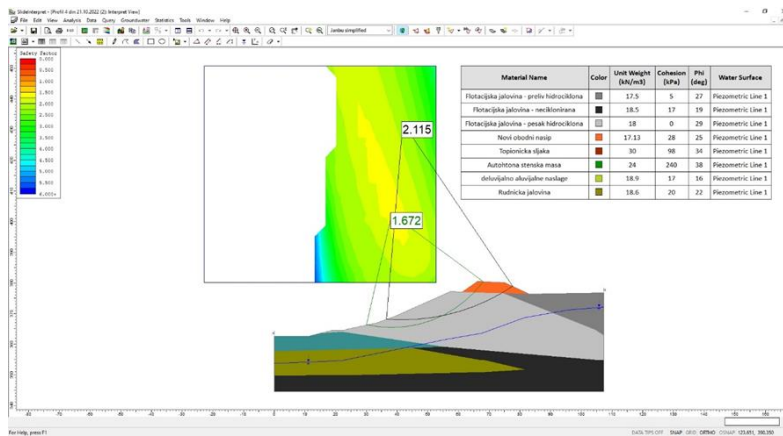
Figure 9 Stability coefficient according to the profile 4 for dynamic loads, Yanbu method

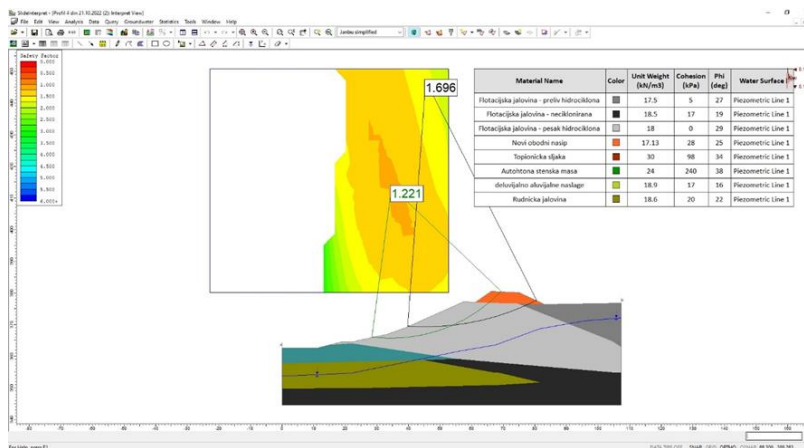
Figure 10 Stability coefficient according to the profile 4 for dynamic loads after embankment rehabilitation, the Yanbu method

By comparison the safety coefficients of the flotation tailing dam with permitted minimum coefficients, according to the valid standard for dams (SRPS U.C5.020), which for the embanked dams over 15 m in height is a minimum of $F_s = 1.50$ in case of permanent static load, i.e., $F_s = 1.00$ in the case of an occasional dynamic load for the occurrence of an earthquake, it can be concluded that for the profile 4 after rehabilitation, the values for both coefficients (for the static and dynamic loads) are more than doubled, i.e., significantly above the prescribed minimums.
