An analysis regarding train derailments caused by cracked wheelsets

Eugen Ghita¹

¹Politehnica University, Faculty of Mechanical Engineering, Timisoara, Romania

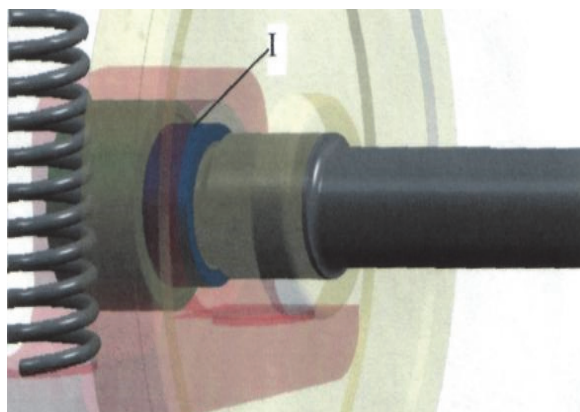
Based on the analysis carried out at the accident site by the research commission [2], it was established that "The breakage of the axle shaft, in the transition (connection) area between the axle shaft and the shutter area, occurred in the distance between Hm Cotești and CFR Guguști Station ..."

Figure 1: Cracking zone

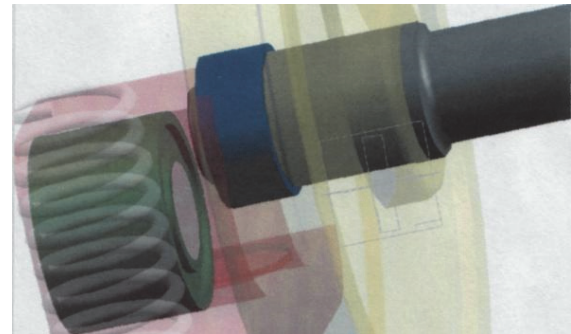
Figure 6: Detaching the grease box from the end of the axle

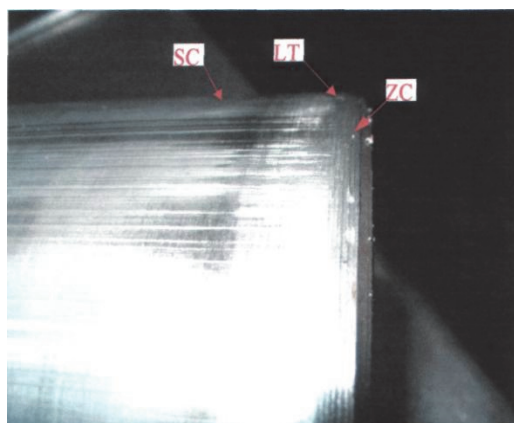
1. The end of the axle spindles has a clearance (5 mm x 6°), which is not found in the execution drawing and can be visualized in Figure 9. This clearance (above which the 2 x 45° clearance was also executed) is found in the design of type A I axles, but also in the design of OR 1 axles.

Figure 9: Tapered zone (ZC) on the end of the broken spindle

The existence of the conical surface with an inclination of 6° represents a deviation from the execution drawing, but it is not invoked as the cause of the spindle breaking, but as evidence of obtaining this axis by processing (cutting the ends) from an old one that had, according to the execution drawing, conical surface. The fact that this conical area has a variable width, but possibly highlighted in the expertise) is evidence of the processing at different grips of SC and ZC. Since ZC was machined by snapping to centering holes in the original axle, it follows that SC was machined by snapping to centering holes machined after cutting the ends. Considering the extremely small tolerances of the spindle on the initial axis (between $+0.037$ and $+0.059$ mm), any dimensional processing in this area involves increasing the diameter by previously adding a layer of material. Visual analysis allows, in the case of a broken axle, to highlight some circular marks on the surface of the spindle. It is specified that this cutting of the ends has the effect of removing all the markings that allow the identification of the modified axle. Whereas in the points of view of the C.F.R. no reference is made to the marking transfer operation, which is not included in the technological flow of the S.M.R. Balş, this operation cannot be considered as being included in a homologated technology and allows the loss of the identities of the modified axle.

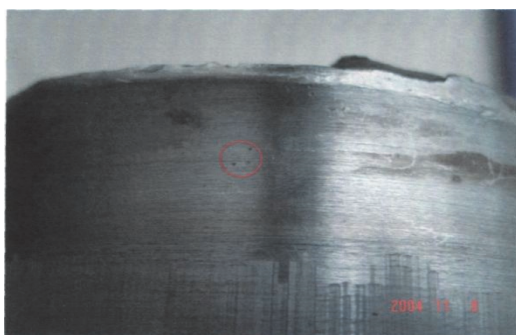
Figure 11: Pores on the surface of the broken spindle

It is found that the pores are located exclusively in the connecting radii. In addition, the pores have a circular section, which is not characteristic for a forged material where the possible porosities from casting are flattened or even closed. The circular pores indicate the existence of a metallurgical operation, which consists of local melting on the entire circumference of the axle in all connection areas.

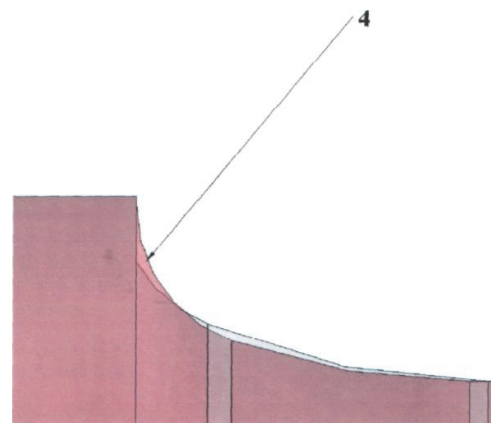
Fig. 19. Zone 4

Zone 4 - The difference between the connection radii in the center of the axle, which imposed the welding loading of the old axle (Fig. 19).

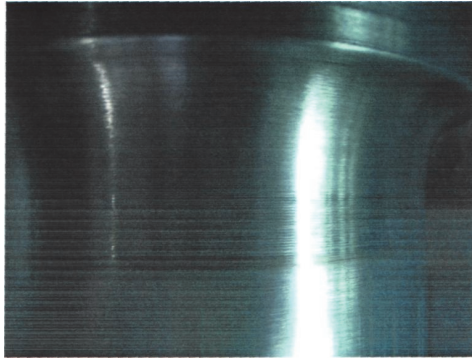
The roughness measurements in the connection areas indicated much higher roughness values than those provided in the documentation ($R_a = 5...5.5 \mu\text{m}$, compared to $R_a = 0.8 \mu\text{m}$ imposed by the drawing) (Fig. 20).

Figure 20: High roughness in the connection area

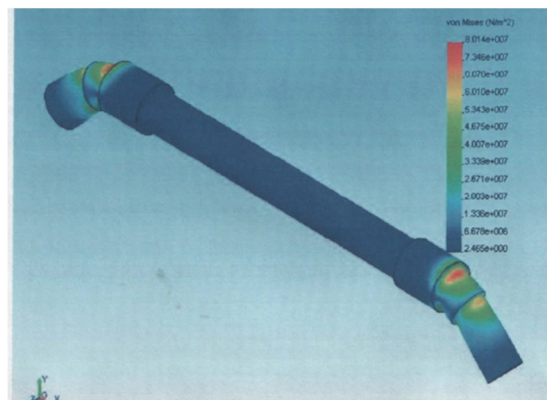
After the finite element discretization of the 3D CAD model of the type A II axle, the numerical calculations were performed and resulted in a maximum von Mises stress value of 80.14 MPa), which is well below the breaking limit of the material used for production of axles (Fig. 23), value between 550 and 700 MPa (according to the U.I.C. 820 sheet).

Figure 23: The von Mises stresses resulting from finite element calculations on the 3D CAD model of the type A II axis, in the case of static stresses

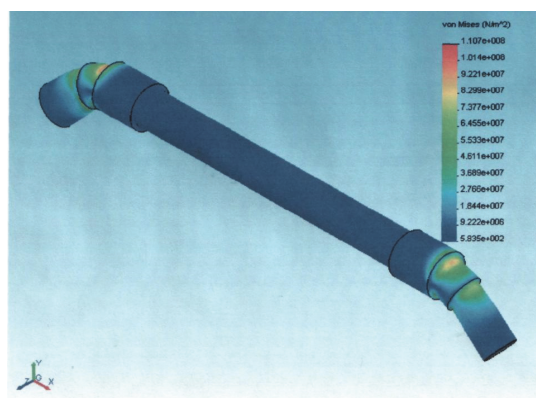
The maximum stress thus calculated, considering the dynamic stresses in curves, with the axle not braked, is 110.7 MPa (Fig. 24).

Figure 24: The von Mises stresses resulting from finite element calculations at the 3D CAD model of the axle type A II, in case of dynamic stresses
