## FAILURE ANALYSIS OF WELDED JOINT BETWEEN ROCKET MOTOR CASE AND FINS

**Abstract:** In this paper a fractured welded joint between rocket motor case and fins was examined. The goal of this study was to determine the cause of fracture which occurred during high pressure probe. Specimens taken from the fractured surface were examined using scanning electron microscope. In order to determine material properties and welded joint quality, chemical analysis, microstructural examination, and microhardness measurements were performed. Macroscopic examination showed that initialization of fracture was on outer surface of the case. Observations of fracture surface using SEM revealed mixed mode of failure, lamellar cleavage, and ductile rupture, without visible plastic deformation. Spherical particles based on Fe and O were also seen on fracture surface. Microhardness measurements showed high difference in microhardness value between base material and heat affected zone (HAZ). Detailed analysis showed that inadequate preparation and welding procedure resulted with unsatisfactory microhardness distribution which led to fracture.

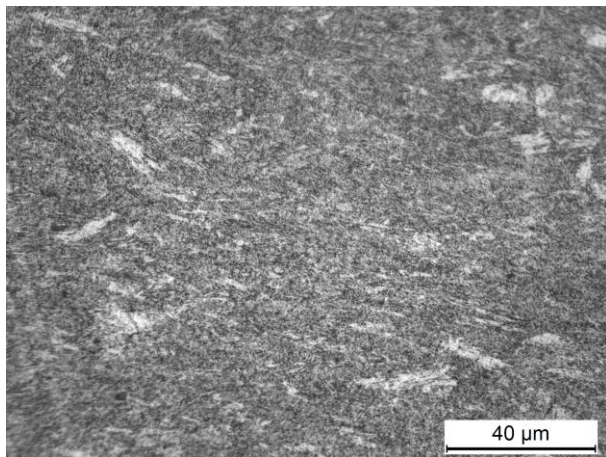
HAZ microstructure, consists of martensite. Microstructure of base material of motor case is fine grained tempered martensite.

**Figure 1.** Microstructure of a) HAZ near fracture initiation site, b) at HAZ/BM border and c) base material of rocket case

By measuring the microhardness of the welded joint at the point of fracture and outside the fracture site, it was determined that there is a difference between the hardness of the base metal and the heat affected zone and amounts to  $\approx 300$  HV1. A major difference in microhardness is undesirable because it contributes to the brittleness of the welded joint. Such significant difference in microhardness can be attributed to observed microstructure. Microstructure in HAZ is martensite which have high hardness values. The microstructure of the base metal is fine grained tempered martensite.

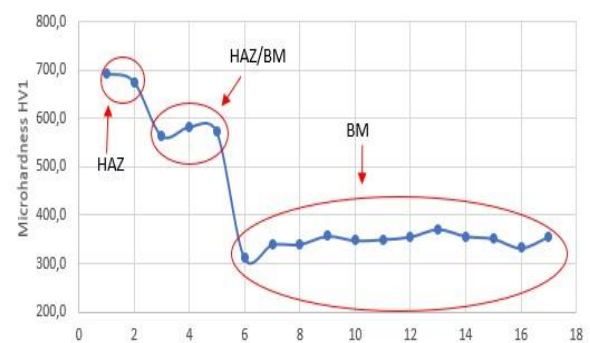
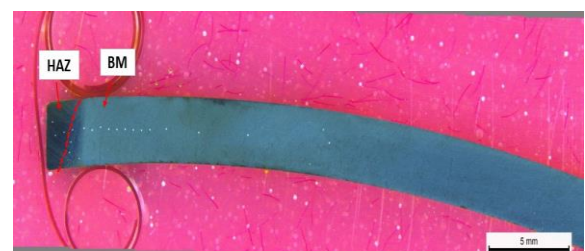
**Figure 2.** Microhardness distribution diagram of sample 1, taken from fractured surface.

From the results presented in table 2, there is significant difference in microhardness values between heat affected zone (HAZ) and base material (BM) of rocket case, more than 300HV1.

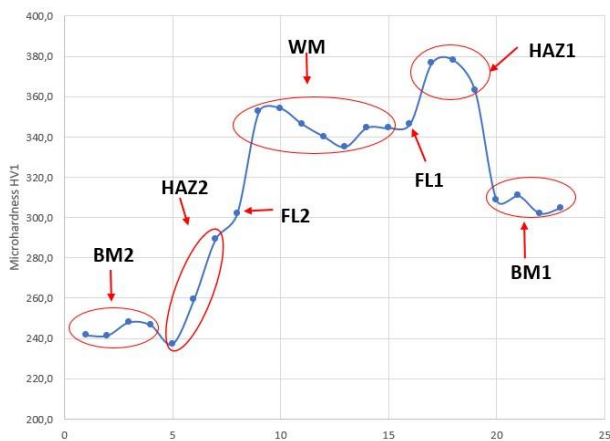
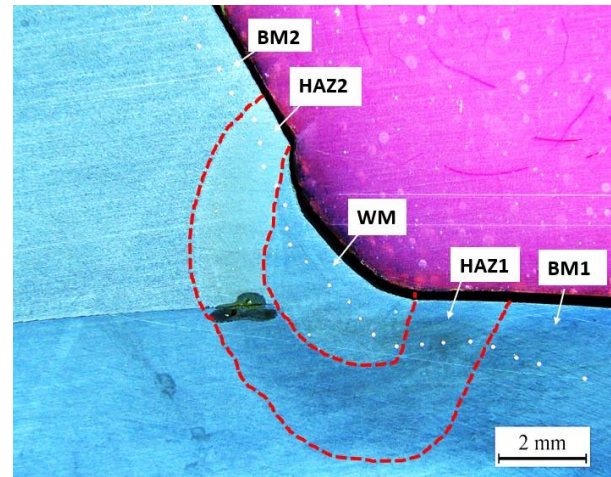
Based on measured values of microhardness, it is clear that heat treatment reduced difference in microhardness between HAZ and BM of rocket case motor, from more than 300HV1 to around 70HV1.

**Figure 3.** Microhardness distribution diagram of welded joint, after heat treatment.

To try to reduce difference in microhardness between HAZ and BM, heat treatment of welded joint was performed on 500°C for 45 minutes. Heat treatment was performed on sample taken from the non-fractured welded joint.

Due to the enormous difference in hardness between the base metal and the heat affected zone, heat treatment of the sample was performed. Heat treatment resulted in a reduction in the difference in microhardness values to  $\approx 70$  HV1. This is attributed to decrease in residual stresses in the welded area (5).

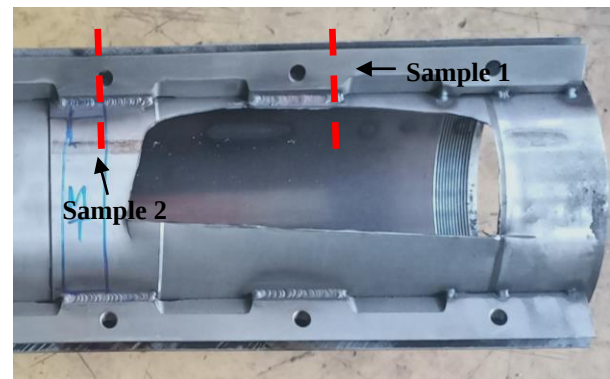
**Figure 4.** Part of rocket case with fractured surface.

Fracture initiation site (FIS) is on the outer surface of the rocket case, and no visible deformation was observed. However, arrow like pattern on fracture surface was observed which can provide insight on how crack propagated through material.

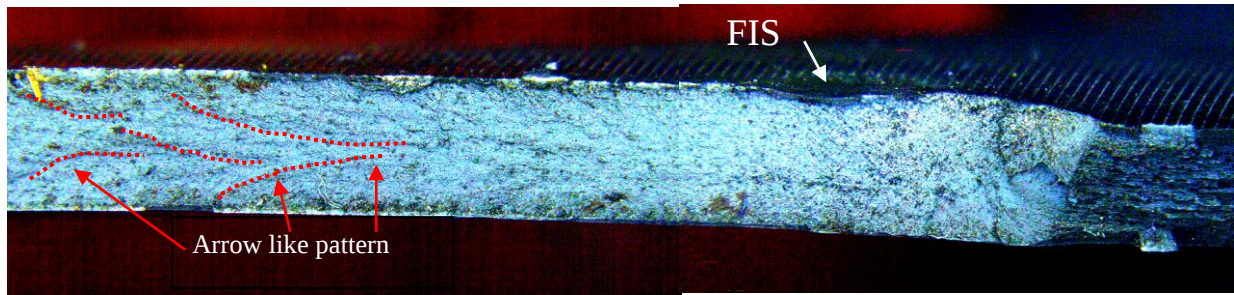
**Figure 5.** Macroscopic morphology of fractured surface with fracture initiation site (FIS)

A macroscopic examination of the fracture showed that the initiation site of fracture is on the outer wall of the chamber, in the zone of the welded joint. The crack, in the initial phase of growth, extended at an angle of  $45^\circ$  to the outer surface of the rocket case. At a further stage of propagation, the crack changes direction and extends at an angle of  $90^\circ$  to the outer surface of the rocket case. No deformation of the material was observed in the vicinity of the fracture. On the fracture surface, arrow-shaped patterns were observed, which indicate the place of fracture and the direction of spread of the crack.

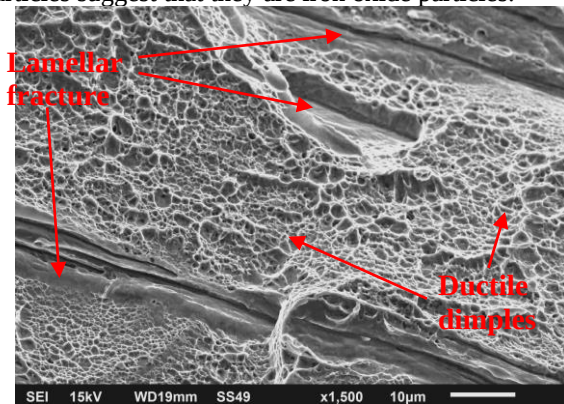
To determine micromechanism of fracture, fractured surface was analyzed in more details with scanning electron microscope. SEM analysis showed two types of fracture, figure 6a:

- Ductile fracture, with shallow and polygonal ductile dimples and
- Lamellar fracture in heat affected zone (HAZ) which is caused by stresses normal to surface of rocket case.

**Figure 6.** a) Characteristic morphology of fractured surface, b) Spherical particles at root of welded joint

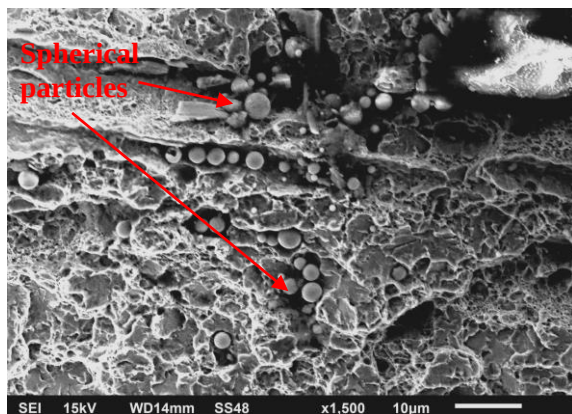
b)

SEM investigation also showed high number of globular particles present in root of welded joint, figure 6b.

cleavage, i.e., stratification of the material in the direction of the thickness of the rocket case wall as well as ductile fracture with shallow low-energy pits. In the root of the welded joint, spherical inclusions based on iron and oxygen are seen. These inclusions were seen along the entire length of the root pass. Fact that these particles were found only in the root of welded joint suggest that welding process during root pass was not properly performed, aka weld metal was not shielded good enough. Nonproper shielding led to absorption of oxygen from atmosphere and formation of oxide particles.

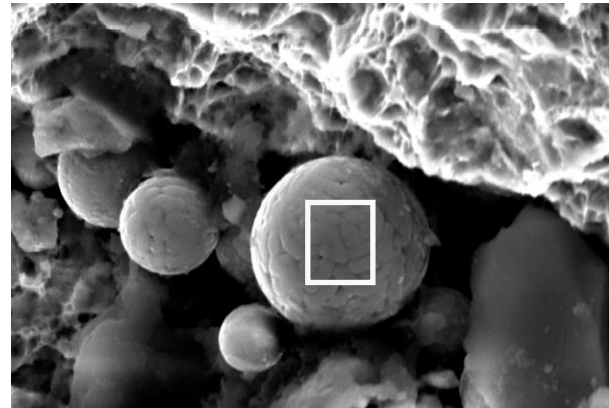
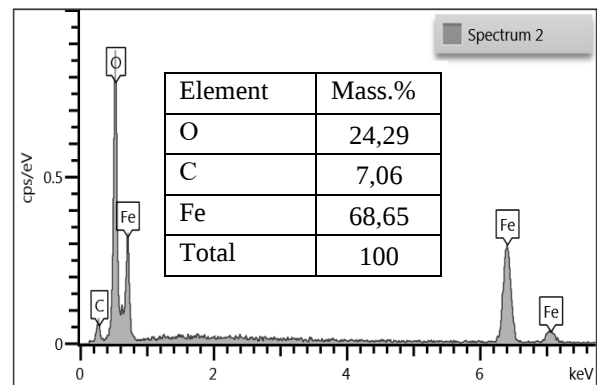
Semiquantitative EDS analysis, figure 7, of spherical particles showed that they contain iron, oxygen, and carbon. High concentration of iron and oxygen in these particles suggest that they are iron oxide particles.

**Figure 7.** EDS analysis of spherical particles.
