# RAILWAY TRACK DEFORMATION RESULTING FROM A CURVE NEAR ONE LEVEL CROSSING

**Abstract** – Numerous deformations and failures occur to the railway superstructure within a period of its projected life of use. The rails are the most exposed part of the superstructure for wear. In addition to transferring the vertical load from the vehicle to other elements of the superstructure and substructure, the rail, being in direct contact with the wheel of the vehicle, is subject to several other static and dynamic effects during traffic. In the case of a predicted impact, some procedures can be implemented to minimize rail wear and extend their service life. However, unfavorable circumstances arise, quickly reducing the service life of rails and might contribute to more serious accidents. The investigation focuses on the specific phenomenon of rail's head deformation and track lateral movement at the point of the curvature, when the curvature was placed next to one level crossing. A collection of field data has been studied for a variety of curves. The findings of this study revealed assumption that position of the curvatures in respect to the one-level crossing disrupts the geometry of the t

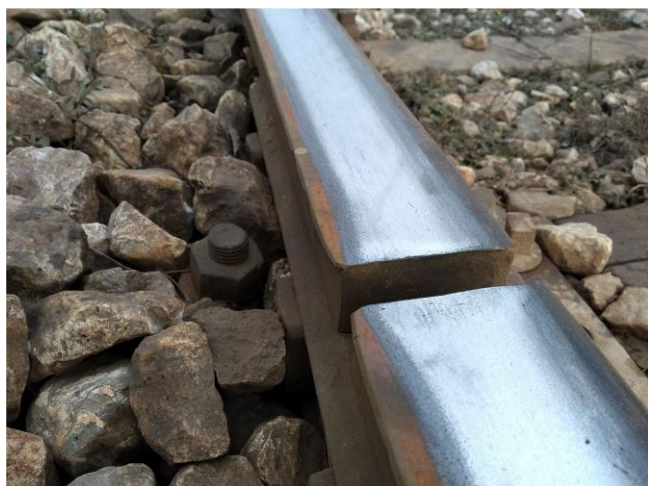
Along with the deteriorating infrastructure, there was significant track deformation prior to reconstruction, including lateral movements toward the curve's center and crushing head of the rail on the inner rail. Frequent one level road crossings cause freight trains to run slower and sometimes even stop moving, which imposes a significant pressure on the inner rail and causes a part of the steel to be pushed out of the inner rail. This is a plastic deformation of rail, which is in jargon called a "nail" (Figure 2).

Fig. 2. Deformation of the rail's head (condition before reconstruction of superstructure)

In the long term, this type of plastic deformation can significantly reduce the profile of head of the rail which is crucial information in terms of maintenance [3]. One of the causes of train derailment is the rail's profile reducing.

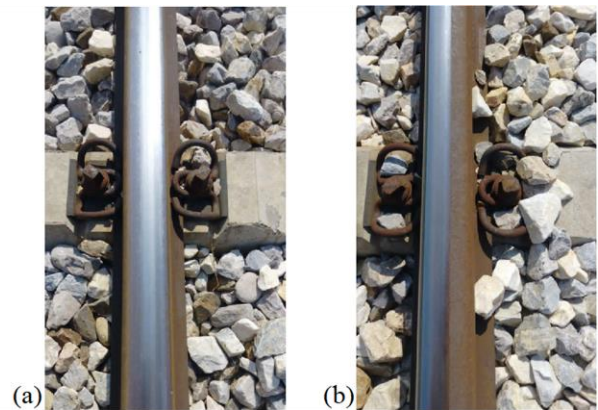
The typical wear and tear of the driving surface at the curvatures was readily apparent. With the rails on the inside of the curvature, it was clear that the vehicle's wheel goes across practically the whole upper surface of the rail's head. In the case of outer

rail, the vehicle's wheel also made a mark but only halfway to the railhead. A typical example of this phenomena is shown in the Figure 5.

Fig. 5. Appearance of the rail's rolling surface following 2,6 years of exploitation: (a)-left inner rail, (b)-right outer rail

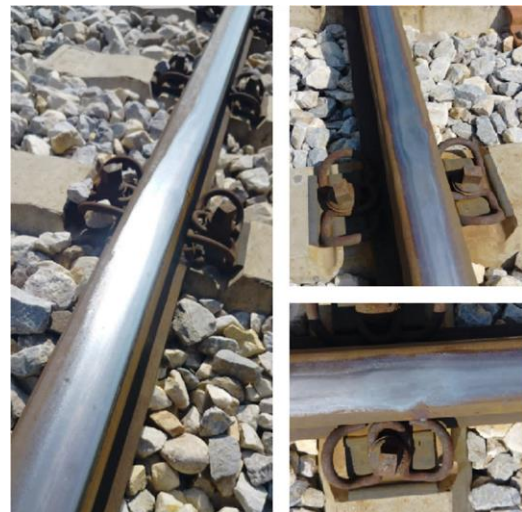
Another sort of deformation on the rails was identified as a wavy imprint on the rail. Given that the deformation occurs in the direction rather than the curvatures, it was determined that the trains have difficult traction. In this aspect, the locomotive's inadequate traction qualities for the specified slope of the track might cause the train to move at lower speeds than intended.

Fig. 5. Rail distortion caused by struggling train traction.
