## CONSTRUCTION OF THE CEHOTINA RIVER BYPASS AND RELIEF IN THE WESTERN AND SOUTHWESTERN PARTS OF THE POTRLICA OPEN PIT WITH THE FUNCTION OF LANDSLIDE REHABILITATION AND CREATION SAFE COAL EXPLOITATION CONDITIONS IN 2024

Nikola Stanić<sup>1a</sup>, Miljan Gomilanović<sup>1b</sup>, Saša Stepanović<sup>1c</sup>, Ivan Jelić<sup>1d</sup>,  
Daniel Kržanović<sup>1e</sup>, Dejan Bugarin<sup>1f</sup>

<sup>1</sup>Mining and Metallurgy Institute Bor, Alberta Ajnštajna 1, 19210 Bor, Serbia

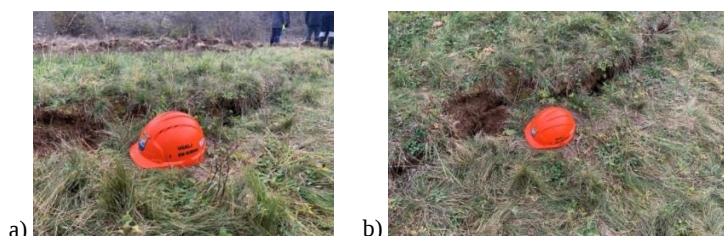
In 2023, the excavation of coal and overburden at PK Potrlica was carried out in the western and southwestern parts. In the western part of the work front, the designed state of the works was reached according to the valid project documentation, so the focus of operation was moved to the southwestern part of OP Potrlica. During the mining works in the western part of the surface mine between sections 15 and 17, instability is occurred. The instability manifested itself in the form of cracks and subsidence on the ground of the front of the mining works, about 40 meters from the Čehotina river flow. Figure 2 shows the occurrences of instability in the Čehotina riverbed zone. Signs of instability appeared in the form of cracks and ground subsidence.

**Figure 2.** Cracks (a) and material settlement (b)

On the basis of slope stability analyzes in the zone of instability as a measure to rehabilitate the endangered zone and the possibility of securing sufficient quantities of coal, the Investor carried out a simplified mining project for the creation of a bypass of the Čehotina river and relief in the western and southwestern part of the Potrlica open pit mine in the function of rehabilitating landslides and creating conditions for safe exploitation of coal in 2024. year.

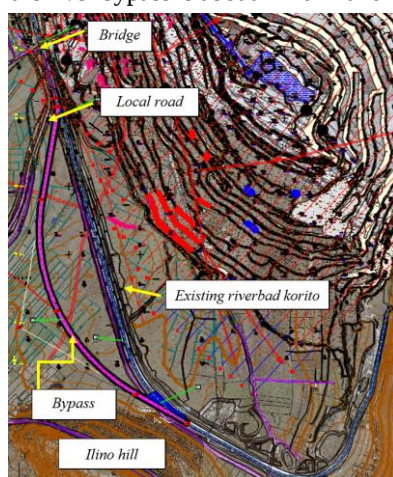
For these reasons, a solution is envisaged in which the Čehotina river is moved to the west of the working front. Limitations for defining the route were Ilino hill and the bridge near the hall for preventive maintenance. By analyzing several solutions, it was established that an option in which the local road is not moved is also possible, while at the same time meeting the conditions of stability and safety. Accordingly, a variant of the bypass was chosen, which starts from Ilino hill and ends at the place where the local road separates from the river bed. The length of the river bypass is about 1420 m and is shown in Figure 3.

Figure 3. Bypass of Čehotina river [2]

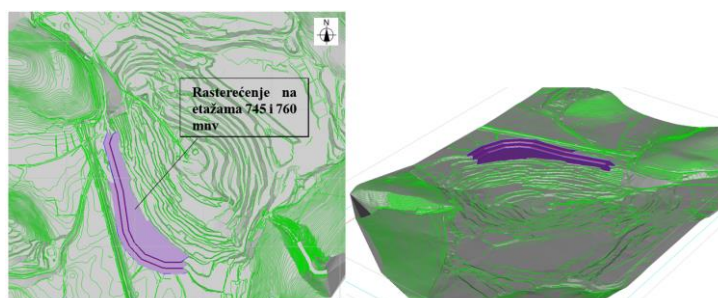
In addition to the construction of the bypass, relief of the slope between section 28 and section 5 at levels 745, 760 and 775 m where Quaternary and Neogene sediments will be excavated was also designed. The masses that will be excavated during the relief work amount to 2,779,789 m<sup>3</sup> or 5,309,372 tons. The position of the working front during relieving, the constructive parameters of the slopes and the volumes of the works were verified through the analysis of the stability of the newly formed slopes.

Figure 4. Relief on benches on levels 745, 760 and 770 m [2]
