## REHABILITATION AND REINFORCEMENT THE OUTER SLOPE OF THE DAM 6

*As a result of a wide front of filtered water through the outer slope of embankment at the tailing dump Valja Fundata, the dam became unstable in the Sector 6. The embankment no. 6 is almost along its entire length of about 1300 m, built with hydrocyclone sand to a designed level height of K+541 m with a design crown level width of 10 m, even more than that. In addition to the seepage of water, the sand suffusion from the embankment body appears in several places, where smaller or larger ravines are created due to the suffusion. This paper provides a solution to this problem.*

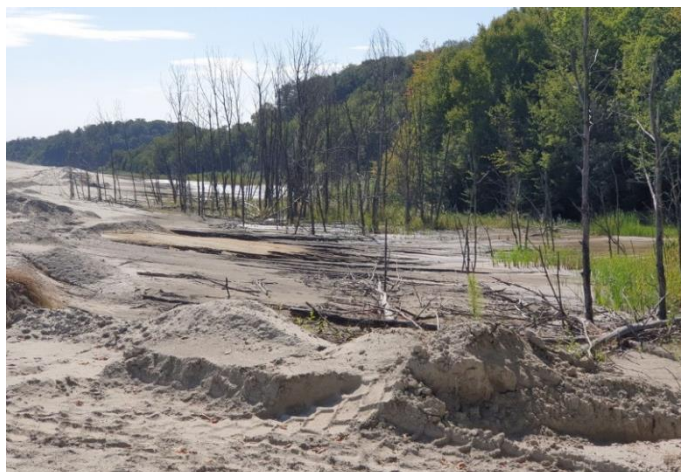
One of the infrastructural facilities on the Valja Fundata tailing dump, next to the Kaluđerica pumping station, is the Dam 6, which is in a very bad condition (Figure1). In order to enable the further elevation of the flotation tailing dump and its exploitation in safe and stable conditions up to the designed elevation of K+545 m above sea level, since the stability coefficients in the part of the tailing dump next to the pump station Kaluđerica are below the minimum due to the wide seepage front through the outer slope of the embankment, its rapid rehabilitation is necessary.

**Figure 1.** *Discharge of material from the dam body in the seepage front zone on the outer slope of embankment in the Sector no. 6, Valja Fundata flotation tailing dump*

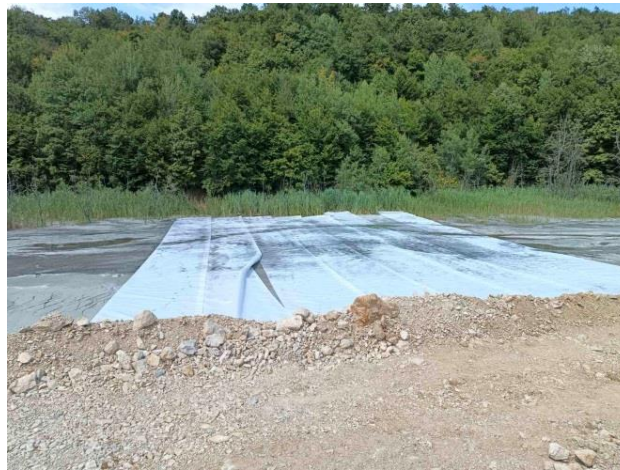
For rehabilitation the embankment in the Sector no. 6 for stabilization the watery part of the embankment outer slope and formation the stone ballast, a geogrid network was procured, in order to determine on the ground on the test section its usability for rehabilitation the watery areas. The geogrid network was installed by the workers on the tailing dump, according to the instructions of the network manufacturer, in a small part of the Sector 6, in order to stabilize the field surface, where due to the needs of rehabilitation of this sector, it is necessary to introduce the construction machinery (Figure 2).

**Figure 2.** *Laying of the geogrid membrane*

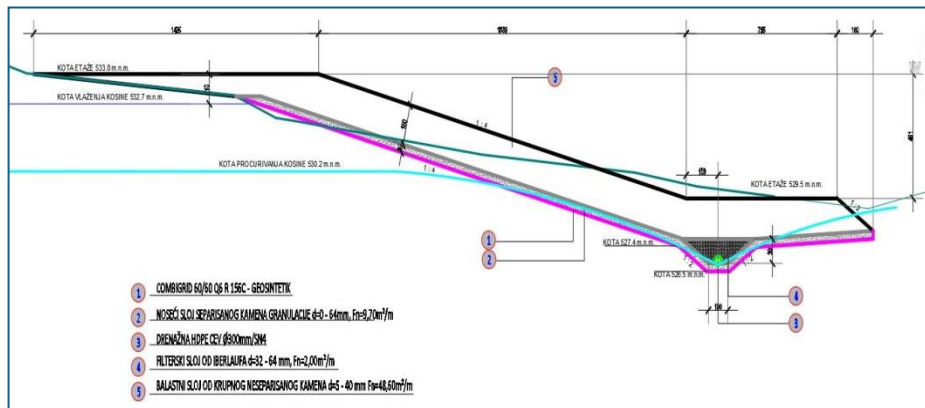
**Figure 4.** Cross-section of the rehabilitated embankment slope with individual layers of embedded material

The solution for embankment rehabilitation in the Sector no. 6 consists of:

- Placement of the first layer for stabilization the terrain surface consisting of a securgrid geosynthetic network, with openings measuring 60x60, covered with geotextile on both sides. This geosynthetic network should also be resistant to the acidic seepage that occurs on the tailing dump on embankments that are ten or more years old.

- The second layer is a bearing layer of separated stone with granulation of 0-64 mm, which is placed over the geosynthetic network in a layer of 30-50 cm thickness. The layer thickness will be determined exactly on a test section of 50 m length on the endangered part of embankment no. 6 and will also depend on the used construction machinery as well as trucks for transporting the crushed stone and stone for making ballast, which will be in use on the field.

- A thicker layer of several meters is placed over the bearing layer. This layer is marked with the number 5 in a drawing, and it represents a ballast layer of coarse stone with a diameter of 5cm - 40cm.

- Points 3 and 4 in a drawing show a drainage channel in which a geosynthetic network is placed on the bottom, over which a drainage HDPE pipe with a diameter of 300 mm/SN4 is placed on the bottom, which is covered with a filter layer of iberlauf, granulation 32-64 mm.

- Due to a large length of drainage channel, a drop of canal of 0.5% (minimum 0.3%) with two sections, upstream and downstream, is foreseen. The upstream section starts almost from the junction of the Dam 1 and embankment no. 6, with the point of pouring the collected drainage water near the road via a concrete channel. The downstream section of drainage canal starts from the road over the

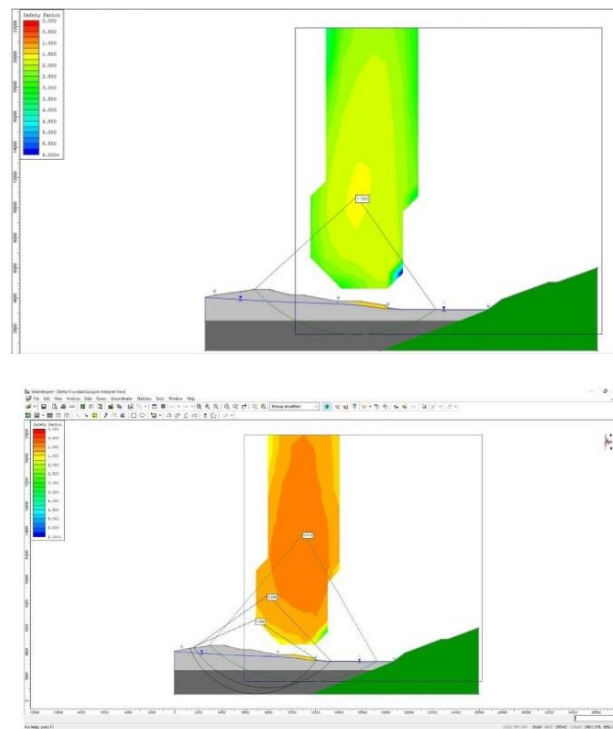
The stability check after the designed rehabilitation works was performed for the same profile 6-6' for identical water level in the piezometers on this profile, as well as the same geotechnical parameters. Figure 5 shows the obtained static and dynamic stability coefficients. Both obtained stability coefficients are above the legally prescribed values. Based on this, it can be concluded that this rehabilitation solution brings the downstream slope of the dam to a stable state and gives the possibility to think about overhanging the Valja Fundata 8 tailing dump.

**Figure 5.** Static and dynamic coefficients of stability after rehabilitation in the Sector 6
