## ANALYSIS OF THE SAFETY FACTORS OF THE FLOORS OF THE INTERNAL LANDFILL FIELD B/C IN THE FUNCTION OF OPENING FIELD E IN MB KOLUBARA

Expert Paper  
DOI: 10.5937/RGD240014P

Petrović Branko

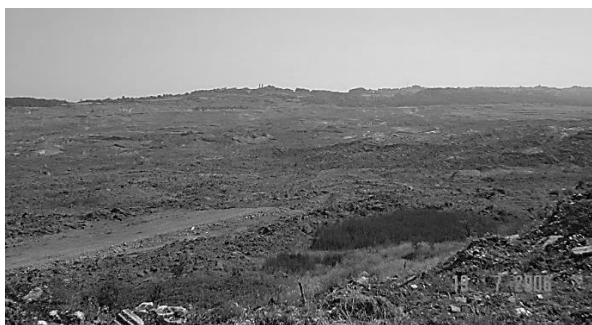
At the end of 2005, a major motion of the disposed masses was registered at the internal landfill FIELD B (space intended for the external landfill FIELD C and later FIELD E), which in early 2006 caused the landfill to collapse and lead to the closure of the space between the landfill and the working coal floors. Therefore, the floors were backfilled with that slippery material, which stopped the technological process of coal production (Figure 2). The deposited material mainly consisted of gray-blue clays with variable content of sandy components, fragments of coal and diatomites, gray-yellow clay with quartz pebbles, clay sands, carbon clay, pieces of diatomite and coal.

*Figure 2, Internal landfill FIELDS B (slip masses), 2006. [1]*

Remediation of the landfill began at the end of 2006 with the construction of a network of wells and the installation of plastic pipes in them for the purpose of draining water from landfills. Along with this started the formation of ballast (12 m in height) on the surface of the landfill, which, due to its load, would contribute to elimination of water from the landfill through these wells. However, due to the demolition of this ballast, and then the newly formed floor of the landfill, works on the remediation of the landfill have been permanently stopped and the existing situation has remained unchanged to this day. This problem of unsanitary landfill has been neglected for years, despite the fact that such a situation has disturbed the scheduled development of active mines, which subsequently negatively affected particularly the opening of new mines within the MB

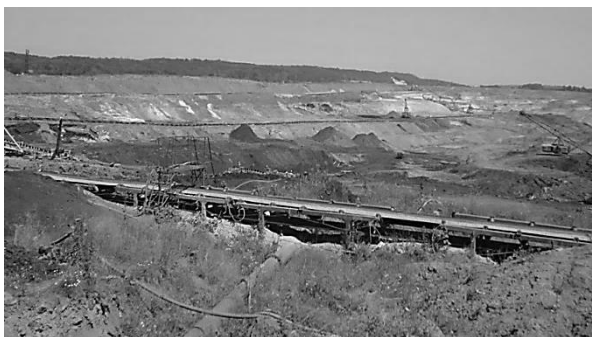
As previously noted, during 2006, a large amount of disposed material (about 80 million m<sup>3</sup>) had slid at the field B/C internal landfill. This material also backfilled the coal floors so that the entire process of mining in this area was stopped. Figure 3 shows the state of the floors at that time.

*Figure 3, The appearance of the internal landfill after backfilling of coal floors, 2006. [1]*

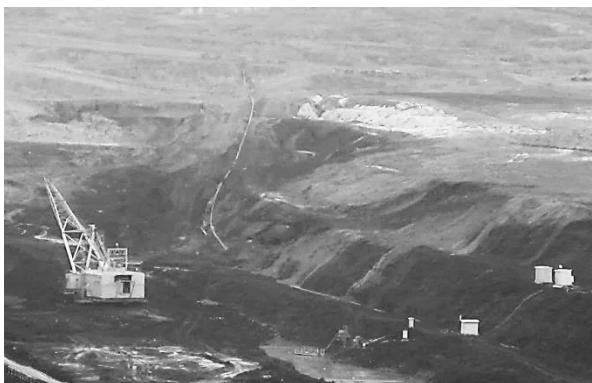
In order for coal mining to continue, it was necessary to define how to rehabilitate the entire area that was jeopardized by slippery material. In 2007, the rehabilitation started, but the proposed method of remediation did not give effect, more precisely, the wrong approach to solving the problem caused new slides of the material so that all activities on the rehabilitation had to be stopped (Figure 4).

*Figure 4, Repeated sliding of disposed material and breakage of coal floors, 2007. [1]*

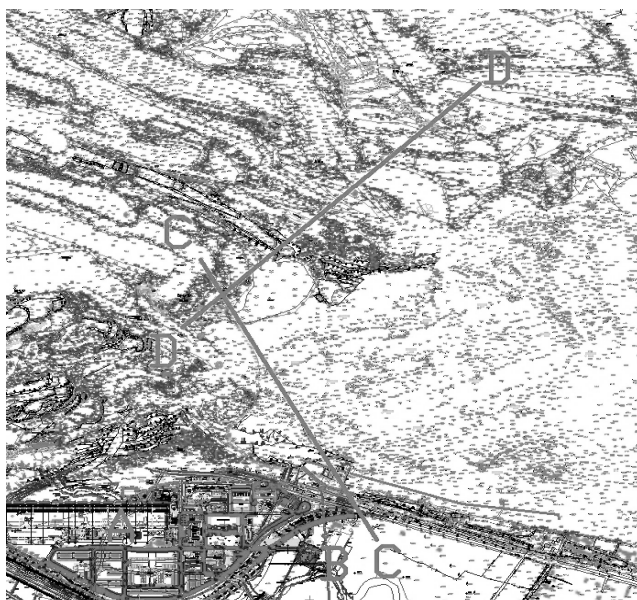
Before starting with the formation of supports, it is necessary to bring the floors of the landfill to a stable state in order to avoid their collapse. This paper presents an analysis of the slope stability of the internal landfill FIELD B /C, both without support and with it. The current state of the landfill with the position of profiles C - C and D - D for which the analysis was done, is given in Figure 5.

*Figure 5, Internal landfill FIELDS B/C with profiles C - C and D - D [1,3]*

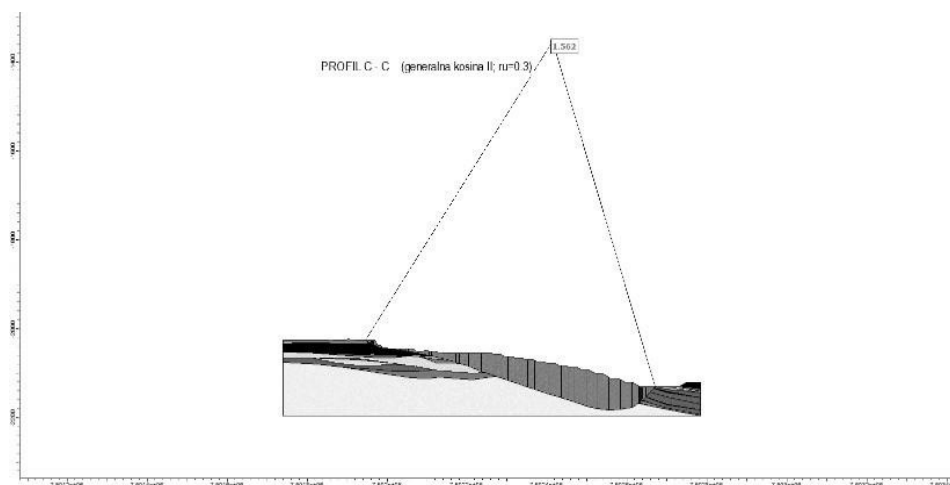
Height of general slope  $H = 76$  m; general slope inclination  $\alpha = 12^\circ$ ; (Figure 8).

Figure 8, Security factor ( $F_s = 1.56$ ) of the general slope of Profile C – C

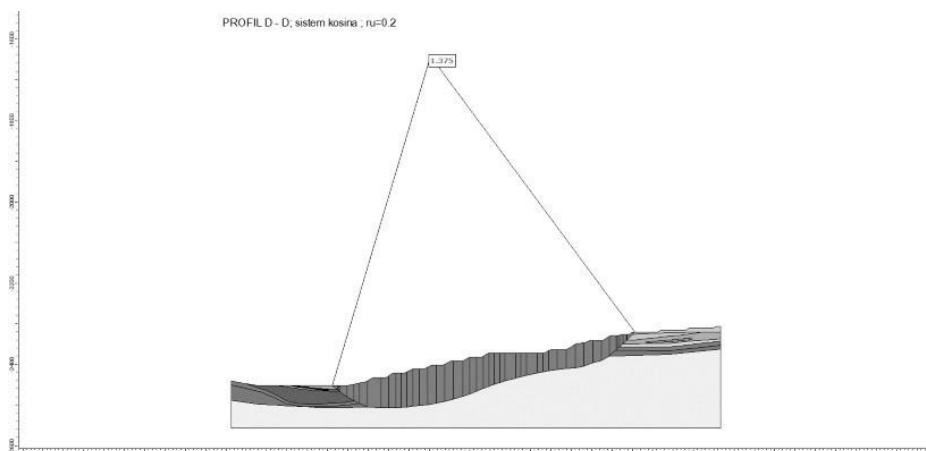
Height of the general slope  $H = 146$  m; general slope inclination  $\alpha = 9^\circ$ ; (Figure 9).

Figure 9, Safety factor ( $F_s = 1.38$ ) of the slope system of the Profile D – D

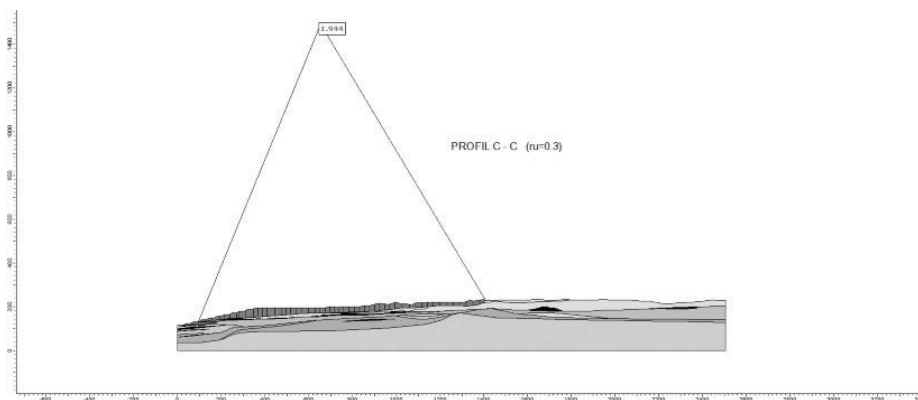
The safety factor for that slope is  $F_s = 1.94$ , with the pore pressure coefficient  $r_u = 0.3$  (Figure 10).

*Figure 10, Safety factor ( $F_s=1.94$ ) of the general slope with protective embankment (support)*

A protective embankment (support) from the deposited material can be formed so that its partial slopes have a height of  $H = 8$  m and a slope of  $\alpha = 28^\circ$ .

It is necessary to compact this material in order to improve its physical and mechanical properties, which would lead to an increase in the stability of the embankment (support).

The total height of the embankment (support) in the first phase should be  $H_g = 80$  m, with a general slope angle  $\alpha_g = 14^\circ$ .
