FACTORS INFLUENCING THE OCCURRENCE OF FLYROCK PHENOMENA ON SURFACE MINES – CASE STUDY

In this study, through the analysis of the "O2" quarry, the previously mentioned factors influencing flyrock phenomena beyond the designated safety zone were analysed to determine which had the greatest impact. The goal was to identify the primary contributors to flyrock phenomena to prevent future incidents and reduce overall risk.

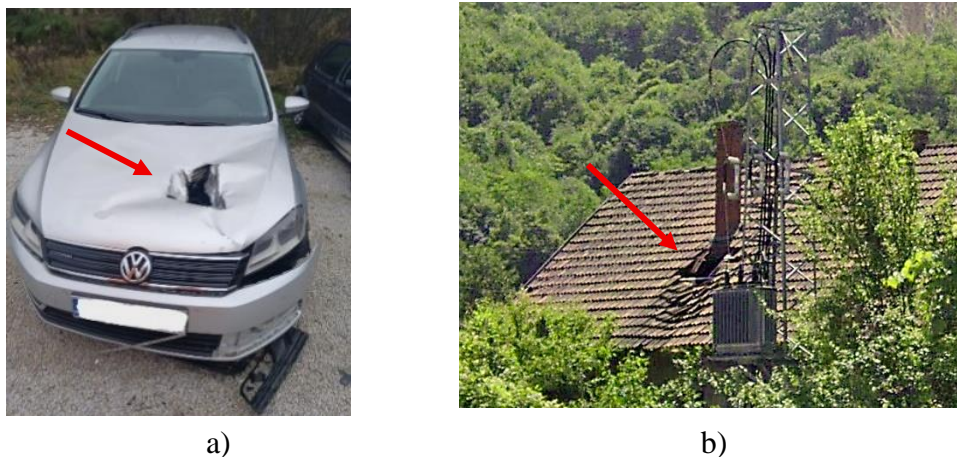
As a result of blasting in the southern part of the "O2" quarry, rock material was projected beyond the defined safety zone at over 500 meters. This caused damage to a residential building and a parked vehicle (Figure 2).

Figure 2. Damage caused by flyrock: a) damaged vehicle in an employee parking lot (525 m), b) damaged roof of residential building 10

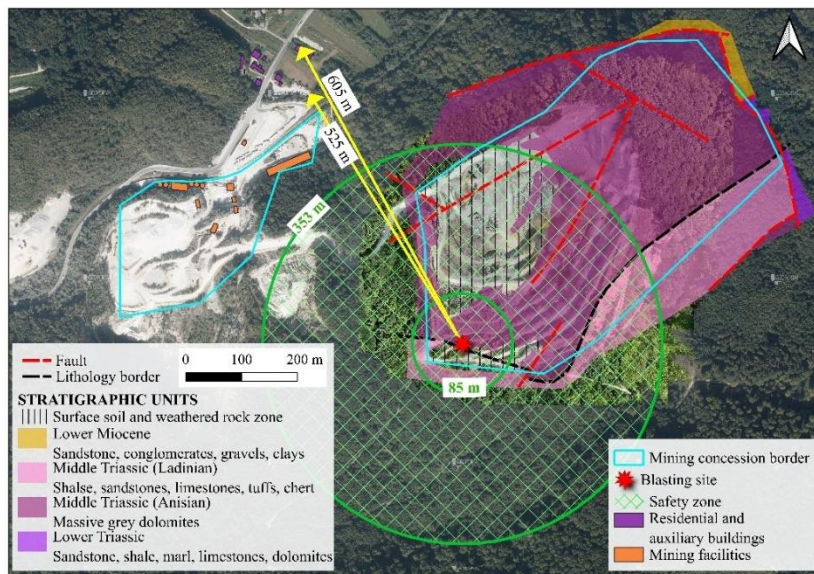
The occurrence of flyrock (shown by yellow arrows in Figure 3) was largely influenced by the drilling parameters of the blast holes. Due to the drilling operator's limited experience, the holes were connected at the bottom of the bench. The first row of holes was drilled at a 70° angle, and the second row at a 60° angle. Additional influence came from the geological setting, as the blast site is located at the boundary between massive grey dolomites and the weathered zone (Figure 3), resulting in lithological heterogeneity within the blasting area and variable explosive performance. Furthermore, the terrain configuration favoured the extended range of the flyrock. The blast site is positioned at +440 m above sea level, whereas the damaged structures are located at +250 m above sea level. The analysis indicates that all contributing factors, to varying degrees, played a role in the occurrence of flyrock.

Figure 3. Safety zones, in conjunction with the geological map [9] and the presence of flyrock
