## ANALYSIS OF CRACK FORMATION IN AlSi11 ALLOY AUTOMOTIVE RIM

### Abstract

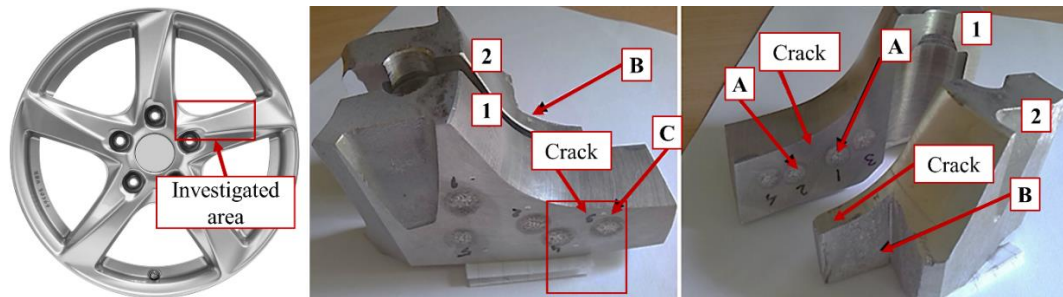
The crack was detected during a radial fatigue test simulating the dynamic load on the wheel when cornering. The crack formed in the hotspot area nucleating on the internal surface of the central

cap and propagated towards the inner part of the spoke (Figure 1). As two parts of the rim with different geometries were affected, the investigated area was cut into two parts (Figure 1; positions 1 and 2), with three different positions for testing (Figure 1; positions A, B, C).

Figure 1. Sampling in the investigated area with the indicated positions for testing (A, B, C)

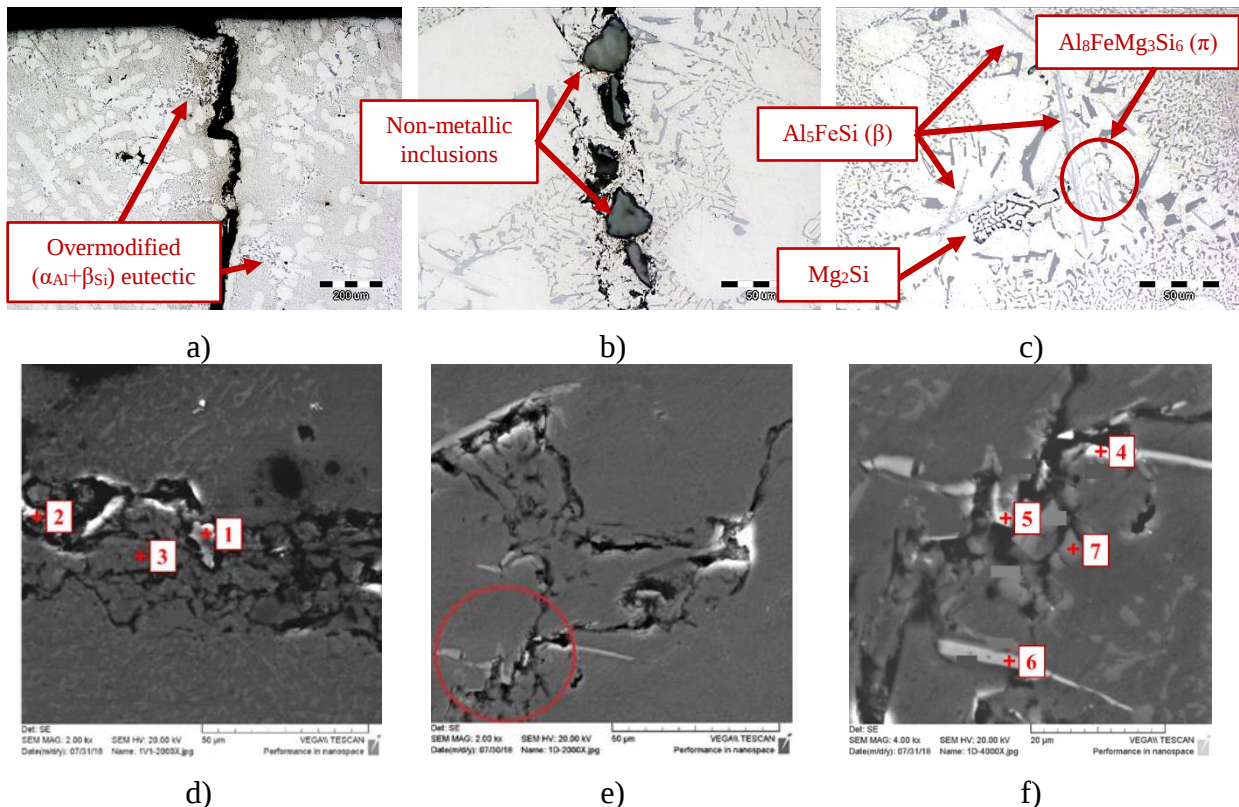
The microstructure at the crack root is given in Figures 2 a – 2 c, while the scanning electron images (SEI) of microstructural constituents affecting the crack propagation are shown in Figures 2 d – 2 e. The results of EDS analysis performed on the indicated positions (Figure 2 d to e) are shown in Table 2.

Figure 2. The microstructure at the crack root (a, b, c) and SEI of microstructural constituents affecting the crack propagation (d, e, f)

The microstructure of the sample in the investigated area consists of the primary  $\alpha_{Al}$  dendrites and the eutectic ( $\alpha_{Al} + \beta_{Si}$ ) (Figure 2). In addition to the fibrous morphology, an over-modified eutectic ( $\alpha_{Al} + \beta_{Si}$ ) in acicular morphology can be observed at the grain boundaries (Figure 2 a), followed

by solidification of  $\text{Al}_8\text{FeMg}_3\text{Si}_6$  ( $\pi$ ) and  $\text{Mg}_2\text{Si}$  phases. The  $\text{Al}_5\text{FeSi}$  ( $\beta$ ) phase is found between the branches of primary  $\alpha_{\text{Al}}$  dendrites (Figure 2 c). The local stress concentration during the radial fatigue test allowed crack propagation via non-metallic inclusions (Figure 2 b) and intermetallic phases at the grain boundaries (Figure 2 c). The results of SEM and EDS analysis confirmed the involvement of non-metallic inclusions of the alumino-silicate type (Figure 2 d, Table 3, positions 1 and 2), over-modified eutectic ( $\alpha_{\text{Al}} + \beta_{\text{Si}}$ ) (Figure 2 f, Table 3, positions 6),  $\text{Al}_5\text{FeSi}$  ( $\beta$ ) and  $\text{Al}_8\text{FeMg}_3\text{Si}_6$  ( $\pi$ ) phase (Figure 2 f, Table 3, positions 4, 5 and 7).
