STABILITY OF THE DAM "PREVOJ ŠAŠKA" OF THE FLOTATION TAILING DUMP 'VALJA FUNDATA" IN MAJDANPEK^{**}

The existing dam "Prevoj Šaška" is located on the active flotation tailing dump "Valja Fundata" in Majdanpek. Since there is no valid documentation for the current maximum height of dam K+538 m, and disposal of tailings into this landfill is continued, the stability of dam has been carried out. Stability is calculated with the software SLIDE v6.0.

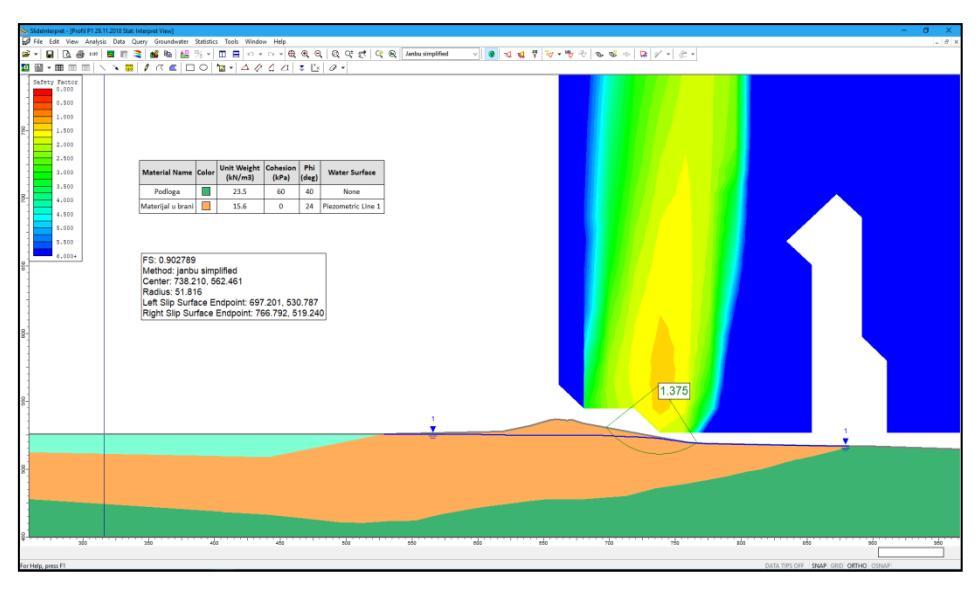
Figure 2 Static safety coefficients by the Janub method for the existing state

Profile P – P'	F _s static	F _s dynamic
Existing state	1.375	0.903
Water level +0.5 m	1.319	0.874
Water level +1.0 m	1.277	0.852
Water level +1.5 m	1.225	0.826
Water level +2.0 m	1.181	0.804

By comparison the obtained safety coefficients of the flotation tailing dump dam with the allowed minimum coefficient, prescribed technical conditions for design of earth dams and hydro technical embankments - SRPS U.C5.020, which for the earth dams above 15 m is minimum $F_s = 1.50$ in case of the constant static load, or $F_s = 1.00$ in case of the occasional dynamic load for the earthquake occurrence, it can be concluded that the obtained safety coefficients for static and dynamic loads are below the prescribed values.

The maximum level of water mirror in the tailing dump should not be above the K+23.3 m. This entails the removal of water mirror from the dam crest and displacement of the pump station from the existing location.

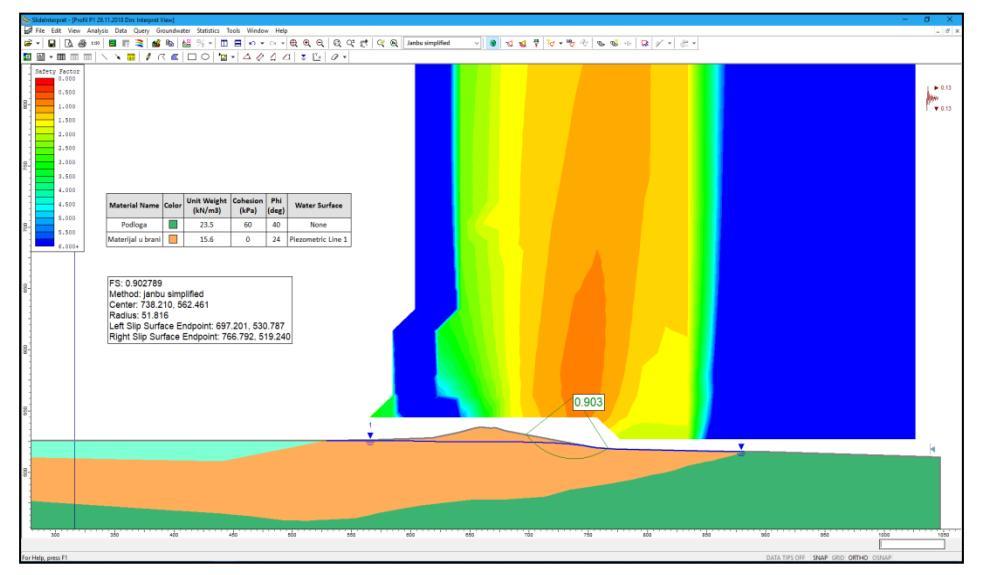
Figure 3 Dynamic safety coefficients by the Janub method for the existing state

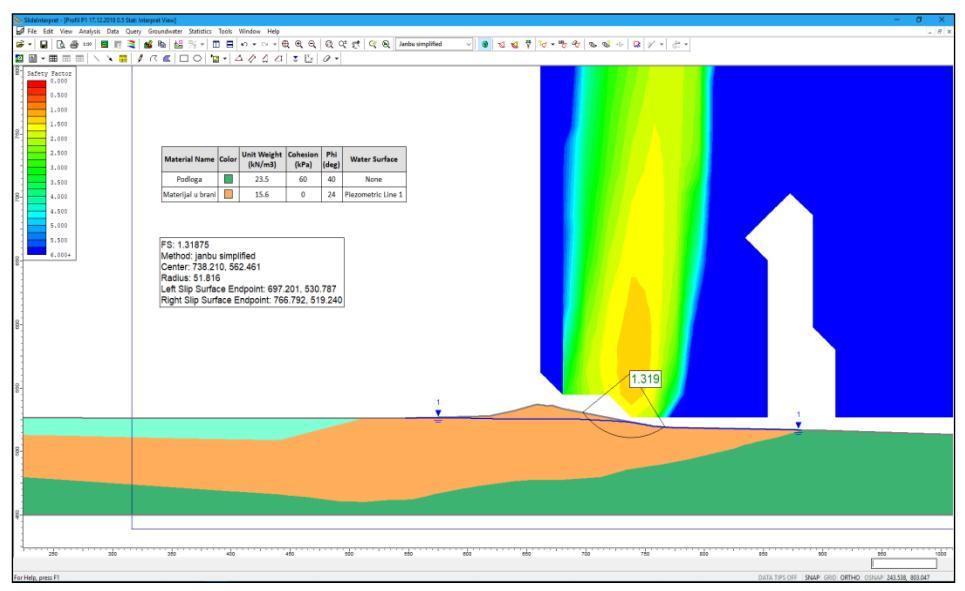
Figure 4 Static safety coefficients by the Janub method with the increased water level 0.5 m

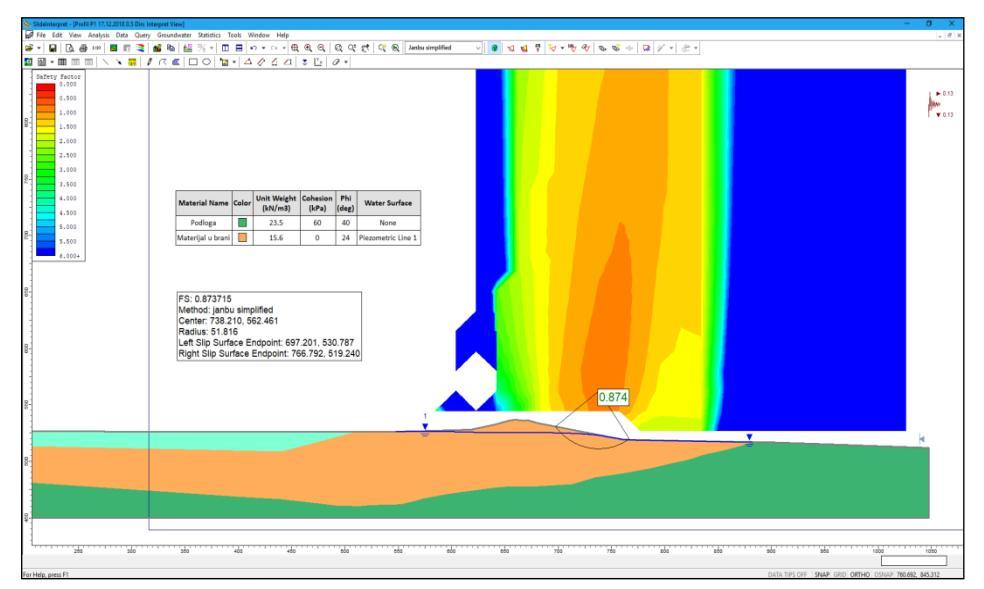
Figure 5 Dynamic safety coefficients by the Janub method with the increased water level 0.5 m

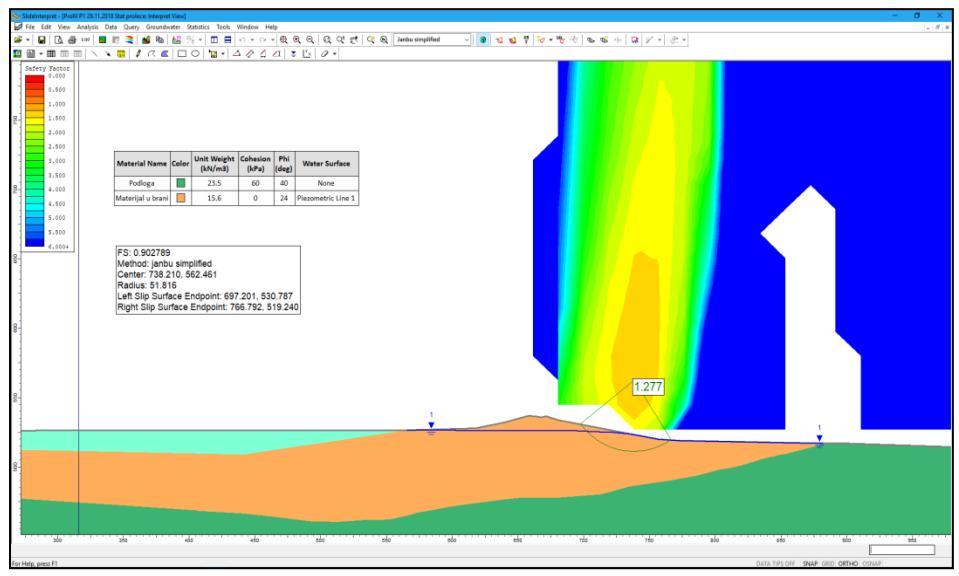
Figure 6 Static safety coefficients by the Janub method with the increased water level 1.0 m

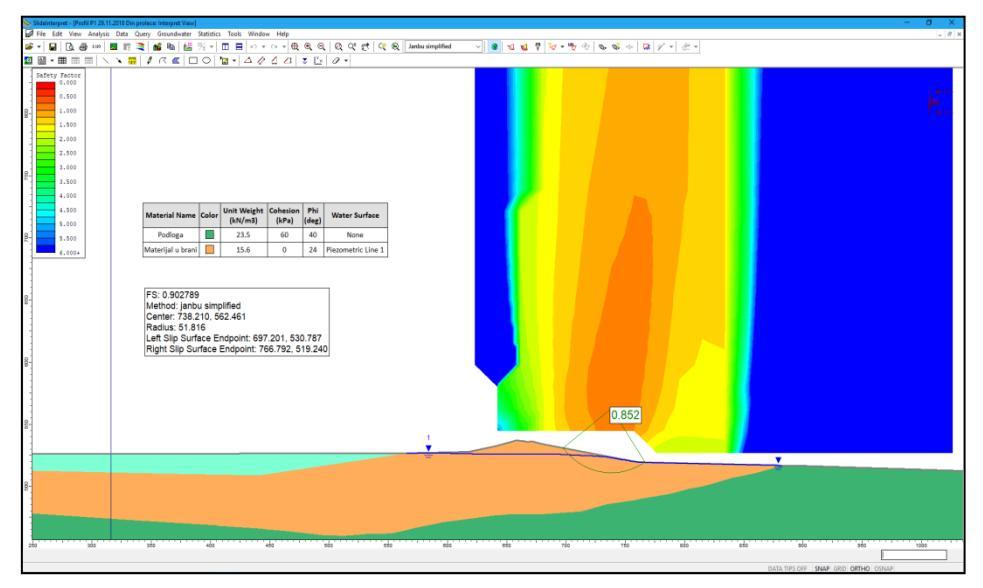
Figure 7 Dynamic safety coefficients by the Janub method with the increased water level 1.0 m

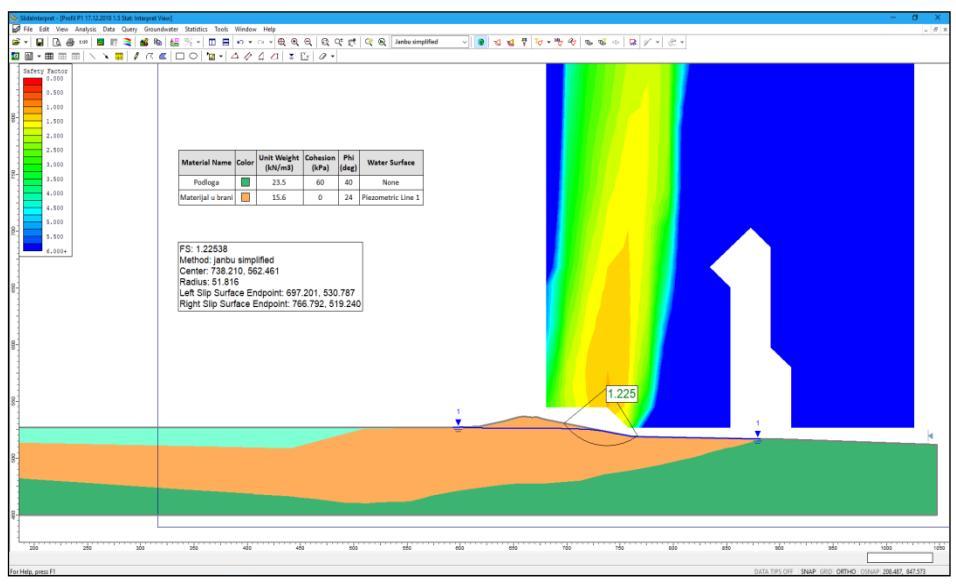
Figure 8 Static safety coefficients by the Janub method with the increased water level 1.5 m

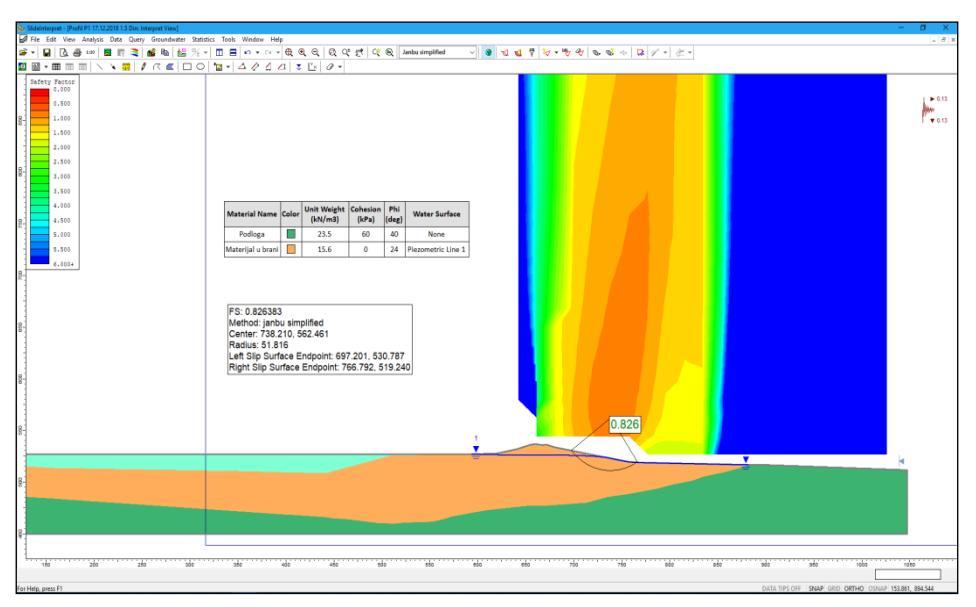
Figure 9 Dynamic safety coefficients by the Janub method with the increased water level 1.5 m

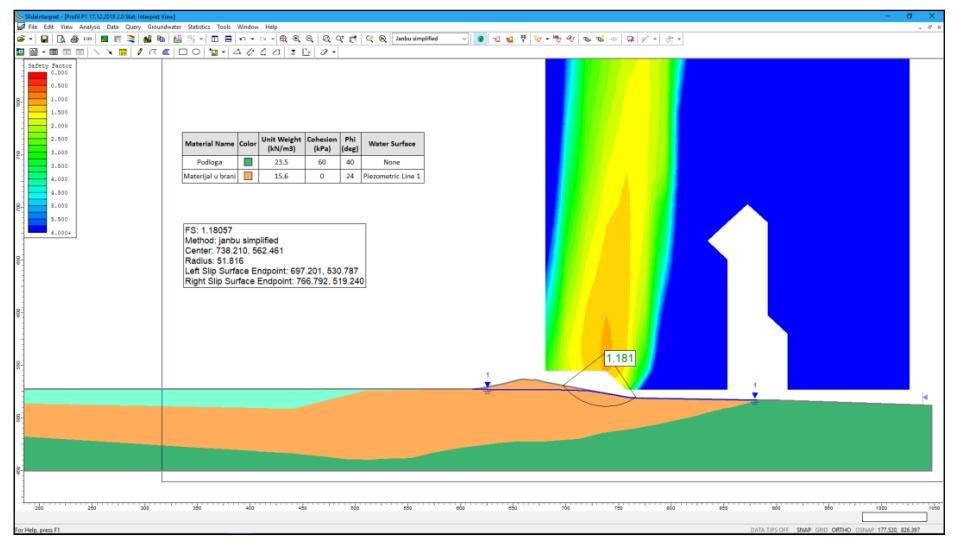
Figure 10 Static safety coefficients by the Janub method with the increased water level 2.0 m

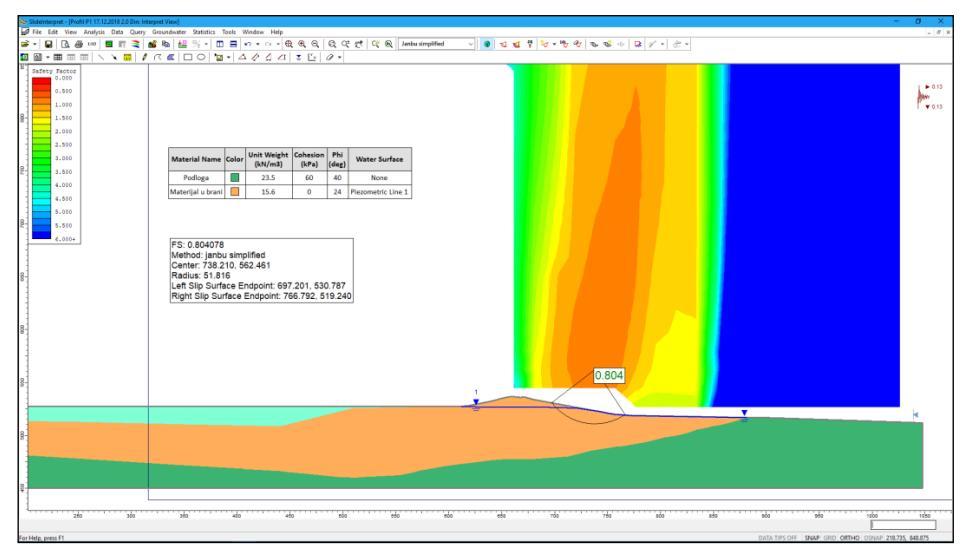
Figure 11 Dynamic safety coefficients by the Janub method with the increased water level 2.0 m

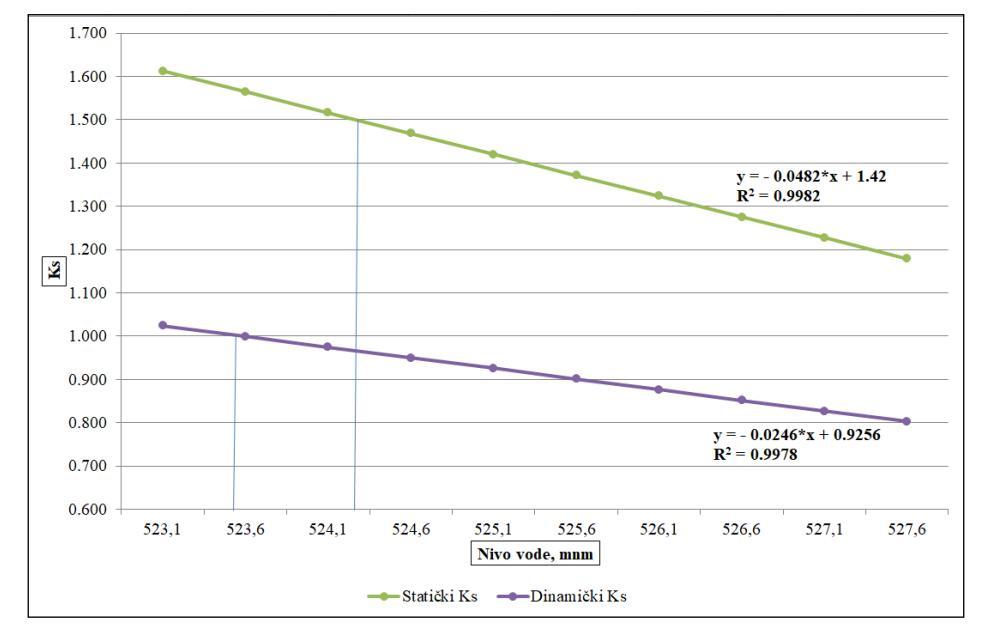
Figure 12 shows the linear dependence of change the safety coefficient for the static and dynamic loads from the water level.

Figure 12 Dependence diagram of changing the value of safety coefficients from the water level
