Landscape Alteration Effects of Quarrying Operation and its Reclamation Prospect Using Drone

Professional paper

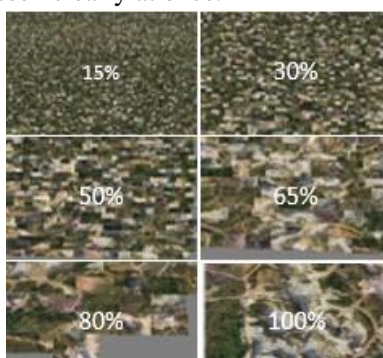
Figure 2 - Matching and stitching stages of the quarry drone-captured images (from 15% very rough to 100% very smooth real-time imagery)

The results of the drone mapping revealed a significant detail of the real-time spatial features of the Golden Girl quarry as captured by the DJI Phantom 4 drone and processed by the DroneDeploy photogrammetry software (Figure 2). From the final orthomosaic (Figure 3), the access roads, the mining pits, the disjointed natural vegetation, and waste dump, all could be seen clearly at once.

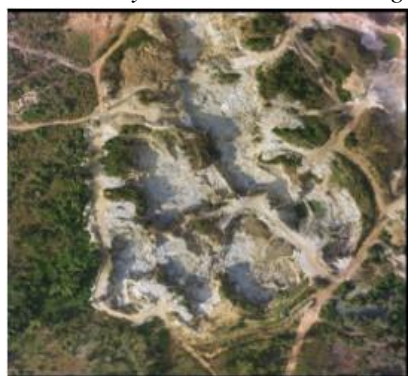
Figure 3 - Real-time Imagery (Orthomosaic) of Golden Girl Quarry

The revealed features show how the disturbances to the natural landscape as a result of the quarrying operations.

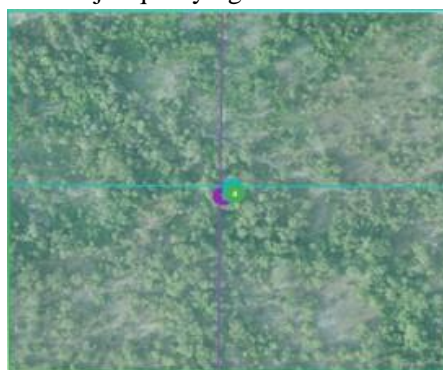
Figure 4 - Real-Time Aerial Imagery (Orthomosaic) of Golden Girl Quarry Adjoining Vegetation

The examination of the real time image of the bordering environment of the quarry showed the forest vegetation to be the dominant land cover in the study area. By implication, the natural landscape in the study area is covered with vegetation with no bare ground surface. The variations in the green-texture landcover in the adjoining area (Figure 4) from that of variegated shades of light brown- coloured quarry area (Figure 3) stems from the differences in the vegetation cover due to absence of anthropogenic activities in one and the presence of major quarrying activities in the other.

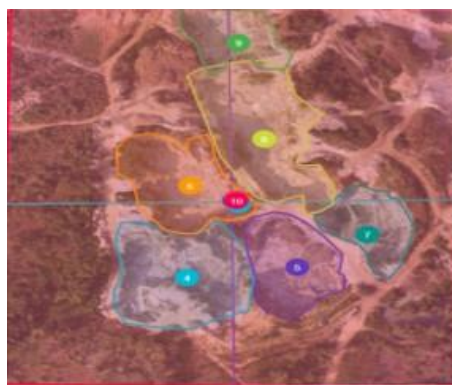
Figure 7 - Total Land Area of the Quarry with the different Mining Pits

This, technically implies that the earth material left for fill is at the present not sufficient to cover up the volume of fill required. Figures 7, 8 and Table 1, show the images of the different quarry pits and their respective calculated cut and fill.
