INVESTIGATION OF SEAM PUCKERING IN WOMAN'S BLOUSE

Professional paper
UDC: 687.241:65.015.13
doi: 10.5937/tekstind1903045M

Abstract: *In this study, mechanical properties of the fabrics were investigated in order to find the cause for seam puckering problem in armhole and neckline area of woman's blouse. The same model of woman's blouse was produced from two types of fabrics with different raw material content: 100% silk and 100 % polyester. The obtained results show that both fabrics have a low shear rigidity, indicating that fabrics extension in bias direction is high. The fabrics extension in bias direction has influence on seam puckering in armhole and neckline area of the blouse because there is sewing in bias direction except sewing in warp and weft directions.*

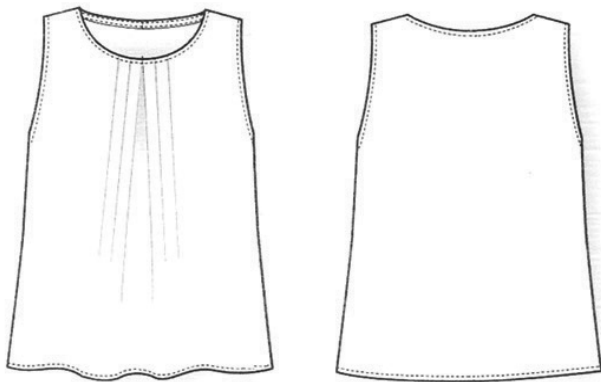
Figure 1: Technical sketch of the model

The same model of woman's blouse from two different fabrics was manufactured. In the both cases there were the seam puckering in neckline and armhole area. The model of woman's blouse is presented in Figure 1. The blouse is sleeveless with six pleats on the front neckline.

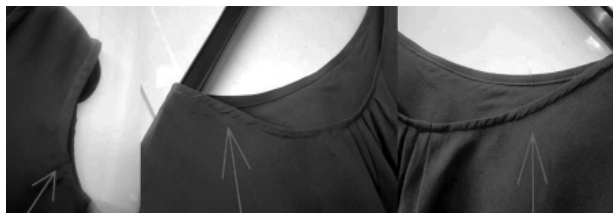
Figure 2: Seam puckering in armhole (left) and neckline (central and right), fabric F1

In Figure 2 and Figure 3 the seam puckering in the woman's blouse is presented for fabrics F1 and F2 respectively.

In the analyzed models of woman's blouse, seam puckering in side seams (seam in warp direction) and shoulder seams (seam in weft direction) didn't occur. There wasn't seam puckering in weft direction because both fabrics have formability in control zone, 0.51 mm² and 1.11 mm² for fabric F1 and F2 respectively. In warp direction, fabric F1 has formability in the control zone 1.003 mm² and there wasn't seam puckering. Although, fabric F2 has formability in non-control zone in warp direction 0 mm², there is no seam puckering because of the high bending rigidity in this direction (16,47 μNm). From Figure 2 and 3 it can be seen that puckering occurs in those seams which have deviation from the warp and weft direction of sewing, i.e. seam sewn in bias direction. The low shear rigidity values, 10.3N/m for fabric F1 and 13,4 N/m for fabric F2, indicate that fabric extension in bias direction is high. For fabric F1 extension in bias direction under 5 g/cm load is 11.9% and for fabric F2 is 9.2%. Although the FAST system doesn't set control limits for fabric extension in bias direction, low shear rigidity shows that the fabric extension is high. Based on the literature, the important property that affect the seam puckering is extensibility. Fabric with high extensibility is proneness to seam puckering.

During the manufacturing of woman's blouse, seam puckering was occurred in neckline and arm-hole area. In order to find the reason for this problem, the mechanical properties of fabrics on FAST system were investigated. The obtained results have shown that the value for shear rigidity in both fabrics is low-

er than 30 N/m. The low value of shear rigidity means that the fabric extension in bias direction (11.9% for fabric F1 and 9.2% for fabric F2) is high and that cause seam puckering.

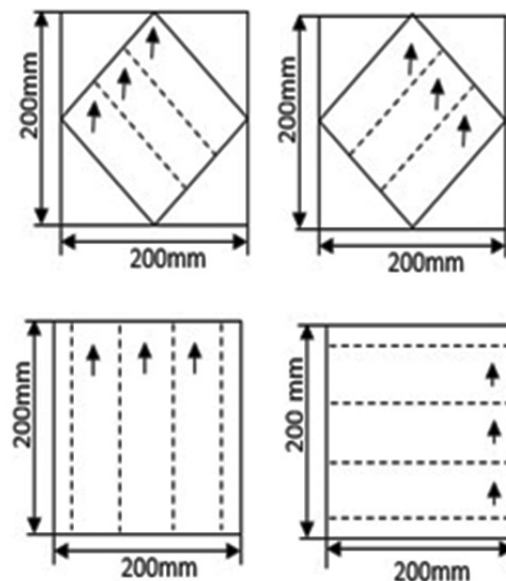
Figure 5: Fabric sample cutting scheme

In order to obtain consistent results, fabrics were conditioned overnight in standard atmosphere 20 ± 2°C temperature and 65 ± 2% relative humidity before cutting. The fabrics sample cutting scheme in Figure 5 is presented.

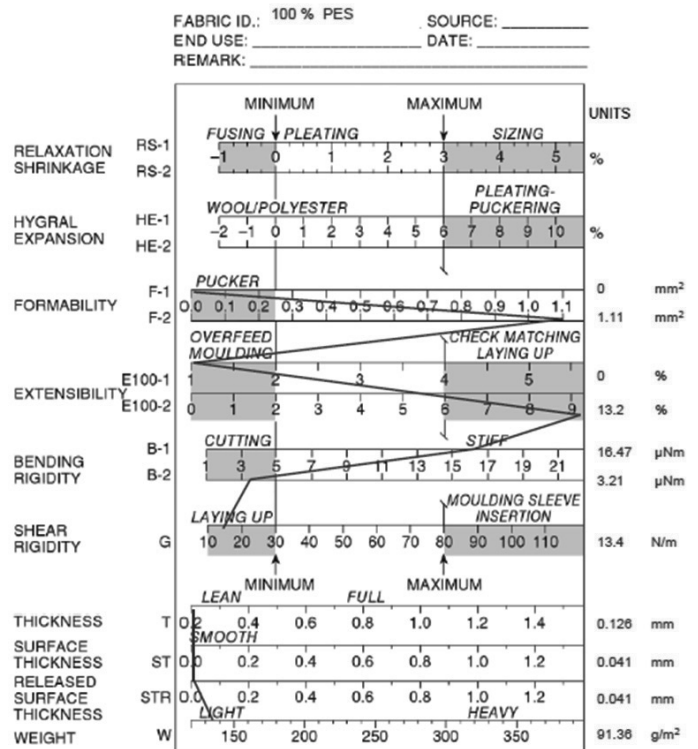
Figure 7: Control chart for fabric F2

Table 2 shows the obtained results for mechanical properties of the used fabrics. The formability values for both fabrics in weft direction are higher than 0.25 mm². In warp direction, the fabric F1 has good formability, higher than 0.25 mm², while the formability of the fabric F2 is 0 mm². Formability values under 0.25 mm² create the possibility of fabrics producing seam puckering after sewing. The fabric F1 in both, warp and weft directions, and the fabric F2 in weft direction have extensibility values higher than upper control limit, which indicate that fabrics can easily stretched during cutting and sewing. In warp direction fabric F2, has extensibility values 0%, and this can lead to problems with overfeed seams. The fabric F1 in weft direction and fabric F2 in both warp and weft directions have bending rigidity below 5 μNm. Low values of bending rigidity mean that those fabrics potentially cause difficulty during cutting and sewing. For shear rigidity, both fabrics have values less than 30 N/m. Low shear rigidity makes the fabric difficult to lay for cutting and these fabrics may require pinning down to avoid displacement of the cutting layer. According to the surface density both fabrics are lightweight fabrics. The control charts for fabric mechanical prop-

erties, in Figure 6 and Figure 7 are shown for fabric F1 and F2, respectively.

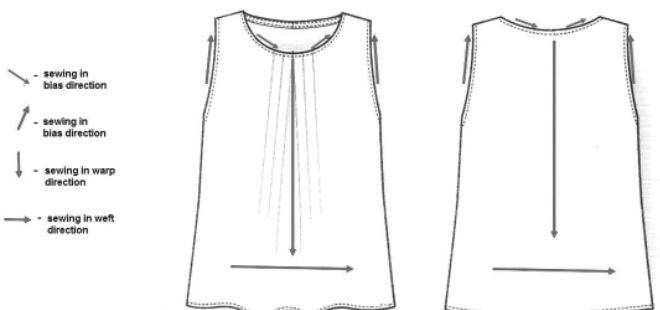
Figure 8: Sewing directions

During the sewing process, fabric is stretched along the stitch line as a result of transporting between feed dog and presser foot. If the fabric has high extensibility then stretching during sewing will be high, which can be reason for seam puckering along the seam line after sewing. In the apparel industry, fabrics are usually sewn in the warp and weft direction. In the woman's blouse, except seams sewn parallel to the warp and weft yarns, there are seams with deviates from warp and weft direction (Figure 8). In the area of neckline, sewing start in warp direction, goes to bias direction, then in weft direction, again in bias and ends in warp direction. Similarly, the armhole seam, sewing start in weft direction, goes to a bias, continue in warp direction, again in bias direction and ends to a weft.
