ERRORS THAT OCCUR DURING THE PRODUCTION OF FABRICS FOR REST AND RECREATION - AN EXAMPLE FROM INDUSTRIAL PRACTICE

Professional paper

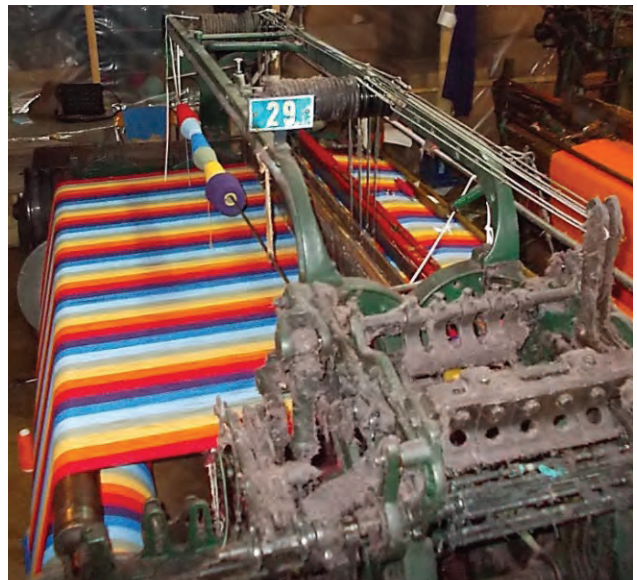
Figure 1: Appearance of a shuttle loom

On the Textima shuttle loom, weaving is done by inserting the weft alternately from the left and right side using the shuttle. Hollow fabrics can also be worked on this loom, and its advantage is that it gives a finishing selvedge to the fabric that does not allow fraying. This loom can work with seven different colours per weft with 24 harnesses. Currently, the factory is making fabrics on looms with 4 harnesses.

Figures 1 - 3 show the appearance of the shuttle loom in different stages of work (end of the warp and preparation for tying a new warp and the weaving process).

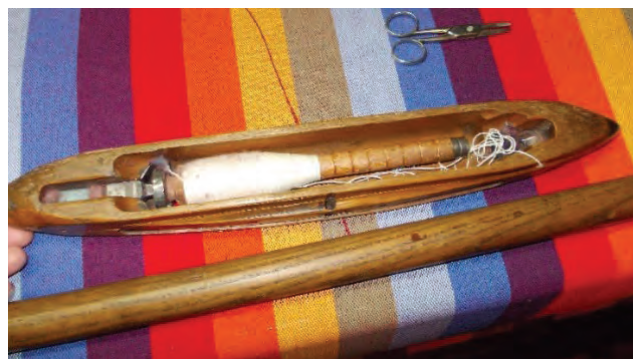
Figure 2: Picking block - shuttle with weft winding

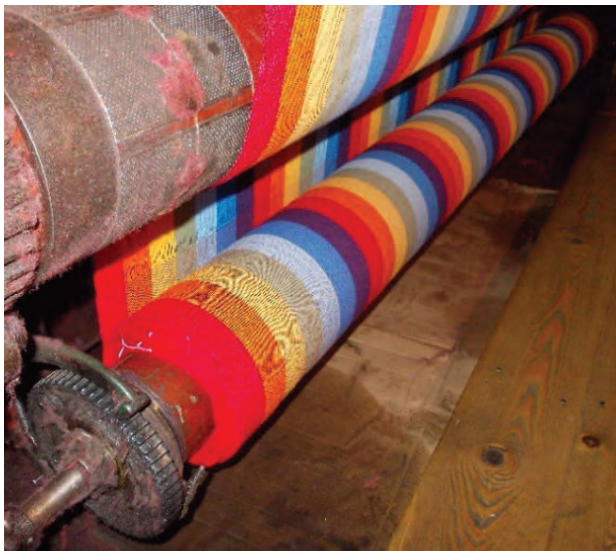
Figure 3: Finished fabric wound on the fabric beam of the Textima loom

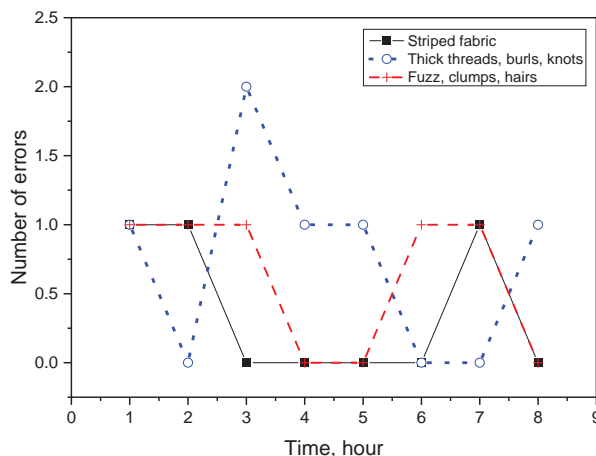
Figures 4 and 5 graphically present the errors on the fabric that occurred during weaving on the loom during the eight-hour working time, i.e. for working in one shift, by recording their number for each hour of machine operation.

It should be noted that all types of errors shown in Figures 4 and 5 are only registered during weaving, i.e. such errors are not removed nor is the loom stopped. Only breaks in the warp or weft threads stop the loom and require the intervention of the loom operator.

Figure 5: The appearance of defects, streaks, thick threads, burls, knots, fuzz, clumps and hairs on the fabric

- Grease stains, warp stripes and non-woven warp on the fabric as a type of fault can be eliminated by more careful work of the server.
- Stripes on the fabric, thick threads, knots, hairs and lumps are errors that are not tolerated, considering that the fabrics are used to make products intended for export, and are subject to mandatory eco-tex certification.
