The debris flow disasters 2012 and 2013 in Austria

Debris flow event 2012 – torrent Lorenzerbach

Debris flow event 2013 - torrent Sattelbach

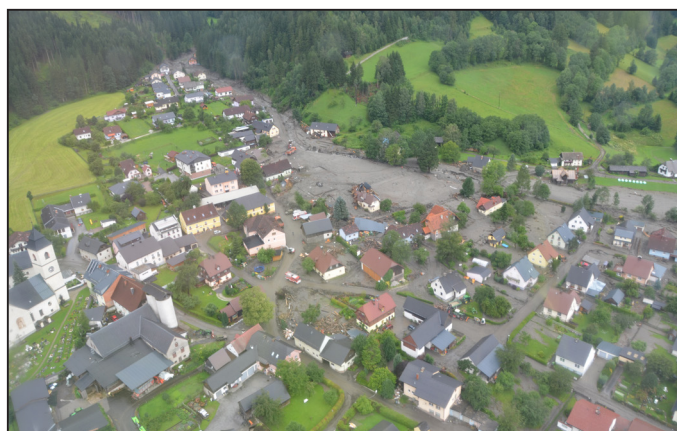
Figure 2 Residential area of St. Lorenzen following the debris flow event of 21st of July 2012

A total of 67 buildings were damaged along the Lorenz torrent, 7 of were completely destroyed. In the town center, flooding heights of up to 3 m were measured.

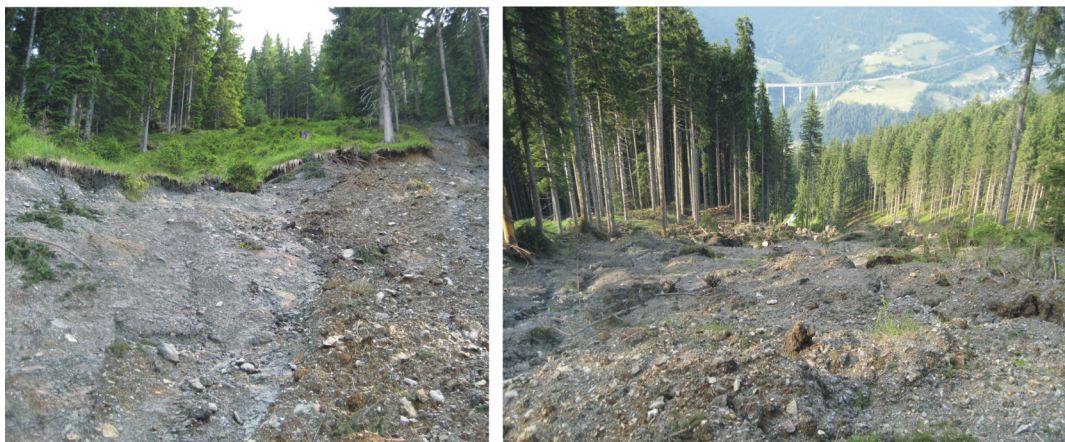
Figure 7 Landslide in the upper catchment

The triggering event for this debris flow can be identified as a landslide of 2000 m² extent in the upper catchment area. This mass movement event developed into a debris flow because of the steepness of the torrent. The previously deposited sediment in the torrent was washed away in its entirety by the debris flow, exposing the underlying bedrock. According to expert estimates, the resulting debris flow transported 12,000 m³ of material.

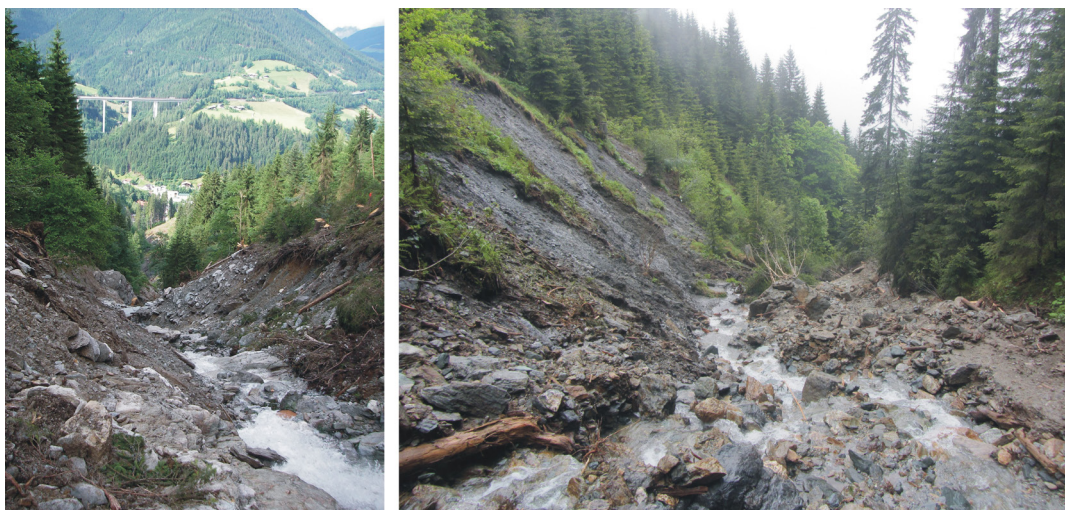
Figure 8 Situation in the middle reach (eroded cross section to bedrock)

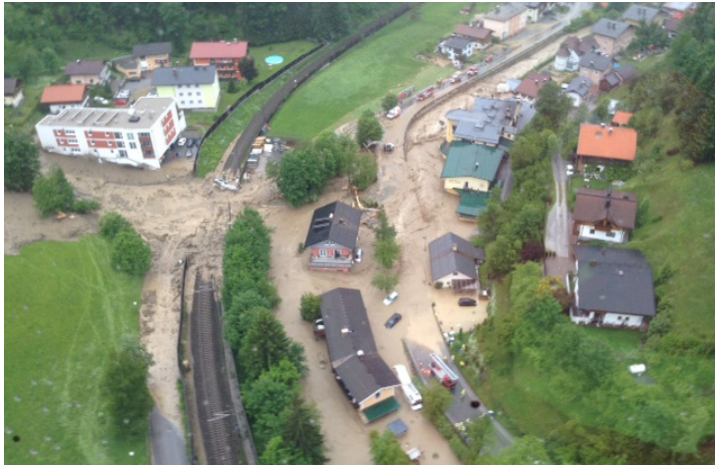
Figure 9 Situation at the junction with the tributary Fritzbach

orographical left side, impacting upon objects on the left bank, after which the debris flow swerved toward the orographic righthand side of the valley, destroying the staff quarters of the Hotel Hubertushof. In the vicinity of the railroad crossing, a blockage of the culvert as well as the receiving stream, the Fritzbach, occurred.

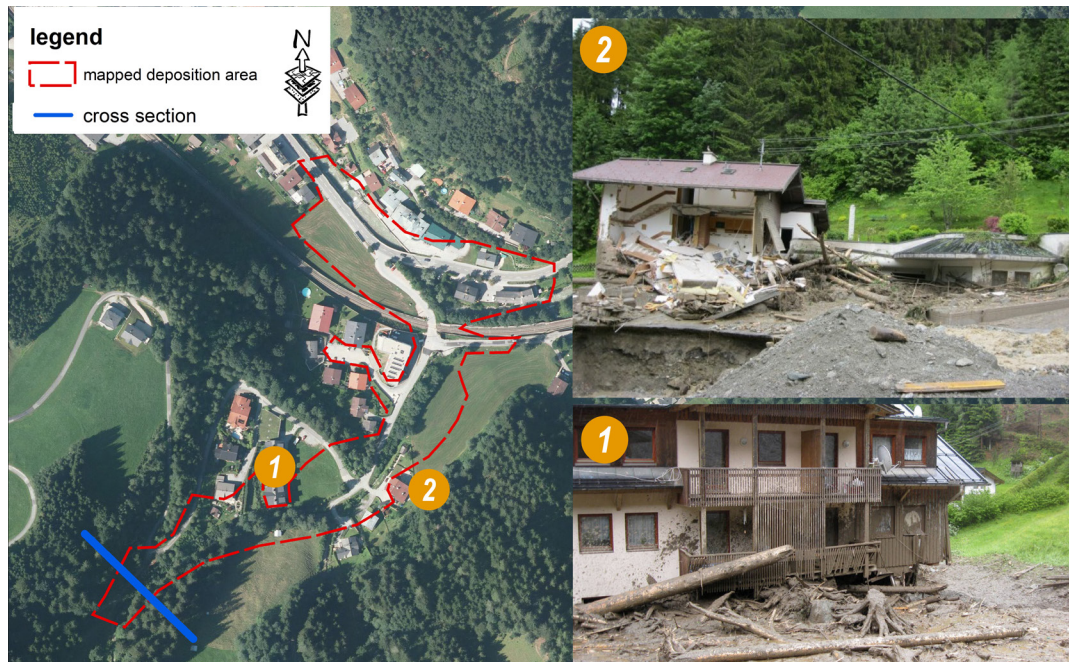
Figure 10 Mapped deposition area with control cross section (violet line)

Due to the steep and very deeply incised torrent, the debris flow was channelized along the middle reaches. At the apex of the debris cone, the debris flow at first swerved strongly toward the
