REHABILITATION OF THE BRIDGE OVER THE RIVER RIBNICA

Paper type: Review paper

Summary: The paper presents a rehabilitation project of the bridge over the river Ribnica, based on on-site inspection and available technical documentation on the condition of the bridge. The existing bridge is a road, reinforced concrete with main steel girders IPE 180. The existing girder bridge has a span of 2 m x 6,5 m. Two variant solutions for the rehabilitation of the existing bridge are analyzed. The first solution included the removal of the existing reinforced concrete plate and the production of a new reinforced concrete plate, with the rehabilitation of the steel girders in accordance with the new load impacts. The second solution includes the removal of the existing reinforced concrete plate, the dismantling of the existing steel profiles and the production of a new reinforced concrete plate. The terms of reference required that the effects on the bridge be considered for the V300 vehicle. In addition to the road construction, two footpaths were designed. The static calculation was done in the Radimpex Tower 8.4 programme.

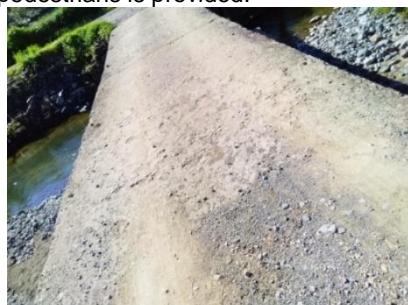
a) Pavement slab / Kolovozna ploča

Figure 1 - Existing condition of the bridge/
Slika 1 - Postojeće stanje mosta

The need for rehabilitation arises due to the bad condition of the bridge and the compromised traffic safety, which is shown in Figure 1. Also, pedestrians are not safe, because no special space for pedestrians is provided.

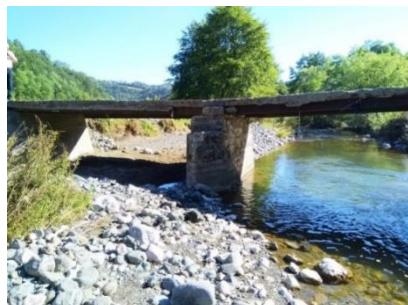
c) Damage to the middle pillar/
Oštećenje srednjeg stuba

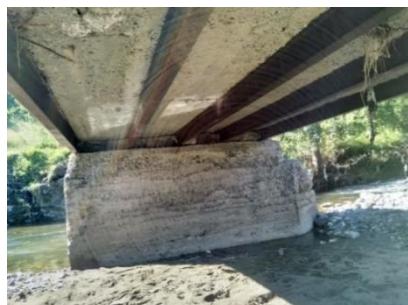
b) Middle pillar and IPE beams/
Srednji stub i IPE nosači

Based on the in-situ inspection and the available technical documentation on the condition of the bridge, the bridge repairment was presented. The existing bridge over the river Ribnica is a girder, reinforced concrete bridge with the IPE 180 beams. It has two openings. The IPE 180 beams are a static system of two simply supported beams. They rely on the middle pillar in the river and the supporting pillars. The pavement structure is a solid reinforced concrete slab with a thickness of 20-25 cm. The existing length of the bridge is 13 m, while the width of the bridge is 3,20 m, without footpaths.

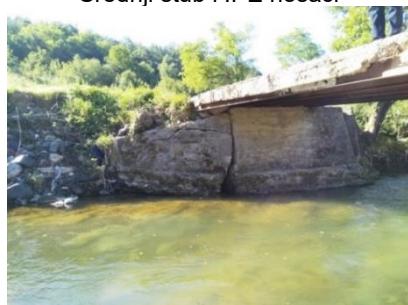
d) Coastal will / Obalni oporac

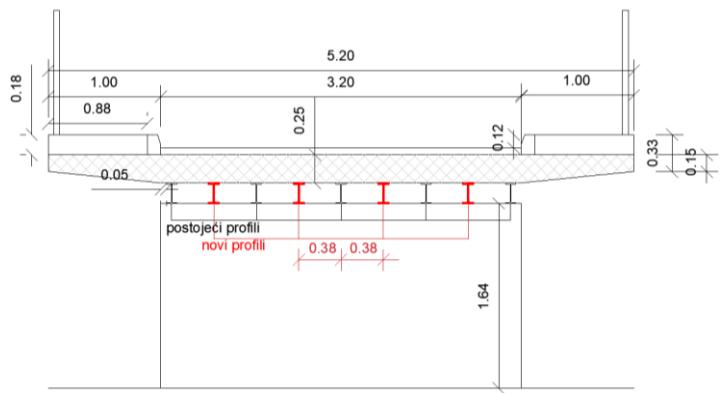
Figure 2 - Cross-section of the repaired bridge - the first alternative solution
Slika 2 - Poprečni presek saniranog mosta - prvo varijantno rešenje

In this paper, two variants of the solutions for the repairment of the existing bridge are analysed. The elements are dimensioned to be able to receive loads from traffic and footpaths. The first solution included the removal of the existing reinforced concrete slab and the repairment of the steel beams (by adding 4 new IPE 180 beams) in accordance with the new loads impacts. A new reinforces concrete deck with a thickness of 25 cm was designed, which rests on 9 steel beams (existing and additional). Table 1 shows the characteristics of the applied steel standard section. Impacts from the load of vehicles and footpaths are transferred to the steel beams.

The planned width, for both analysed variant solutions, of the repaired bridge is 5,2 m, the roadway width 3,20 m and the pedestrian paths are 1 m wide. The pavement is raised 12 cm in relation to the road surface and a 12 cm x 15 cm curb is installed. In order to protect pedestrians, a 1 m high fence is provided on the footpaths.

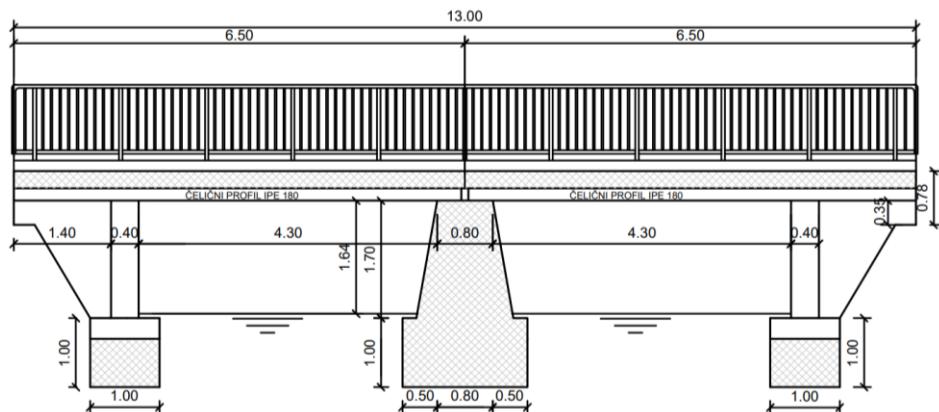
Figure 3 - Longitudinal section of the repaired bridge - the first alternative solution
Slika 3 - Podužni presek saniranog mosta - prvo varijantno rešenje

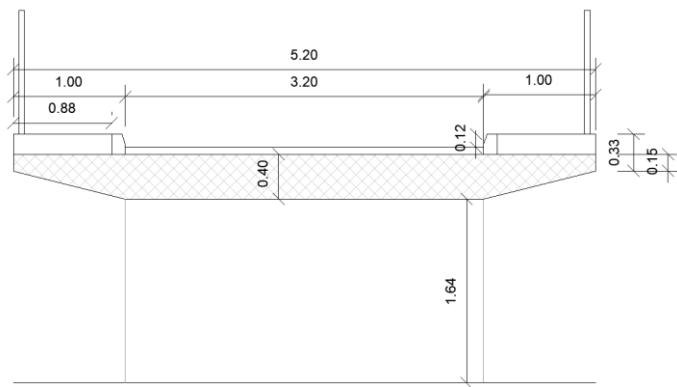
Figure 4 - Cross-section of the repaired bridge - the second alternative solution
Slika 4 - Poprečni presek saniranog mosta - drugo varijantno rešenje

The second solution of the repairment includes the removal of the existing reinforced concrete slab and the dismantling of the existing IPE profiles, after which a new reinforces concrete slab with a thickness of 40 cm is constructed. Impacts from vehicle loads and footpaths are transferred to the concrete slab.

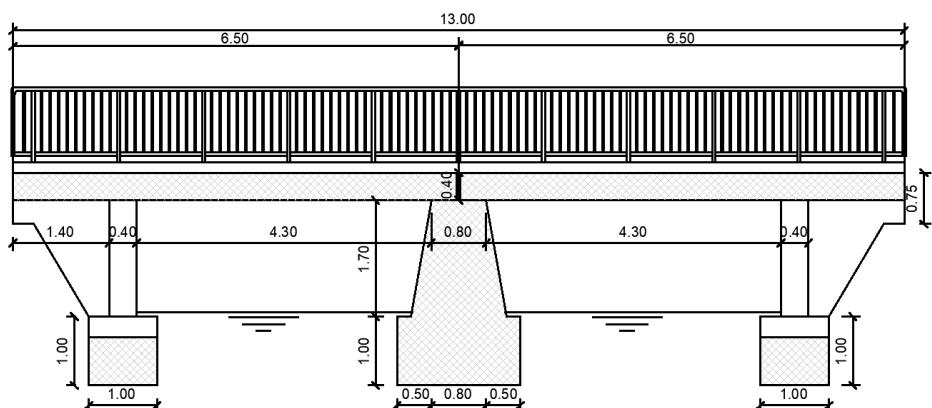
Figure 5 - Longitudinal section of the repaired bridge - the second alternative solution
Slika 5 - Podužni presek saniranog mosta - drugo varijantno rešenje

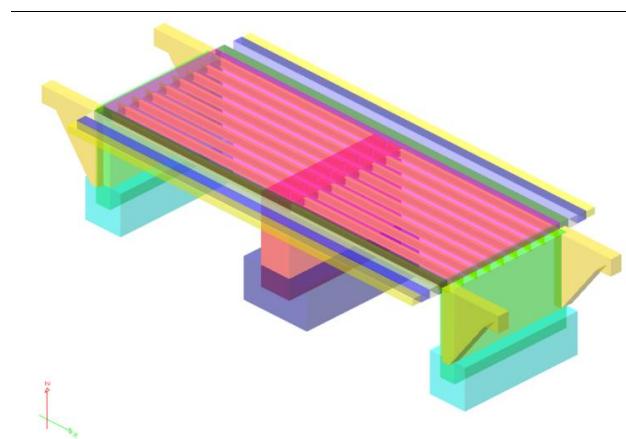
Figure 6 - 3D model of the first variant of the rehabilitation solution
Slika 6 - 3D model prvog varijantnog rešenja sanacije

The static calculation of the bridge was performed by using the Radimpex Tower 8.4 programme, a static system of two simple beams. Materials are modelled as elastic and isotropic for all structural elements. Steel and hot-rolled profiles with Young's modulus of elasticity $E = 210 \text{ GPa}$, Poisson's coefficient $\nu = 0,3$ and coefficient of linear thermal expansion of the material at were used $\alpha_t = 10^{-5} \text{ } 1/\text{^{\circ}C}$. The foundation, columns and reinforced concrete slab are made of concrete strength class C 25/30 with Young's modulus of elasticity $E = 31 \text{ GPa}$ and Poisson's coefficient $\nu = 0,2$. The load analysis [1-3] included loads from: the structure's own weight, additional permanent load, axle traffic load from the LM1 model for the V300 vehicle, continuous traffic load from the LM1 model for the V300 vehicle, axle traffic load from the LM2 model for the V300 vehicle, vehicle starting and braking forces, loads on pavements, uniform temperature changes, linear temperature changes and vehicle impact on the kerb.

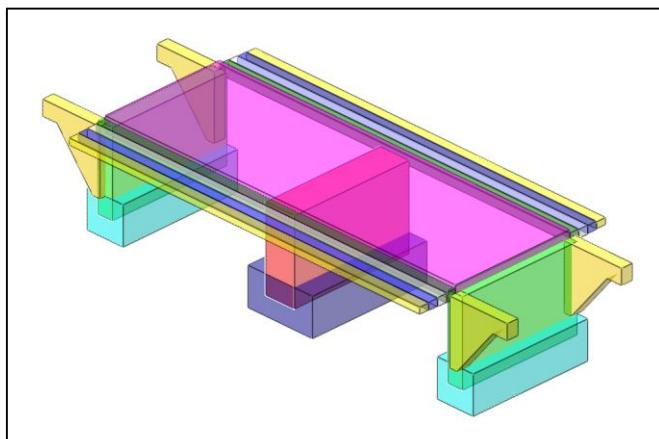
Figure 7 - 3D model of the second variant of the rehabilitation solution
Slika 7 - 3D model drugog varijantnog rešenja sanacije

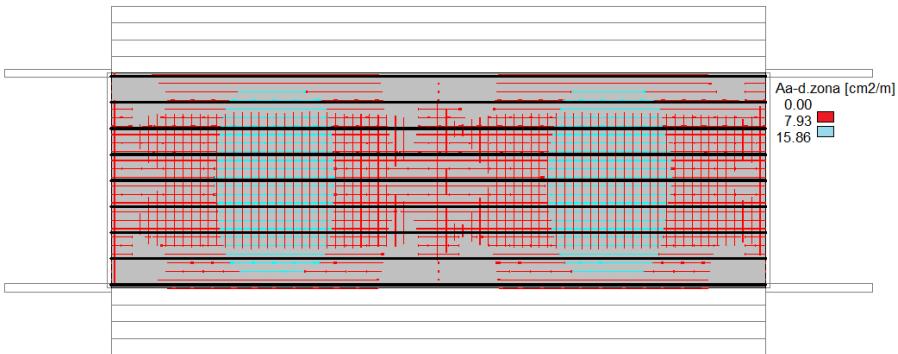
Figure 8 - Diagram of the required reinforcement in the lower zone of the reinforced concrete slab of the newly designed bridge - the first variant solution

Based on the conducted static analysis, the obtained results show that both variant solutions of rehabilitation meet the conditions for dimensioning. Figures 8 and 9 show the required reinforcement for the first case of repairment, and Figure 10 and 11 show the reinforcement for the second case of repairment. It can be noted that the isolines for the required reinforcement in the lower zone have a relatively similar appearance for both predicted variants, which is also shown by the required reinforcement. Also, it is the same for the upper zone, only for the first variant solution, a larger amount of reinforcement appears above the middle column, compared to the second variant solution.

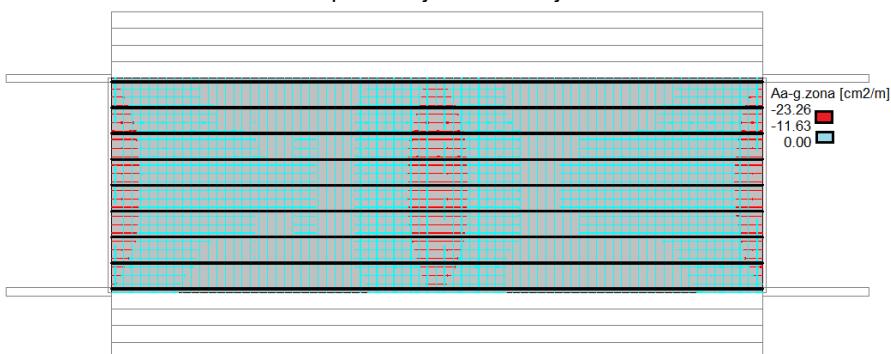
Figure 9 - Diagram of the required reinforcement in the upper zone of the reinforced concrete slab of the newly designed bridge - the first variant solution

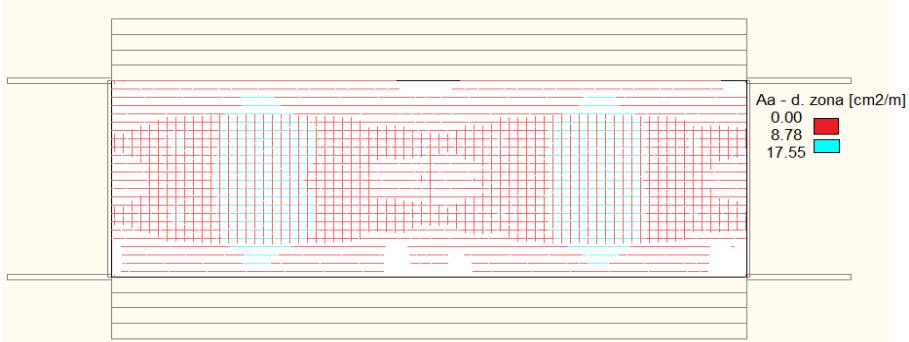
Figure 10 - Diagram of the required reinforcement in the lower zone of the reinforced concrete slab of the newly designed bridge - the second variant solution

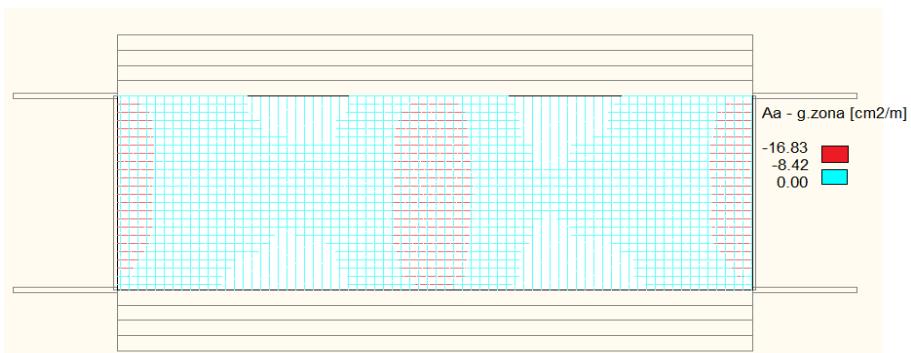
Figure 11 - Diagram of the required reinforcement in the lower zone of the reinforced concrete slab of the newly designed bridge - the second variant solution

Slika 11 - Dijagram potrebne armature u gornjoj zoni AB ploče novoprojektovanog mosta
- drugo varijantno rešenje
