# CORROSION BEHAVIOR OF FRICTION STIR WELDED AlMgMn ALLOY

## KOROZIONO PONAŠANJE AlMgMn LEGURE ZAVARENE POSTUPKOM TRENJEM ALATOM

**Originalni naučni rad / Original scientific paper**

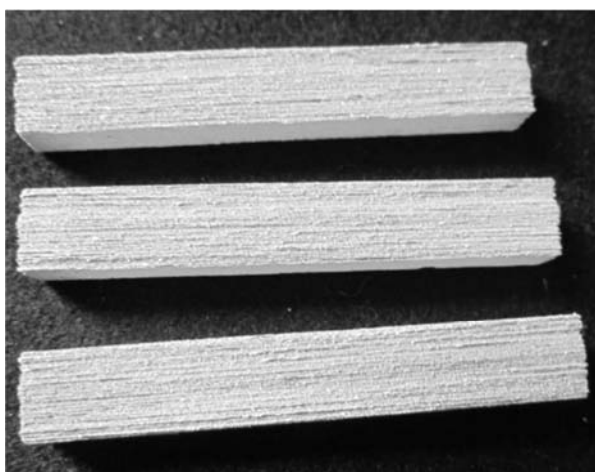
**Slika 2.** Uzorci AlMg6Mn legure nakon NAMLT testa.

Rezultati merenja gubitka mase uzoraka legure i zavarenih spojeva nakon NAMLT testa su dati u tabeli 2, a izgled uzoraka nakon testa na slikama 2 i 3.

Na bazi rezultata gubitka mase i dimenzionih merenja, moguće je izvršiti približnu procenu gubitka mase u „samom“ FSW spoju. Vizuelnom analizom uzoraka nakon ispitivanja i poređenjem dimenzija uzoraka pre i nakon testa, je uočen različit korozioni uticaj po dužini uzoraka (slike 2 i 3). Uočeno je da su krajevi uzoraka „stanjeni“ u

Uočena je znatna razlika u morfologiji površina nakon NAMLT testa u L-S ravni uzoraka OM i zavarenog spoja. Kod OM koroziona oštećenja su makroskopski homogena sa jasno izraženom usmerenosti duž pravca valjanja (slike 2 i 4). Posmatranjem na stereo mikroskopu jasno je uočen interkristalini karakter razaranja kod uzoraka OM (slika 5a) i uzorcima zavarenog spoja (slika 5b levo), što je potvrđeno i posmatranjem na SEM-u.

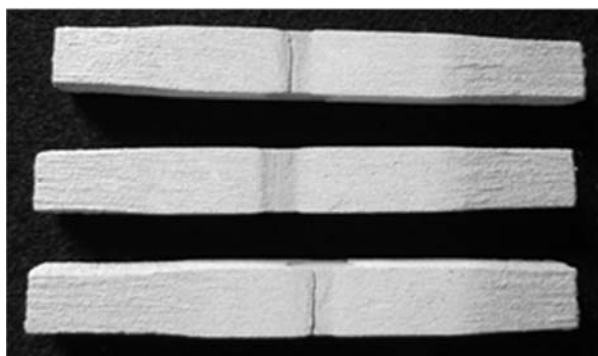
**Slika 3.** Uzorci FSW zavarenog spoja AlMg6Mn legure nakon NAMLT testa: a) L-S ravan; b) (L-T ravan, korena strana).
