# ANALYSIS OF CYLINDER HEAD REPAIR OF MAIN ENGINE: A CASE STUDY OF PASSENGER SHIP KM GD IN INDONESIA

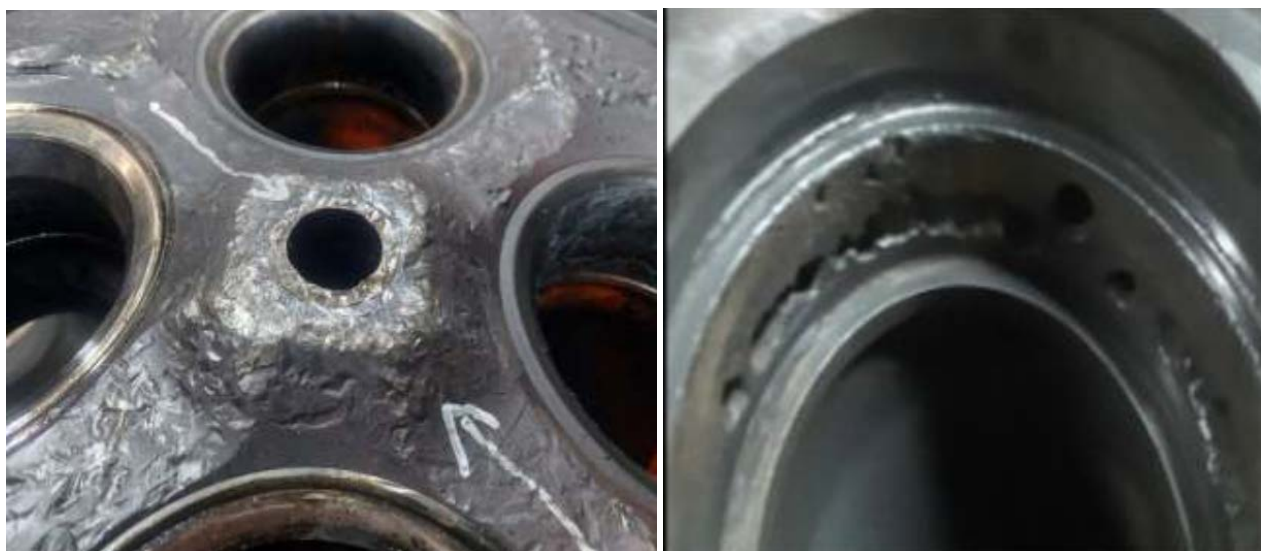
Fig. 2. of the cylinder head crack

Observations based on the Repair Assessment Form (FPP) report showed repeated cracks in the *cylinder head*. KM GD especially in the area of the combustion chamber.

Damage symptoms include oil leakage, white smoke, decreased water pressure, unusual sounds in the cylinder, high temperature, and water discharge from the indicator. PMS data (Table 1) shows the treatment schedule that has been carried out for the cylinder head based on the manual book, but the damage to the cylinder head after reconditioning still occurs, so the researcher searches more deeply using the five whys method and fishbone diagram.

As a recommendation, increased supervision is needed in implementing reconditioning procedures, including adhesive quality control, pressure tests according to manufacturer's specifications, and technician training to improve technical competence and awareness of the importance of standard procedures. In addition, consistent implementation of the Planned Maintenance System (PMS) program, using original parts, and evaluating spare parts procurement management are also important steps to prevent repeated breakdowns.

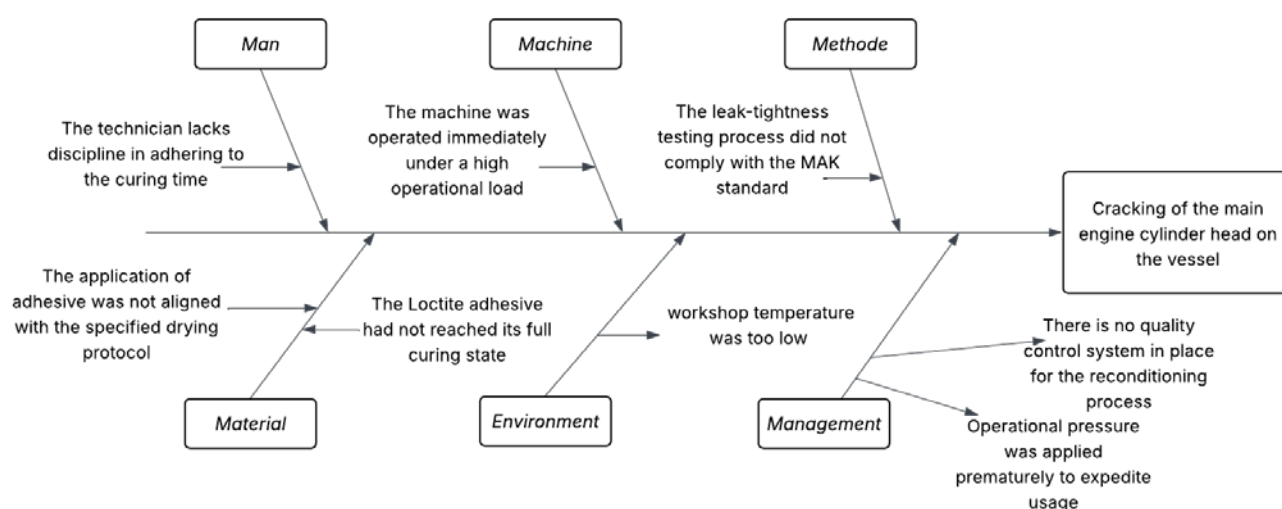
Fig. 3. Fishbone crack diagram

With the data obtained in the five why interview, it can be concluded through grouping as in (table 3) and found fishbone diagrams such as Figure 1 Fishbone Diagram Crack cylinder head

- 1) Overheating is generated when the cooling system is not working optimally; the engine's temperature increases to the extreme. The uneven expansion of the metal due to excessive heat causes thermal stress that triggers cracks.

- 2) **Excessive Compression Pressure:** Compression pressure that exceeds the tolerance limit is caused by fuel injection timing errors, imperfect combustion quality, or carbon deposits in the combustion chamber. Too high a pressure puts an excess load on the cylinder head structure, which in the long run can cause cracking, especially in the area around the valve seat and injector.

- 3) **Material Fatigue** occurs due to using components over a long period and continuously experiences high pressure and temperature cycles. This accumulation of cyclic stress leads to a decrease in the durability of metal structures. At some point, the strength of the metal decreases to the point where it can no longer withstand typical workloads and eventually gives rise to micro-cracks that develop into structural cracks.

- 4) **Improper Reconditioning Procedure** Reconditioning procedures that do not comply with technical standards are one of the significant factors that cause cracks. Some common findings in the field include over-welding of pocket valves, inconsistencies in the pressure test process, and neglected chemical cleaning processes. This mismatch causes the cylinder head to not return to the manufacturer's standard condition and becomes susceptible to stress when the engine returns to operation. This shows the importance of standardization and quality control in the reconditioning process.

In the Fishbone Diagram analysis, cooling system factors were conceptually represented under the “Machine” and “Environment” categories. Issues such as coolant flow restriction, temperature imbalance, and insufficient circulation were identified as contributing elements that directly cause overheating and thermal fatigue leading to cylinder head cracking. Although no structural modification was made to the diagram, the inclusion of these aspects provides a clearer understanding of how cooling performance interacts with other operational variables.
