## THE INFLUENCE OF DESIGN CONDITIONS ON THE FAILURE OF THE UNIVERSAL CROSS JOINT (UCJ) OF THE CARDAN COUPLING

**Abstract:** In the system of power transmission from the driving to the operating machine, cardan couplings are components of vital importance. Due to the ability to transmit power over long distances, as well as insensitivity to the coaxiality of the connecting shafts, they have found wide application in all branches of mechanical engineering. In the plant for the production of profiled semi-finished steel products, a volumetric failure of the sleeve on the universal cross joint (UCJ) of the cardan coupling occurred. This type of failure occurs very rarely with cardan couplings. In order to understand the real reason for the failure of the sleeve, analytical and numerical models were formed, and tests of materials and fracture surfaces were carried out. The influence of the line load distribution at the mating surfaces and the geometric stress concentration on the load capacity of the UCJ was analyzed using the developed models. With the increase in the unevenness of the line load distribution, the influence of tangential stresses on the stress state in the critical cr

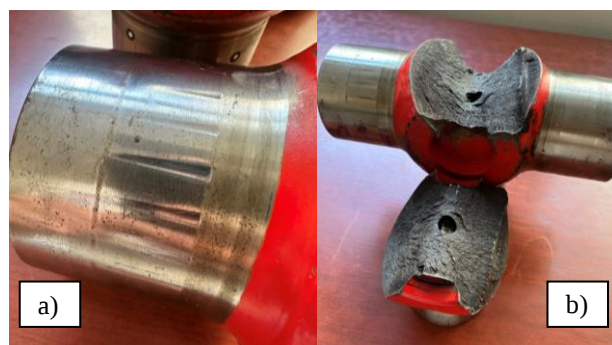
Surface and volumetric damage were generated on the sleeve of the UCJ of the cardan coupling which connects the shaft of the working machine and the telescopic shaft. Destruction in the form of local plastic deformations appeared on the contact surface of the sleeve in question, Figure 2.1a. It is common that after long-term usage, unilateral wear occurs at a joint's shaft journal; this eventually leads to grooves forming on the contact surface of the universal joint, which in turn causes looseness and

noise [7]. In addition to the surface destructions, volumetric destruction in the form of breakage were also generated on the sleeve, Figure 2.1b. The surface damage is located in the load zone of the needle bearing, i.e. in the zone where the load is transferred between the sleeve and the bearing.

**Figure 2.1.** a) Surface damage of the sleeve in the form of local plastic deformations, b) volumetric damage of the sleeve in the form of breakage

Formed damage is manifested by the appearance of grooves due to plastic deformation of the surface layers of the contacting surfaces of the sleeve and rolling elements -- needles. The direction of the grooves coincides with the direction of the longitudinal axis of the sleeve. Grooves are not present along the entire length of the sleeve's contact surface. They extend from the beginning of the contact surface, which is located near the root of the sleeve, to approximately the middle of the length of the sleeve, Figure 2.1a.

On the basis of the generated surface damage on the sleeve, Figure 2.1a, it can be concluded that the depth of the formed grooves changes along the sleeve. It is the largest at the beginning of the contact surface, which is located near the root of the sleeve. Then it gradually decreases, and in the middle of the length of the sleeve it is negligibly small. On the basis of these damages, it can be concluded that the load distribution along the length of the contact of the contacting parts, the sleeve and the rolling bodies (needles), was uneven. Due to such distribution of the line load, the contact surface on the upper part of the sleeve's length participated minimally in the transmission of the working load.

In the considered UCJ, two needle bearings are placed between the sleeves of the cross and the fork. After dismantling the coupling, an uneven distribution of the line load was registered by visual control. Figure 2.1.a, that is, one needle bearing, placed closer to the root of the sleeve, was significantly more involved in transferring the load. The engagement of the second bearing, placed closer to the top of the sleeve, is less than the first bearing.

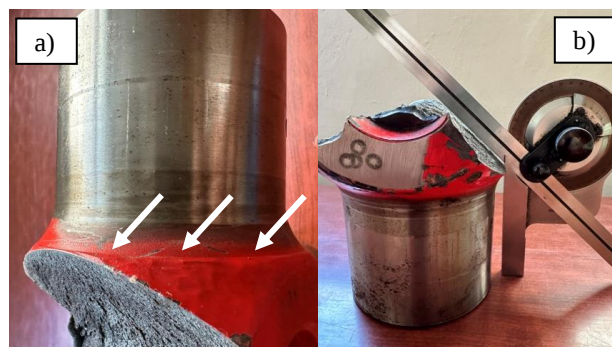
**Figure 2.2.** Fracture of the sleeve of the UCJ

there was a volumetric destruction of the sleeve, Figure 2.2a and 2.2b. The fracture occurred on the sleeve of the UCJ, which is connected to the fork of the intermediate shaft. On the surface of the fracture, two zones are clearly visible, the zone of dynamic and the zone of static destruction, Figure 2.1b. The size of the fatigue failure zone is approximately 30% of the static failure zone. On the basis of this fact, it can be concluded that the process of dynamic destruction gradually expanded and progressed. The fracture surface does not lie in one plane, but in two planes that form an angle of  $90^\circ$ . This means that, in addition to normal stresses, tangential stresses also had a strong influence on the destruction process.
