## RESEARCH OF THE DRAW HOOK FAILURES ON RAIL VEHICLES IN SERBIA

**Abstract** – Draw hook failures present significant problems for railway safety and operational efficiency. Although failures on the draw gear are not frequent, they can induce serious problems on the vehicles and infrastructure when some elements break. This paper presents comprehensive research on the potential causes of these failures, aiming to provide insights for prevention measures related to materials, production process, geometry and manipulation practices during train operation. The draw hook, as one of the vital components in connections of wagons and locomotives, ensures the safety and reliability of trains during operation. By analyzing the historical failure data and relevant literature, this study identifies several key factors contributing to coupler failures. Material degradation emerges as a prominent concern, with factors such as fatigue, wear, and corrosion compromising the structural integrity of the coupler hook and other components over time. Overloading during starting, impacts, or improper coupling procedures further increase the risk of failures. Mechanical and physical characteristics of

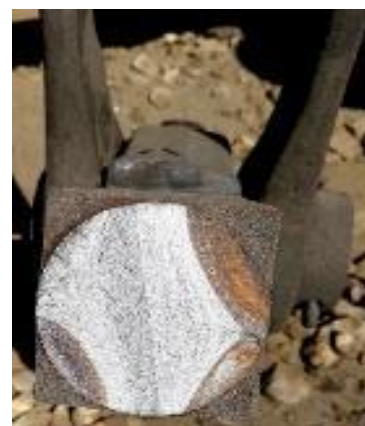
The aim of this paper is to show and identify some of draw hooks failure on rail vehicles in Serbia, as well as to present method for determine causes that contribute to these failures. Surface of the broken locomotive draw hook (Section 3, Fig. 1) happened in 2020. in Serbia is presented in Figure 3 [8].

Fig. 3. Locomotive draw hook

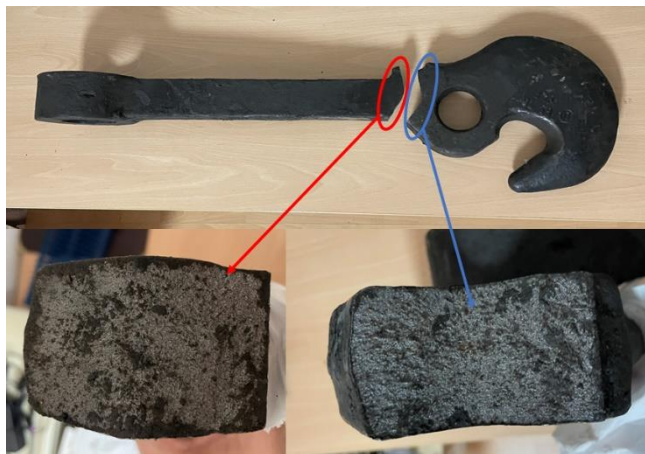
Two more broken hooks in Serbia were presented in Figures 4 and 5. The first draw hook broke in March 2021. on the line Belgrade-Novı Sad, Figure 4. The place of break fits Section 2 in Figure 1. The draw hook

was a part of the draw gear of one of 29 freight wagons in the train with a gross weight of 1920t and a total length of 479 m.

Fig. 4. Draw hook 1

The experimental investigations of the failures of these two draw hooks will focus on the analysis of the material properties and the operational conditions.

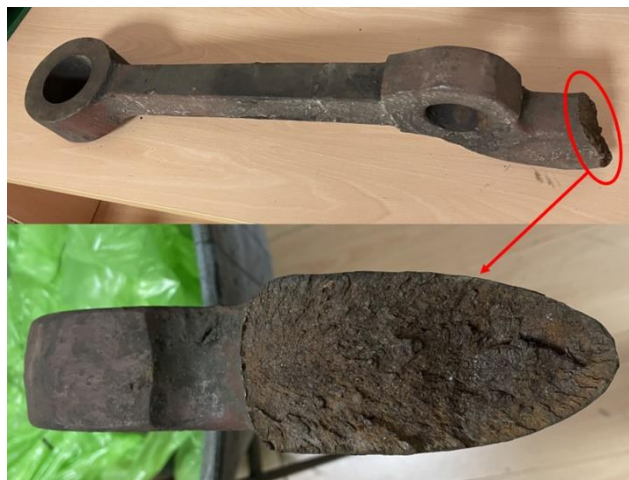
The second draw hook accident happened in July 2021, Figure 5. This accident occurred when the train of mass 1662t was accelerating from 20 km/h to 30 km/h on an incline. Reaching the speed of 30 km/h, the train was stopped due to a loss of air from the main brake line. The place of the break fits Section 1 in Figure 1.

Fig. 5. Draw hook 2
