## THERMOGRAPHIC ASSESSMENT OF PRESSURE RELIEF VALVE OPERATION

**Abstract:** This paper presents a thermographic investigation of the Bowen HR560 coiled tubing unit, used in drilling operations in oilfield applications. The unit enables well interventions using coiled tubing, including pressure control via safety valves. The aim of this study was to assess the operational condition and detect potential malfunctions in the unit, particularly around the pressure relief valve, using thermography as a non-invasive diagnostic method. An infrared camera was employed to identify thermal anomalies, such as localized overheating, which may indicate mechanical faults, inadequate lubrication, or excessive operating pressure. The obtained thermograms were compared with reference thermal profiles to detect deviations and potential indicators of operational issues. The results demonstrate that thermography is an effective tool for early fault detection and for maintaining the operational reliability of coiled tubing units, thereby contributing to safety and uninterrupted performance in well intervention operations.

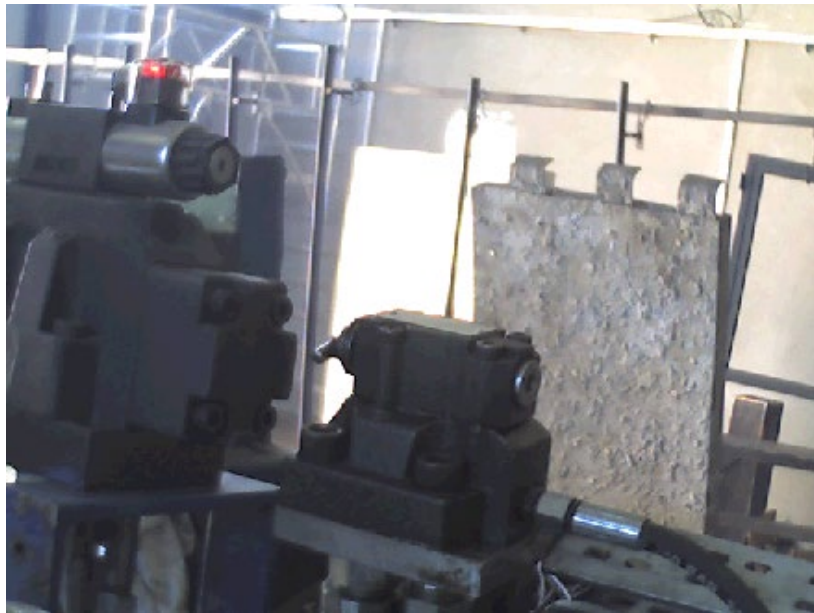
**Fig. 2a.** Pressure relief valve temperature after entering the second hour of continuous machine operation

**Fig 2b.** Pressure relief valve

From the thermal image, it can be observed that, compared to the first hour of machine operation, there has been a noticeable heating of the pressure relief valve, with the thermal image indicating that the temperature of the observed valve has now reached a value of 53.6 °C.

Based on a three-hour monitoring of the pressure relief valve, it can be observed and concluded, from the thermal image obtained through thermographic inspection and diagnostics, that the central issue of the Bowen system is the heating generated by the pressure relief valve, which is definitively malfunctioning. A potential cause of the pressure relief valve malfunction in this system is the weakening of the valve spring, leading to frequent 'opening' of the valve, thereby preventing the oil in the reservoir from cooling properly.

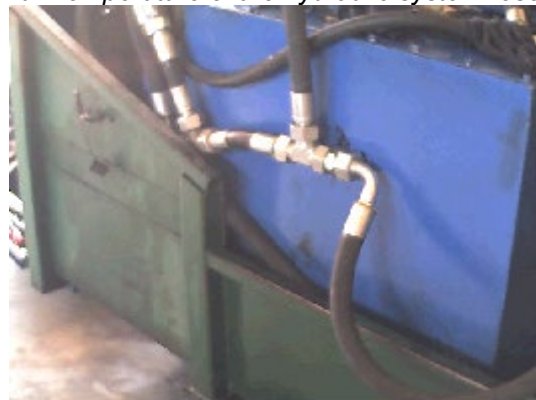
Fig. 4 shows the reservoir, which also began to heat up after a two-hour period of operation, with its temperature increasing exponentially. This confirms that the oil in the reservoir cannot cool down sufficiently quickly due to the malfunctioning of the valve.

**Fig. 4a.** Temperature of the hydraulic system reservoir.

**Fig 4b.** Hydraulic reservoir.

From Fig. 4, it can be seen that the heating poses a potential risk of contamination of the hydraulic oil within the system. After two hours of operation, the oil temperature in the reservoir began to rise, reaching 46.5 °C.
