## Partial Replacement of the Active Steel on the Turbogenerator End Zone

Original scientific paper

This modernization was done on the generators type TVV-200-2A in TPP Bitola, and is subject of this paper.

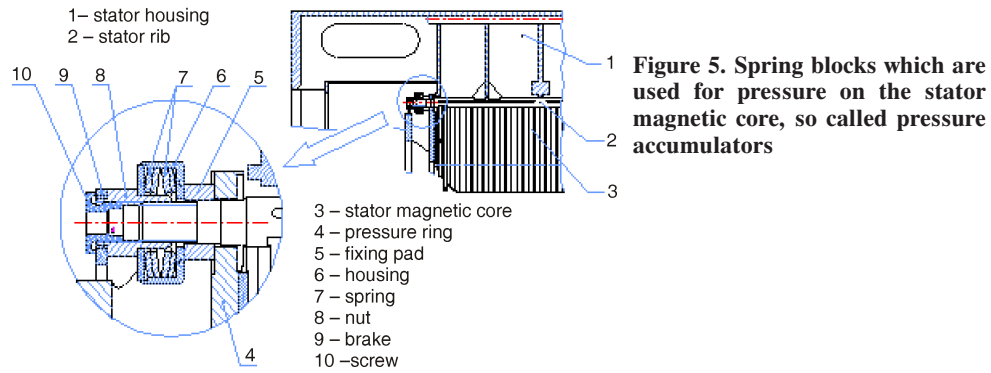
On fig. 6 one pressure accumulator which has been mounted on turbo-generator n.1 in TPP Bitola is presented.

**Figure 6. Pressure accumulator mounted on turbogenerator n. 1 in TPP Bitola**

The efficient method of restoring the active steel tightening force at the first and the second loosening stages is the installation of special spring devices having the specified and adjustable pressure under the core tightening nuts (fig. 5).

The spring blocks (pressure accumulators all together 20 from each side of the core) are mounted after carrying out the works on the teeth local repairs and additional works ensuring the core pressure rings movability.

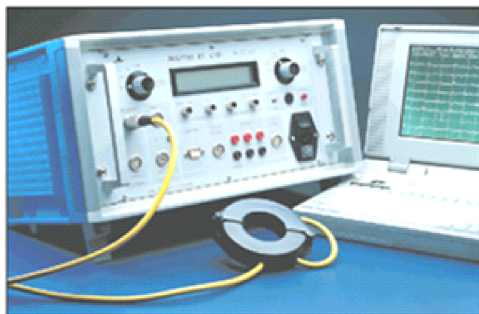
**Figure 7. Instrument ELCID and probes in process of electromagnetic control of stator core**
