### БРЗА ДИЈАГНОСТИКА КАТАСТРОФАЛНОГ ДОГАЂАЈА КОЈИ СЕ ДОГОДИО 3. АВГУСТА 2015. ГОДИНЕ У ПОЛОШКОЈ ОБЛАСТИ

### RAPID DIAGNOSTIC OF THE CATASTROPHIC EVENT HAPPENED ON 3<sup>RD</sup> AUGUST 2015 IN THE POLOG REGION

<sup>1\*</sup>Ss. Cyril and Methodius University in Skopje, Faculty of Forestry

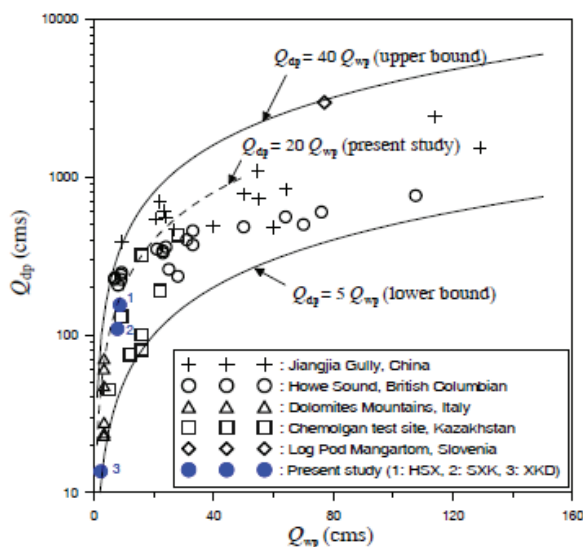
**Figure 15.** Relationship between the debris-flow discharge  $Q_{dp}$  and the water-flow discharge  $Q_{wp}$  (J.-C. Chen and M.-R. Chuang, 2014).

Above figure show that Debris flow discharge is 5-40 times higher than the water flow discharge. It additionally proves mistakes in torrent control designing in Macedonia in the last 15 years. Taking in consideration complexity of this issues it would be studied in further research.
