Investigations on the Oxidation of Zn-coated Steel Cables

The automotive component industry has been constantly being studying to improve its performance. Bowden cables are present in opening doors, moving windows and others. In braided cables formed by galvanized wires with Zn steel exposed to the usual environmental conditions, the generation of ZnO appears, a phenomenon known as "white corrosion". The investigation consisted of mitigating the causes of the ZnO formation. Scanning electron microscopy (SEM) and Electron Probe Micro-Analyzer (EPMA) technology, allowed to detect that the generation of ZnO was induced by the presence of nucleating elements of ZnO on the surface of the steel cable before galvanizing with Zn. The S, Cl and O became visible in the interface between coating and substrate. This allowed concluding, under the coating, there were harmful products capable of triggering the ZnO nucleation reaction. So, the storage and cleaning of the steel wire before galvanizing is essential to prevent the ZnO formation.

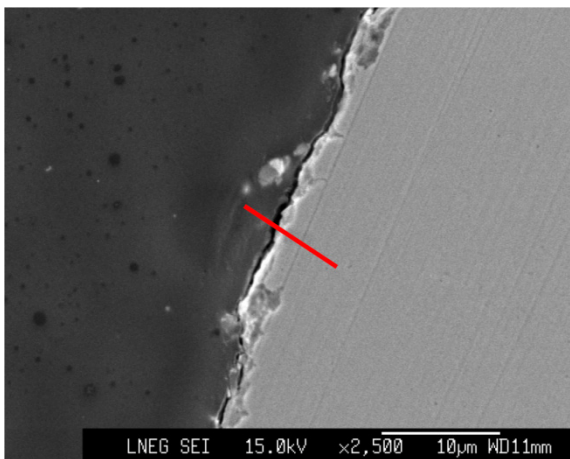
To understand whether these elements were on the outer face of the coating or on the coating/substrate interface, new analyzes were performed following a line (see figure 15) that runs through the coating, from the external resin used in the assembly process to the substrate.

Figure 15. Sample subjected to EPMA analysis following a line.

The results can be seen in figure 16, where four channels were used in order to divide the intensity and location of each element present along the line, considering that the left side of the images is the external resin and the right side the substrate of steel. Each channel was linked to a specific element: pink to O, cyan to Cl, green to S and red to Zn. Cl and O were present in the external resin (assembly process). After that, Zn became visible (coating layer) and S, Cl and O were again visible at the interface between coating and substrate. This ensures that, under the coating, there were harmful products capable of triggering the ZnO formation.
