REHABILITATION OF THE LANDSLIDE AT THE "LANDFILL 3" IN THE ZONE OF THE ČUKARU PEKI FLOTATION TAILING DUMP**

Abstract

The "Landfill 3" was formed at the location of the flotation tailing dump "Čukaru Peki", where the earthen material, created during the dam construction of the flotation tailing dump was placed. A part of the deposited material and substrate at this landfill has slipped that endangers the local road and "Kusak" stream at the landfill foot. That is why this landslide needs to be rehabilitated.

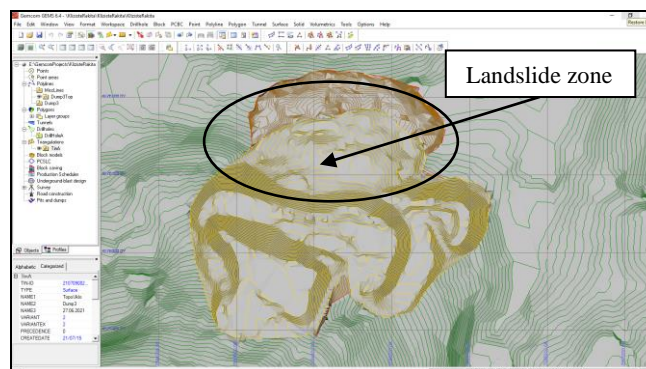
Figure 3 2D view of the field and landfill model

Based on the geotechnical profiles, a 3D model [10-13] of the field and landfill was made in the Gems program, Figures 3 and 4.
