POSSIBILITY OF REHABILITATION AND OVERHANG THE DAM 6 AT THE "VALJA FUNDATA" TAILING DUMP IN MAJDANPEK**

INTEGRATED DISPOSAL OF MINING WASTE, AN EXAMPLE OF REHABILITATION THE DAMAGED EMBANKMENT AT THE RTH TAILING DUMP BY THE MINE OVERBURDEN**

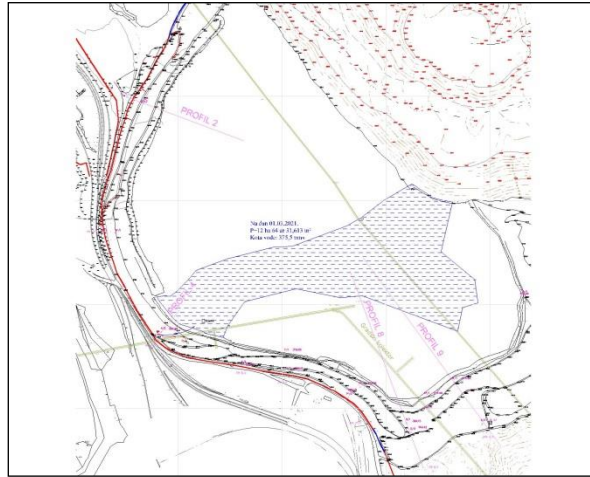
Figure 6 Position of analysis profiles

The stability calculation was done with the SLIDE v6.0 program of the company ROCSCIENCE [7]. The stability calculation is carried out under conditions of limit equilibrium, according to the Yanbu method. The impact of groundwater on stability was modeled on the basis of measured water levels in piezometers and level of the water mirror in tailing dump.
