# RAILWAY TRACK DEFORMATION RESULTING FROM A CURVE NEAR ONE LEVEL CROSSING

**Abstract** – Numerous deformations and failures occur to the railway superstructure within a period of its projected life of use. The rails are the most exposed part of the superstructure for wear. In addition to transferring the vertical load from the vehicle to other elements of the superstructure and substructure, the rail, being in direct contact with the wheel of the vehicle, is subject to several other static and dynamic effects during traffic. In the case of a predicted impact, some procedures can be implemented to minimize rail wear and extend their service life. However, unfavorable circumstances arise, quickly reducing the service life of rails and might contribute to more serious accidents. The investigation focuses on the specific phenomenon of rail's head deformation and track lateral movement at the point of the curvature, when the curvature was placed next to one level crossing. A collection of field data has been studied for a variety of curves. The findings of this study revealed assumption that position of the curvatures in respect to the one-level crossing disrupts the geometry of the t

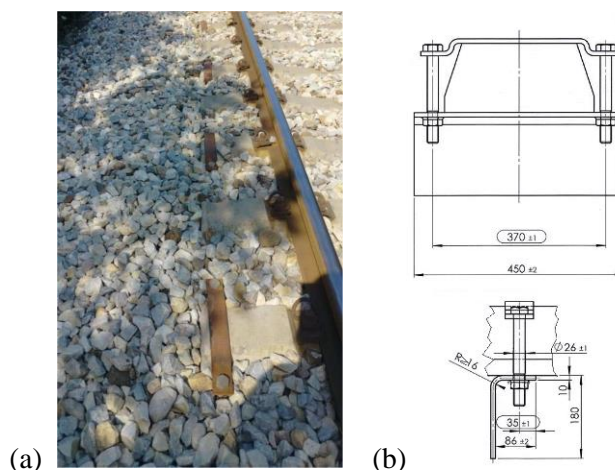
Fig. 4. Concrete sleeper's devices against lateral movement of the tracks: (a)-appearance of the devices on the track, (b)-device's workshop detail (DIV-Svrljig)
