## REHABILITATION AND REINFORCEMENT THE OUTER SLOPE OF THE DAM 6

*As a result of a wide front of filtered water through the outer slope of embankment at the tailing dump Valja Fundata, the dam became unstable in the Sector 6. The embankment no. 6 is almost along its entire length of about 1300 m, built with hydrocyclone sand to a designed level height of K+541 m with a design crown level width of 10 m, even more than that. In addition to the seepage of water, the sand suffusion from the embankment body appears in several places, where smaller or larger ravines are created due to the suffusion. This paper provides a solution to this problem.*

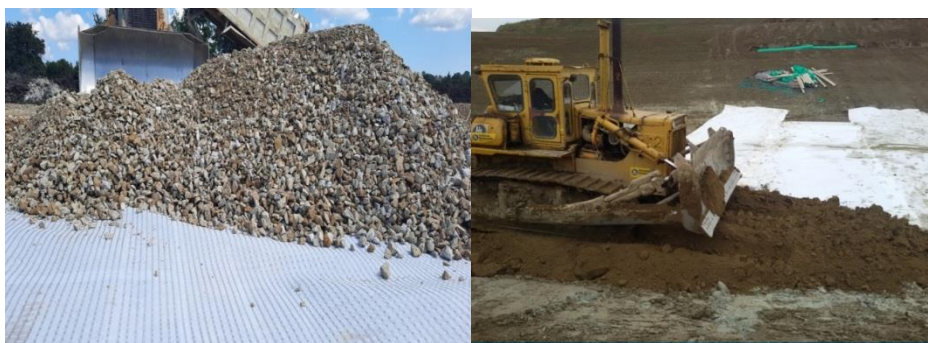
Figure 3 presents the examples of use a securgrid (geogrid with double-sided geotextile) on highways throughout Serbia [3].

**Figure 3.** *Laying of granulate over a securgrid, the Miloš Veliki Highway and Kolubara River bed [3]*
