# Effects of Residual Ni60 Spray Particles on Structured-Blue-Light Scanning Accuracy of Helical Gears

*Residual unmelted alloy particles left after laser cladding severely interfere with structured blue-light scanning for helical gear remanufacturing, resulting in incomplete surface data and distorted geometric measurements in actual production. This study prepared 20CrMnTi helical gear specimens in three steps with varying particle coverage levels and conducted comparative scanning experiments. Real-time images were captured for real-time scanning to observe surface optical changes, while surface completeness, mesh retention, and surface curvature deviation were calculated to evaluate the scanning performance. Experimental results revealed that both scattered and clustered particles triggered scanning defects, and built-in software processing could not fully eliminate errors caused by heavy contamination. A combined pre-scanning solution that included air cleaning, exposure adjustment, and multi-angle scanning was proposed. After treatment, the overall scanning quality of heavily contaminated gears improved significantly. The measurement indicators returned to levels close to th

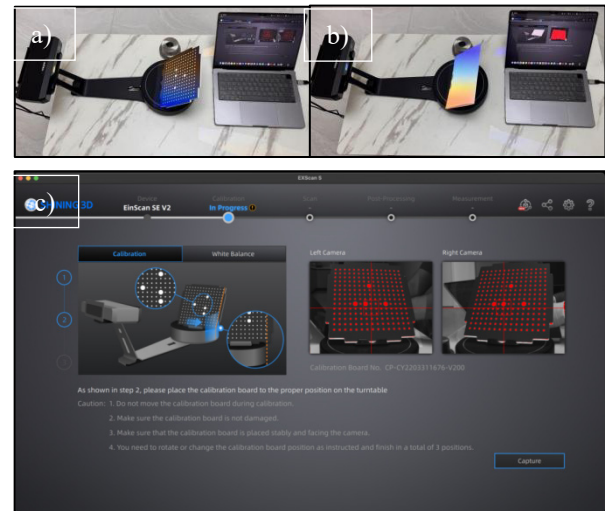
The EXscan SE V2 software shown in Figure 6c was activated to build an independent experimental project and input the standard geometric parameters of the tested helical gear in advance. Three differently pre-treated gear samples were sequentially installed on the turntable, with the installation posture carefully adjusted to ensure that the gear rotation axis coincided with the central axis of the turntable.

**Figure 6. a) Calibration of 3d Scanner. b) White Balance of 3d Scanner. c) EXscan SE V2 Software Interface**
