Nikola Stanić, Saša Stepanović*, Aleksandar Doderović*, Miljan Gomilanović**

DETERMINING THE STRUCTURAL PARAMETERS OF SLOPES AT THE OPEN PIT POTRLICA IN THE ZONE OF SEPARATION DOGANJE

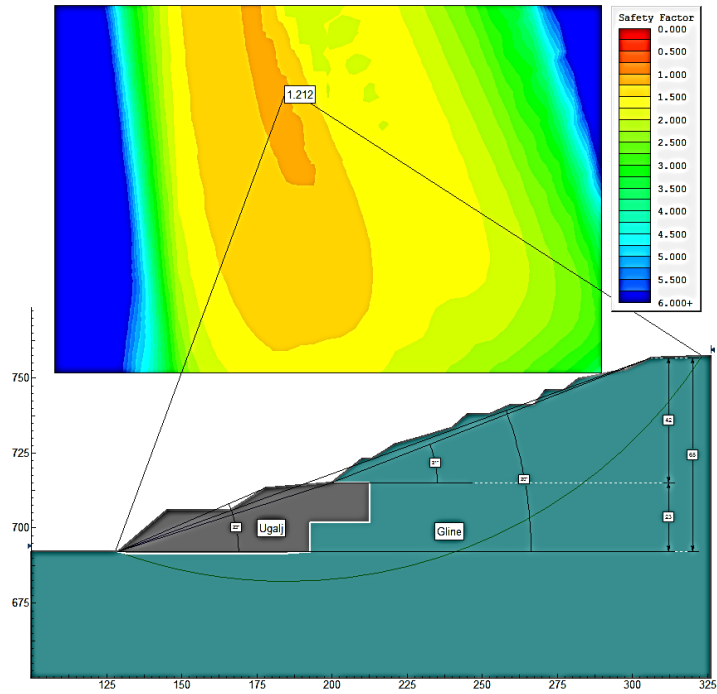
Figure 2 Model and calculated slope stability factor on section 8a

Verification the eastern slope stability of the open pit at the site Cementara was done on sections 8a, 9 and 9a. [2]

Engineering - geological sections for calculation the slope stability factors are formed on the basis of reinterpretation the structural characteristics, made on the basis of the results of exploration drillings, specifically carried out for the needs of rehabilitation. As an illustration of derived calculations, the appearance of geomechanical models is given on characteristic sections, with the values of safety factor for one of the used methods. Typical geomechanical sections are shown in Figures 2, 3 and 4.

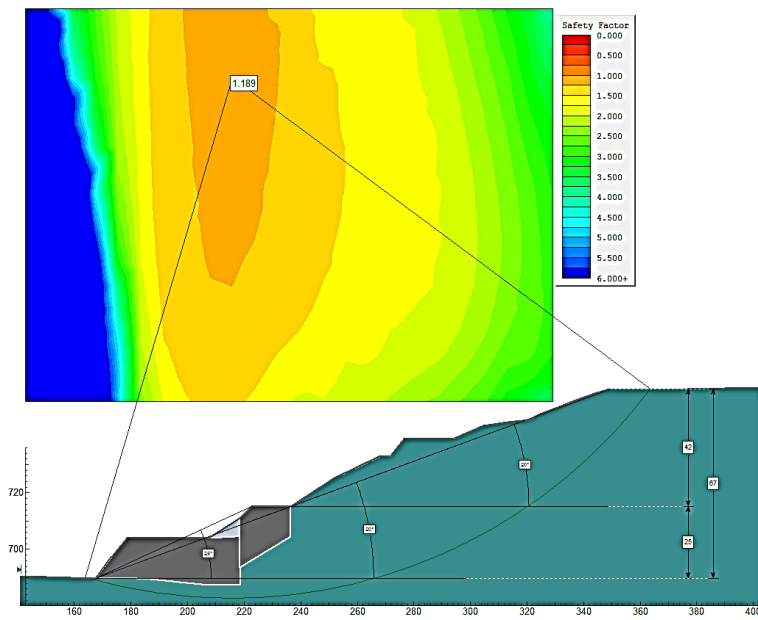
Figure 3 Model and calculated slope stability factor on section 9

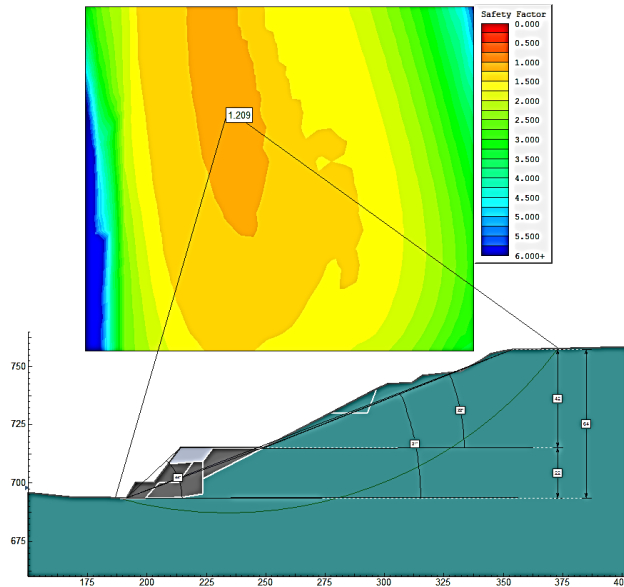
Figure 4 Model and calculated slope stability factor on section 9a
