## Impact of electrolytic hydrogen charging on the mechanical properties and microstructure of AISI304 austenitic stainless steel

FIELD: materials

ARTICLE TYPE: original scientific paper

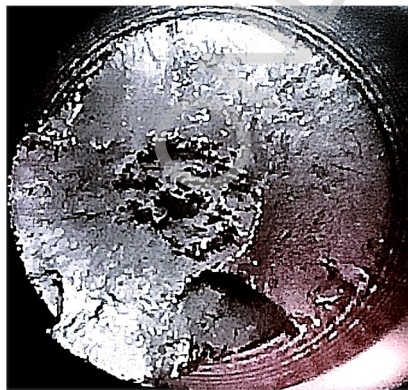
*Figure 9 – Specimen faces after mechanical fracture at tensile testing: (a) crude state faces, and (b) propagation of cracking faces, after the hydrogen pre-loaded state of 13 hours*

in the air serve as a baseline, revealing the specimen crude state without any heat treatments, as Subfigure 9 (a) shows. In contrast, the tests performed in the hydrogen environment for 13 hours, following quenching at 1050°C and tempering at 700°C, show significant internal cracking along the edges of the cylindrical specimen (Subfigure 9 (b)) (Aurélié Laureys et al., 2020). This damage is attributed to a high concentration of absorbed hydrogen which adversely affects the matrix integrity under industrial conditions. The findings highlight the detrimental impact of hydrogen exposure on the mechanical properties of AISI304 steel. The diffusion and penetration of hydrogen molecules, particularly in the form of ( $H_2$ ), are more pronounced in the austenitic phase ( $\gamma$ ) of metals compared to the ferritic phase ( $\alpha$ ), even at room temperature (Frappart et al., 2011). This phenomenon leads to a significant deterioration of the metal's mechanical properties under various mechanical stresses during application. The observations regarding AISI304 steel, which was mechanically deformed and subjected to tensile loading, reveal a heightened sensitivity to crack initiation (Subfigure 9 (b)), with numerous inclusions present on the surface of the hydrogen-loaded samples. The deformed samples show an increased concentration of dislocation tangles at the interface with the matrix, resulting in localized hydrogen accumulation that promotes crack formation. Additionally, the presence of micro-voids (Subfigure 11 (b)), further accelerates the hydrogen embrittlement mechanism. The high number of inclusions in the material (Subfigure 10 (b)), along with the initiation of cracks at the grain boundaries and near these inclusions, suggests that they may act as nucleation points for hydrogen-induced cracks.

A reference Scanning Electron Microscopy (SEM) Quanta FEG650 (accelerating voltage at 20.00Kv, spot size of 5.0nm) in combination with Energy Dispersive X-ray Analysis (EDXA), for the observation of fracture surfaces on cylindrical specimens, has revealed large inclusionary zones where the number of these inclusions represents privileged sites for the initiation of internal cracks in the mechanism of hydrogen-induced cracking (HIC) (Jin et al., 2010). That is particularly true for the HIC phenomenon. The nature of these ODA (Optical Dark Area) inclusions (Jin et al., 2010) is characterized by their shapes, sizes, numbers, and distribution state, which are their main characteristics. These characteristics have a significant influence on the cracking process in the presence of hydrogen molecules ( $H_2$ ). The most harmful inclusions are coarse and closely spaced elongated inclusions (Murakami et al., 2013), as shown in Subfigures 12 (a) and (b). This results in a fracture surface where the metallic matrix is less ductile, and micro-cavities that appear at the particle interfaces can act as internal cracks. If the stress intensity factor exceeds the toughness of the material under study, crack propagation then leads to sudden fracture, which is highly brittle, as depicted in Subfigure 9 (b).
